Williams Walk - Stage 2, Rockbank

Level 1 Inspection & Testing Report

Reference: 1120 0274-1

Bitu-Mill

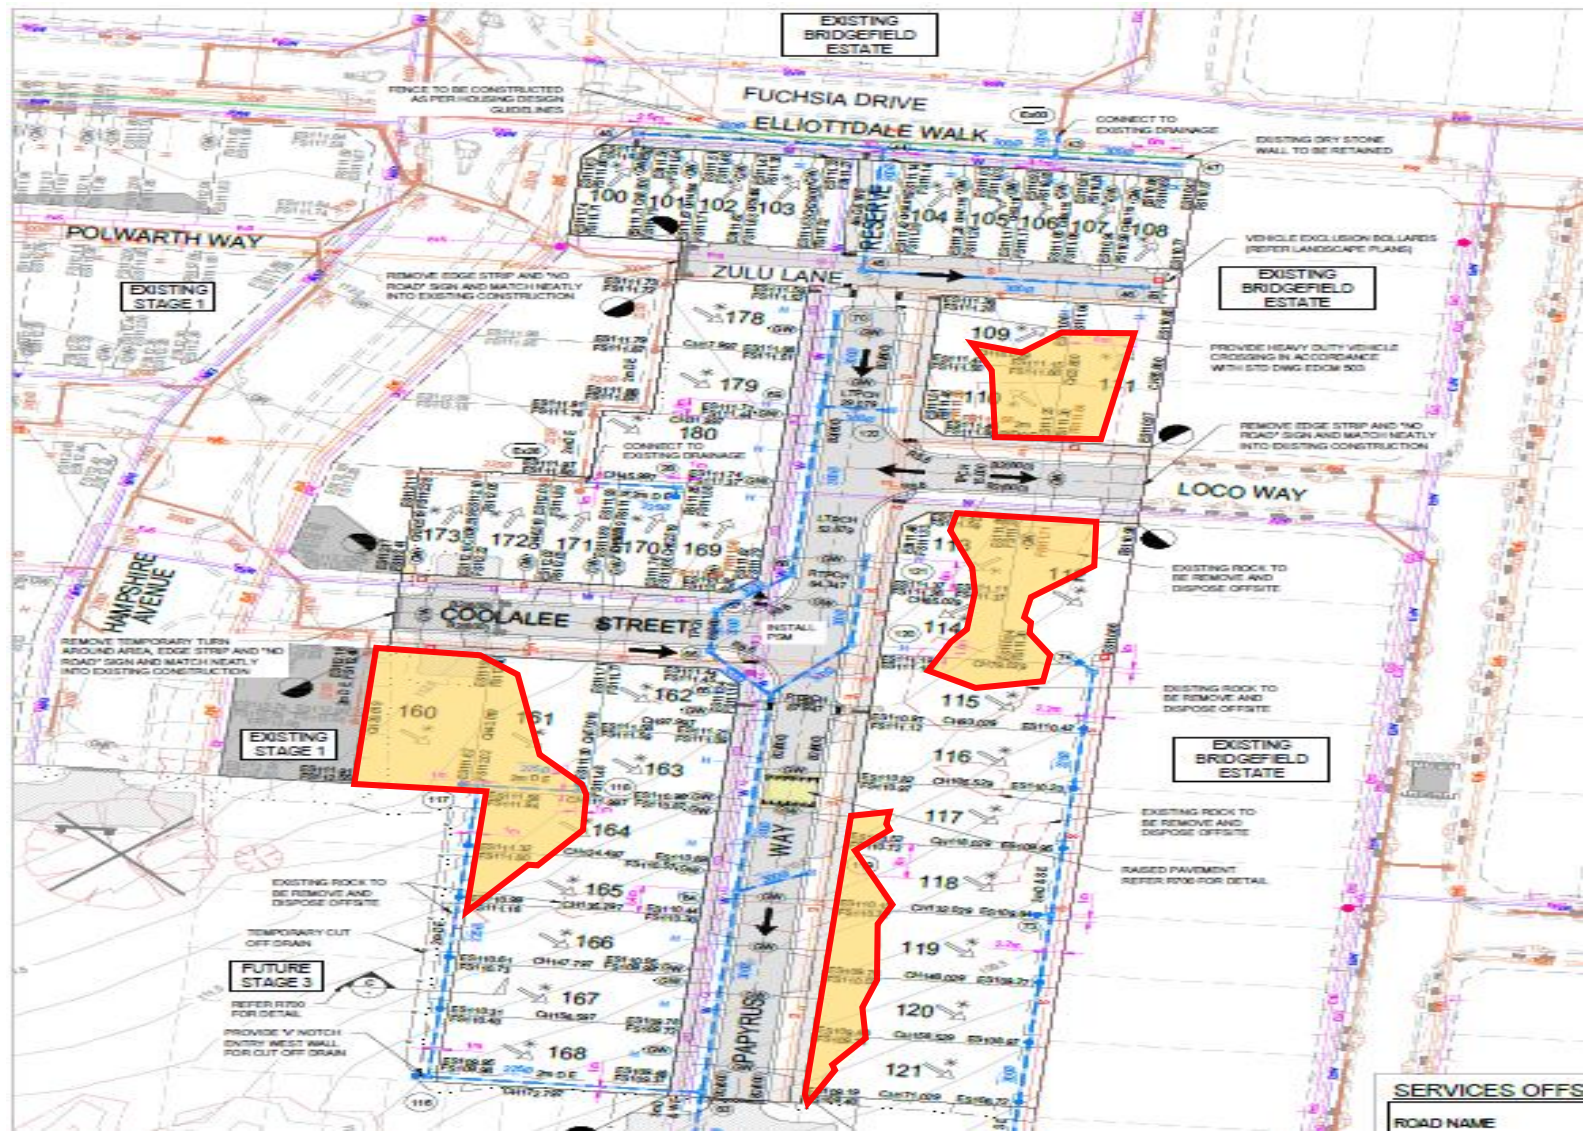
Appendix A - Site Plan

Area Inspected and Tested

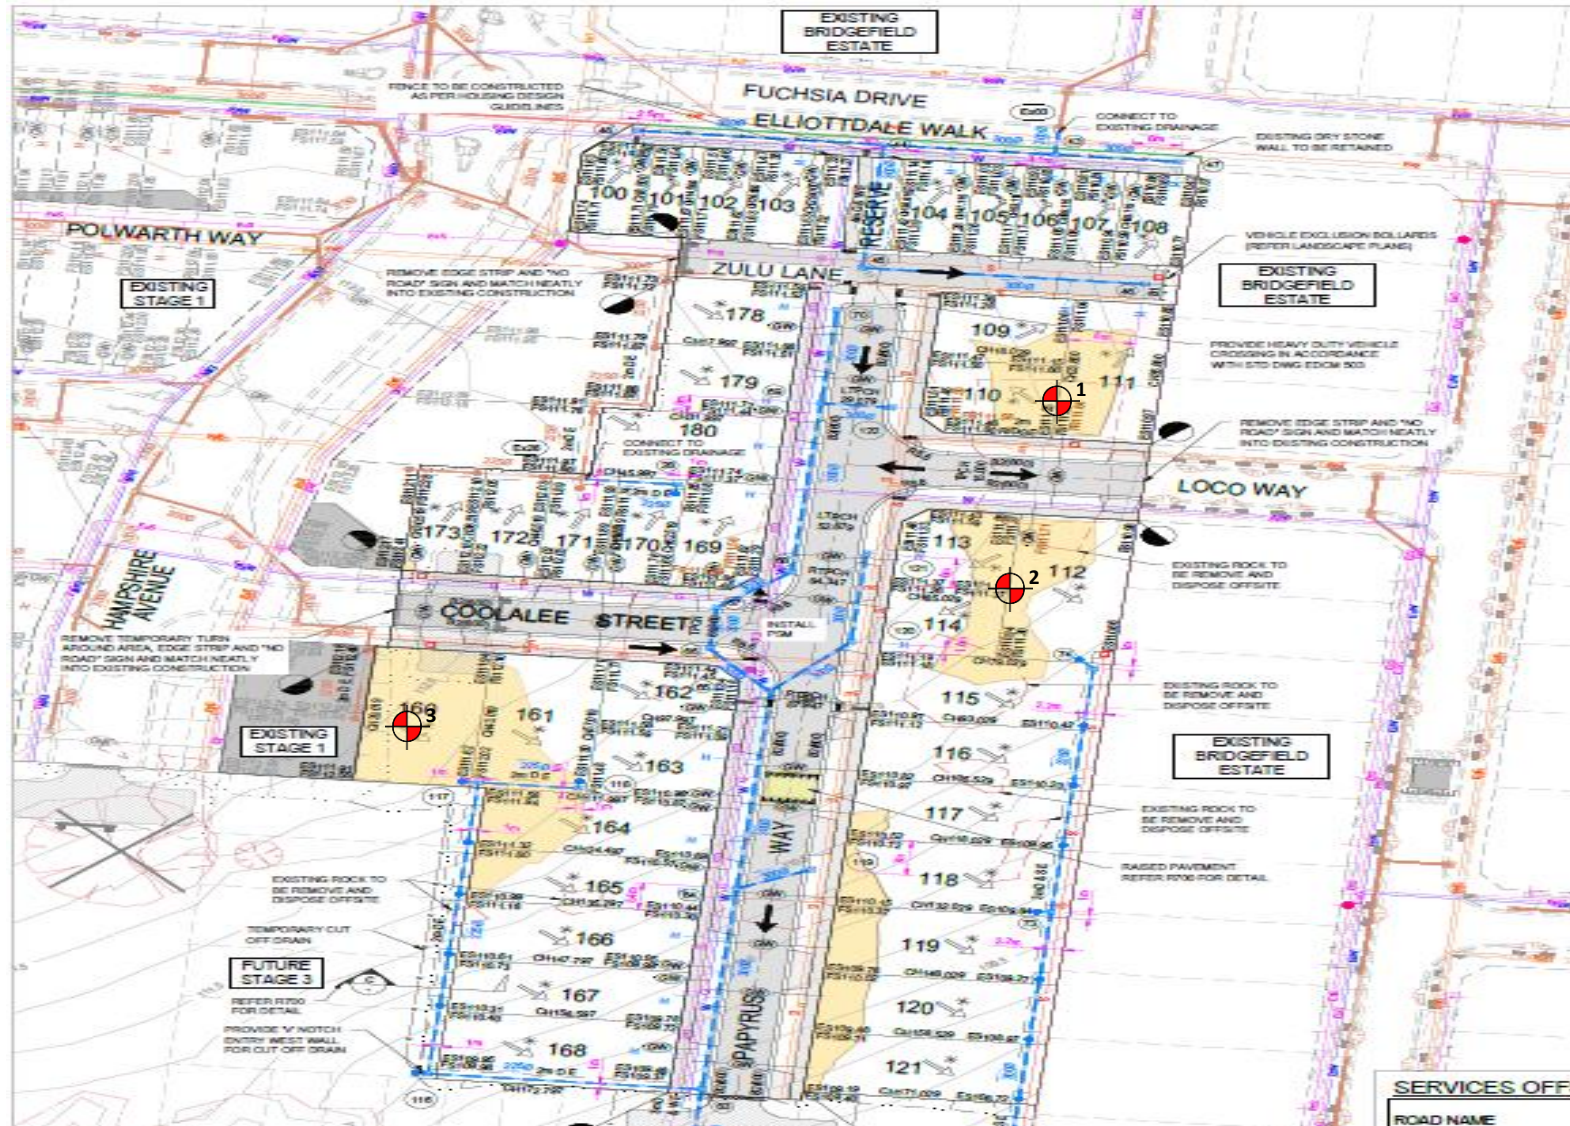
Appendix B – Test Locations

A total of 3 field density tests were performed during the earthworks. All of the test results met the specified compaction requirement of 95% Standard Compaction.

Indicative Test Location
