Our Reference: 22640:NB1354

**RE: LEVEL 1 EARTHWORKS INSPECTION AND TESTING
ALAMORA – STAGE 10 (TARNEIT)**

Job No 22640
 Report No 22640/R001
 Date Issued 29/09/2022

Job No 22640
 Report No 22640/R002
 Date Issued 05/10/2022

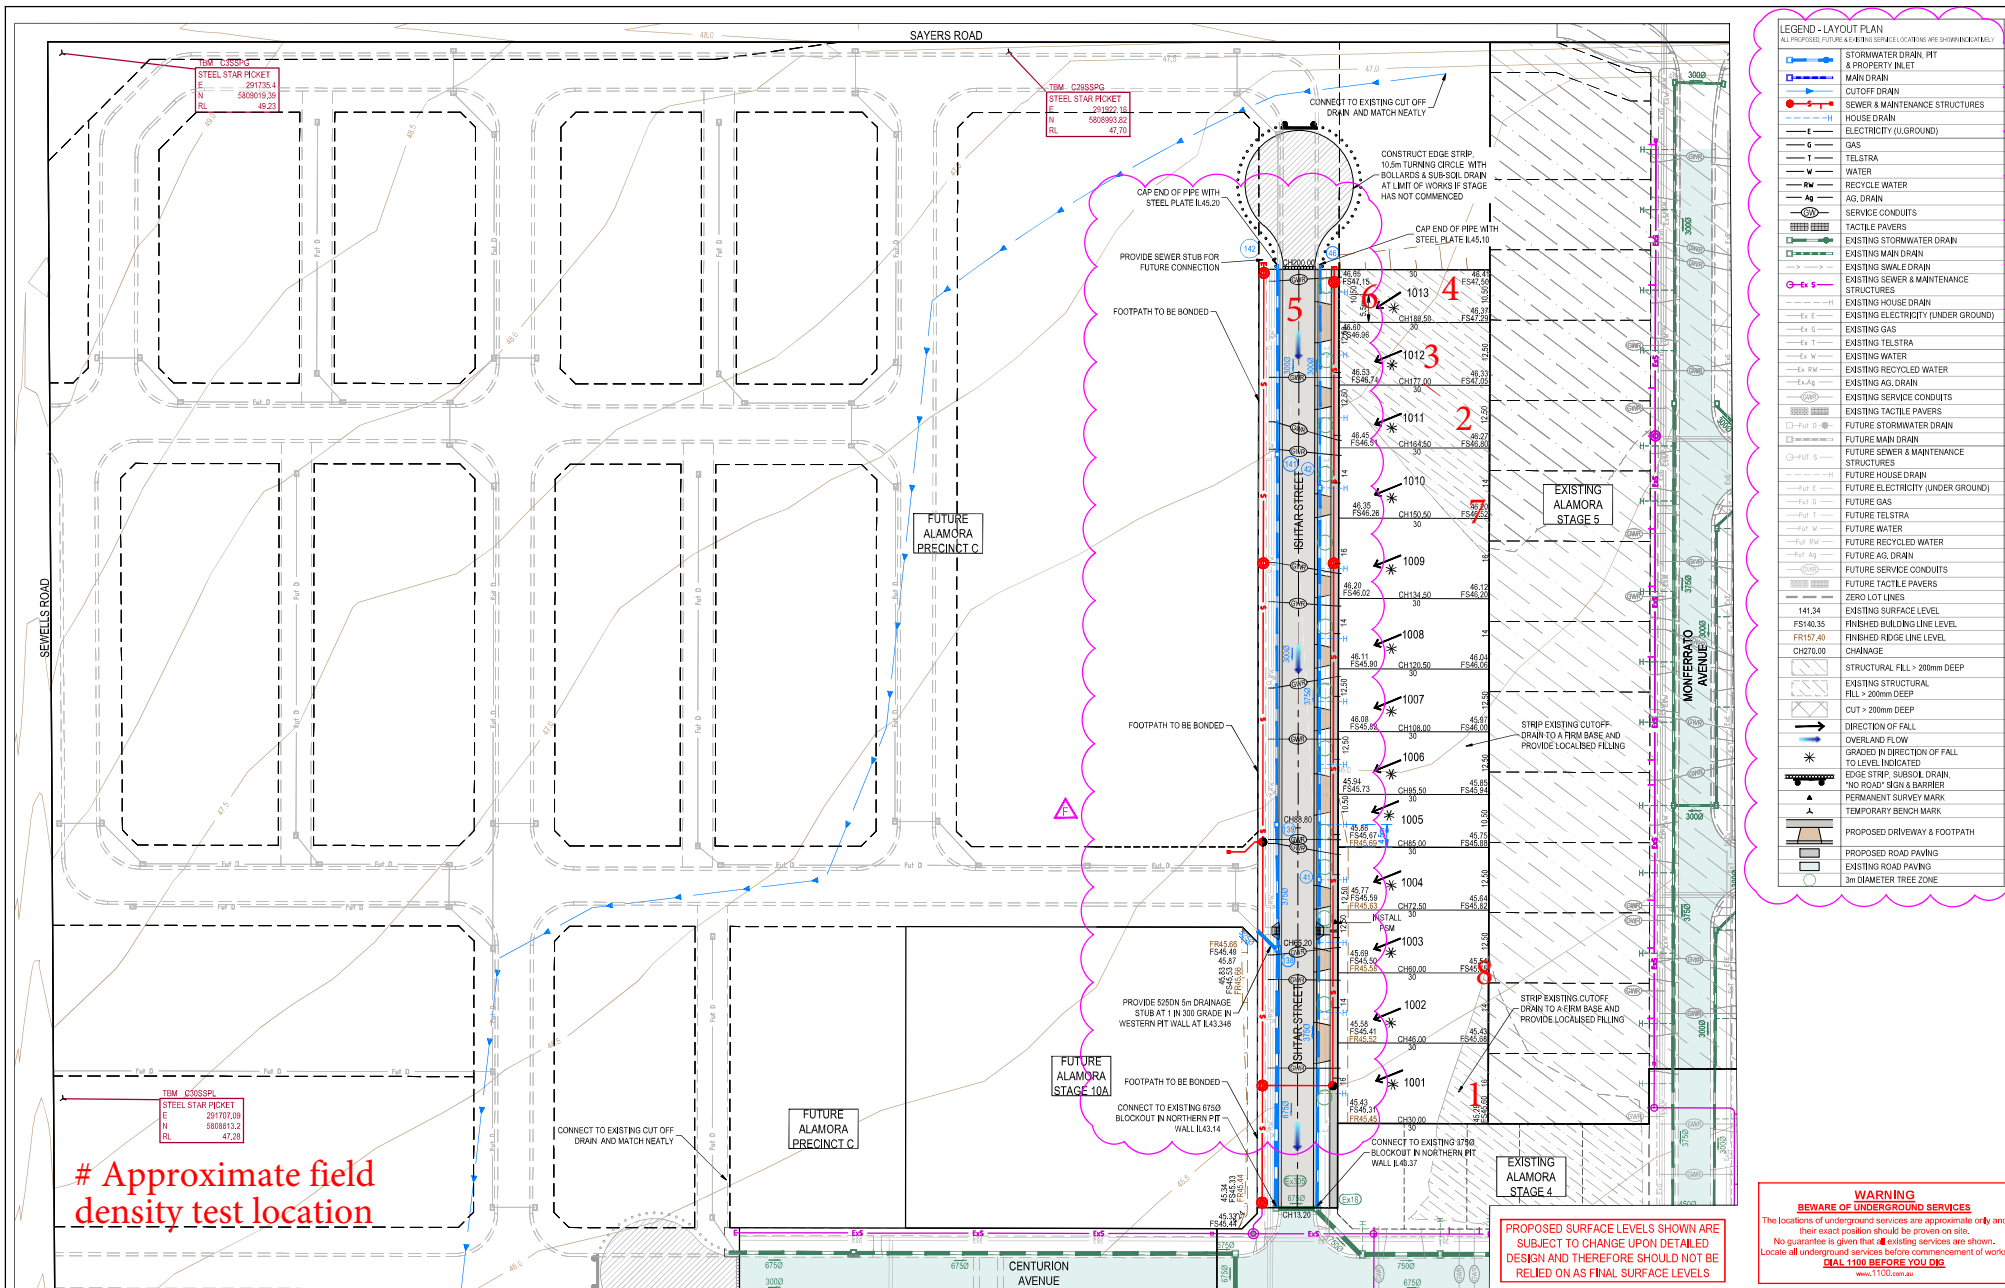
FIGURE 1

The site inspection and testing was performed by experienced geotechnicians from this office. Any areas that were deemed unsatisfactory were reworked and retested under their supervision. The testing was performed to the relevant Australian Standards and the accompanying test reports carry NATA endorsement. The attached compaction results, which were located randomly throughout the fill profile, are considered to be representative of the bulk fill materials that were placed across the reported allotments by Winslow Constructors during the aforementioned period. The approximate locations of the field density tests can be seen on the attached plan (Figure 1).

We are of the view that the bulk fill materials that have been placed across the reported allotments by Winslow Constructors during the aforementioned period can be considered as having been placed in a controlled manner to a minimum density ratio of 95% (standard compactive effort).

Approximate field density test location
