# Level One Inspection & Testing Report

## MAIDENS GREEN, MOAMA – STAGE 4

Prepared for Northern Constructions Group PTY LTD

09/04/2024

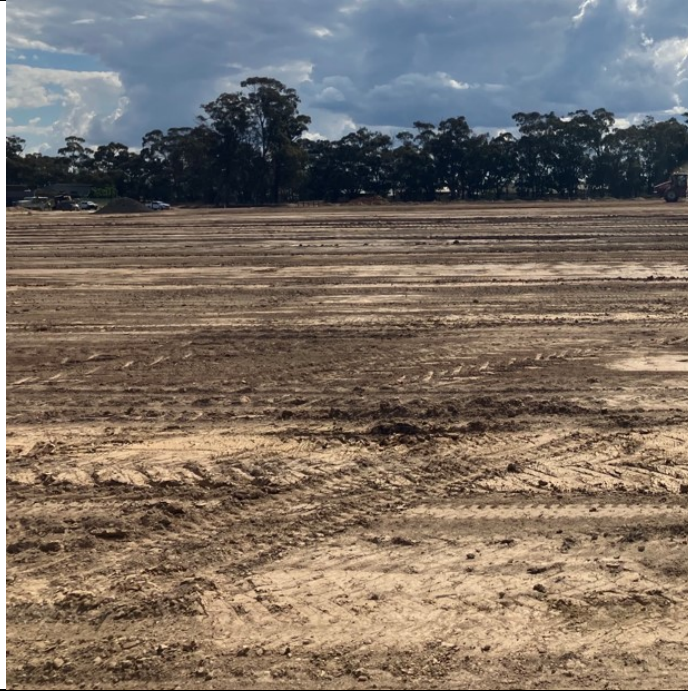
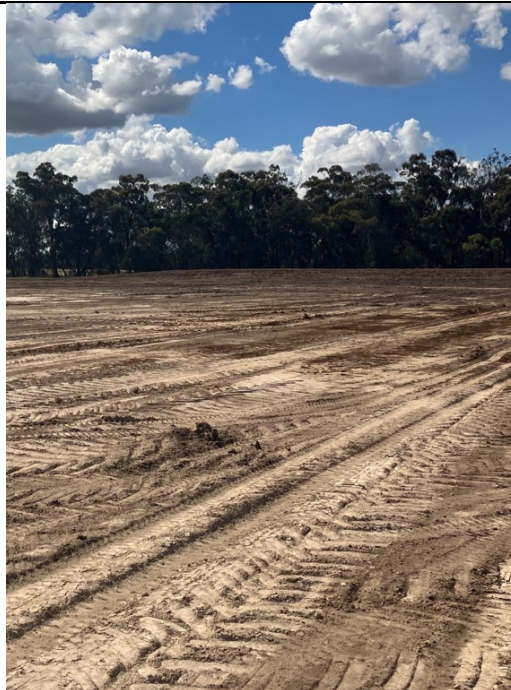
| | <b>Result:</b> | Stripping of topsoil and removal of all organic material from Stage 4 |

| | <b>Result:</b> | Yes |

| | <b>Result:</b> | Continue works |

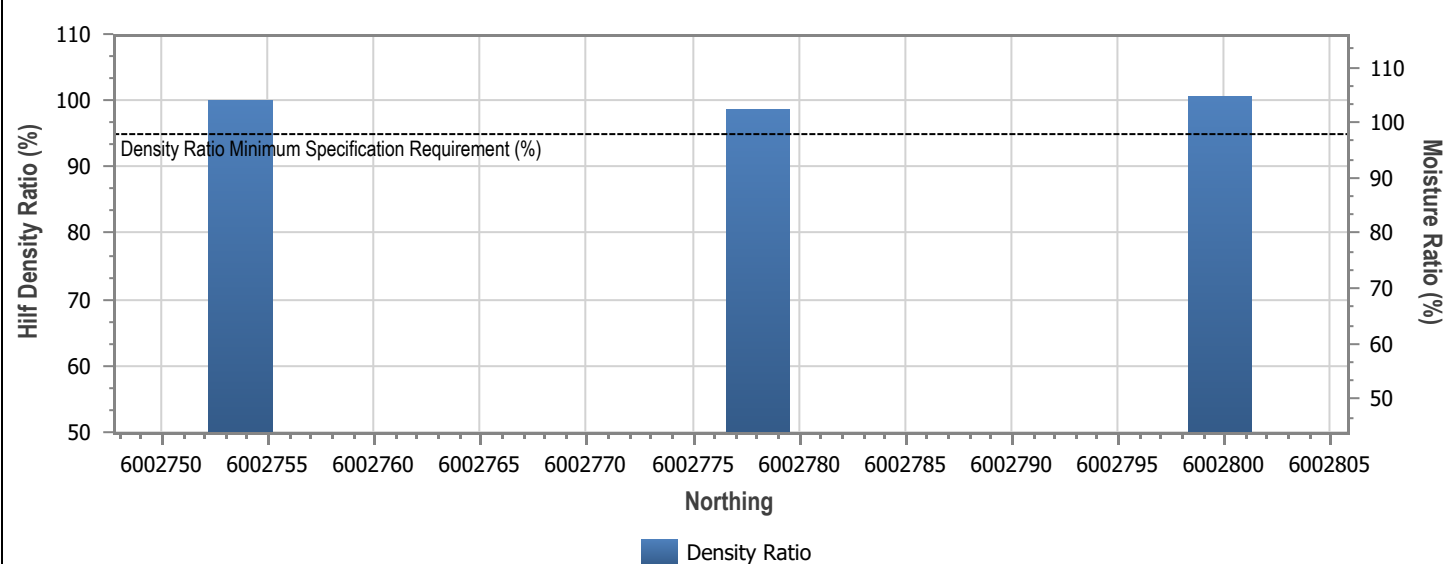
### LOT TEST RESULT SUMMARY

| Tests in Lot = 3 | Lot Minimum | Lot Maximum | Lot Mean | Standard Deviation |
| Half Density Ratio (%) | 98.6 | 100.6 | 99.7 | 1.026 |

**Mean Density Ratio (%):** 99.7

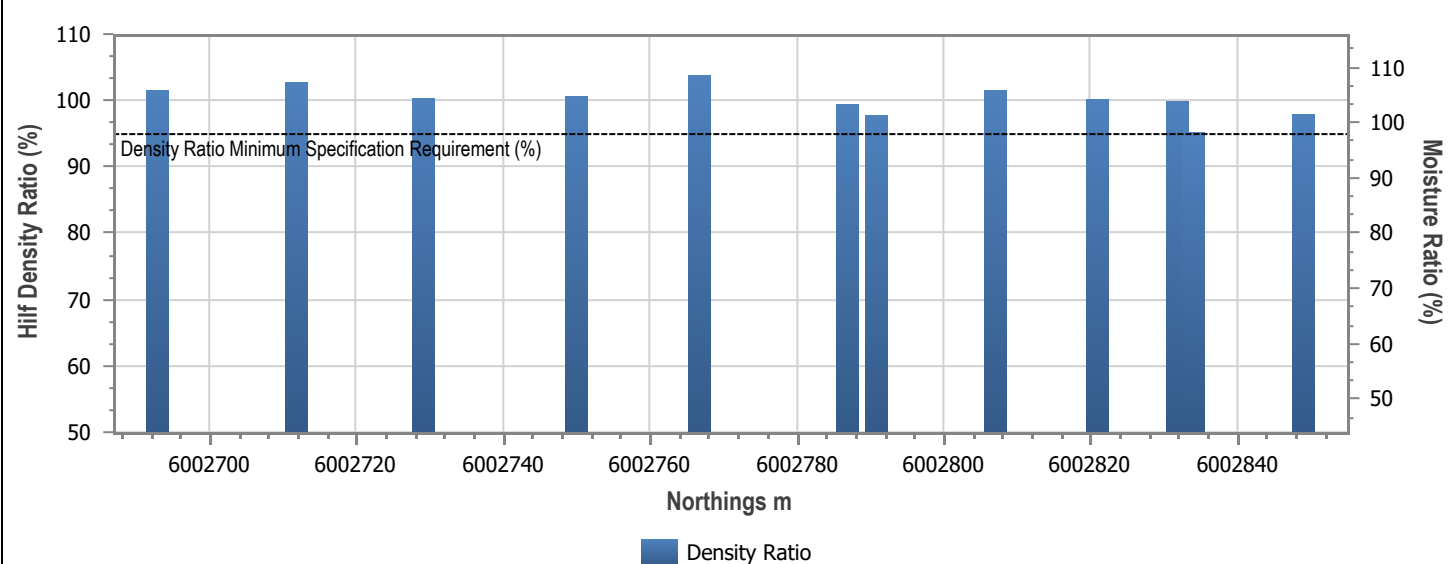
### LOT TEST RESULT SUMMARY

| Tests in Lot = 12 | Lot Minimum | Lot Maximum | Lot Mean | Standard Deviation |
| Half Density Ratio (%) | 95.2 | 103.8 | 100.0 | 2.333 |

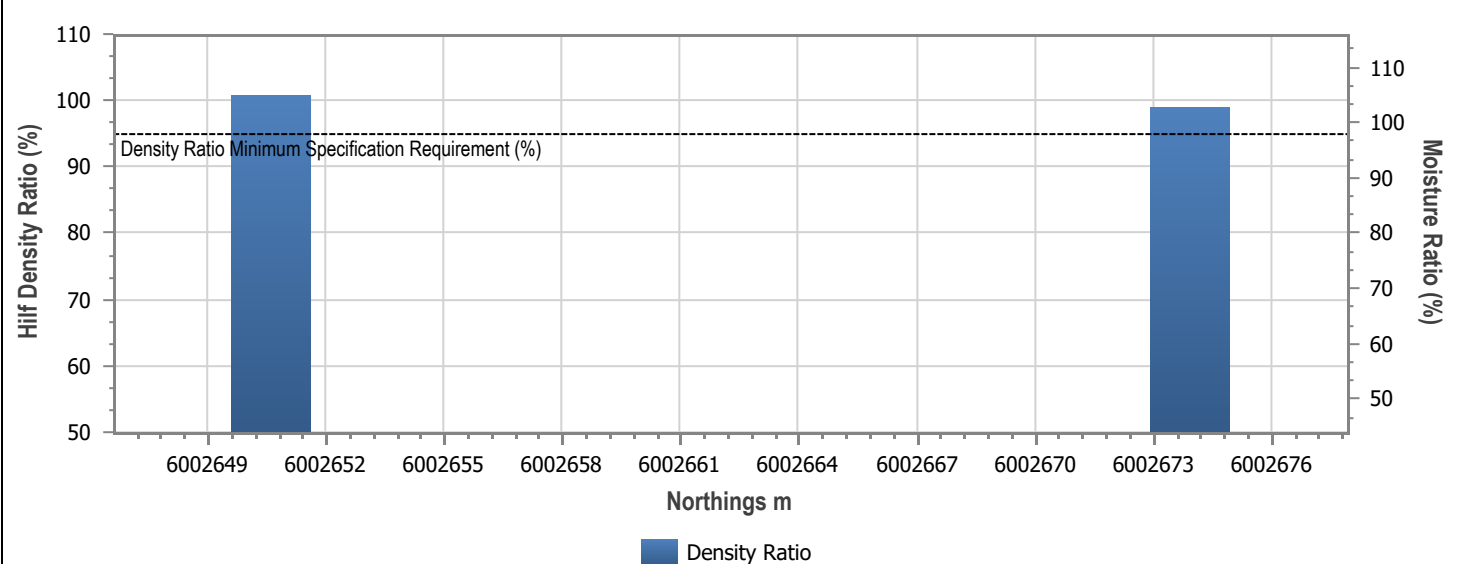
### LOT TEST RESULT SUMMARY

| Tests in Lot = 2 | Lot Minimum | Lot Maximum | Lot Mean | Standard Deviation |
| Hif Density Ratio (%) | 99.0 | 100.8 | 99.9 | 1.276 |
