# Level One Inspection & Testing Report

## MAIDENS GREEN – STAGE 5A

Prepared for Northern Constructions Group PTY LTD

17/7/2025

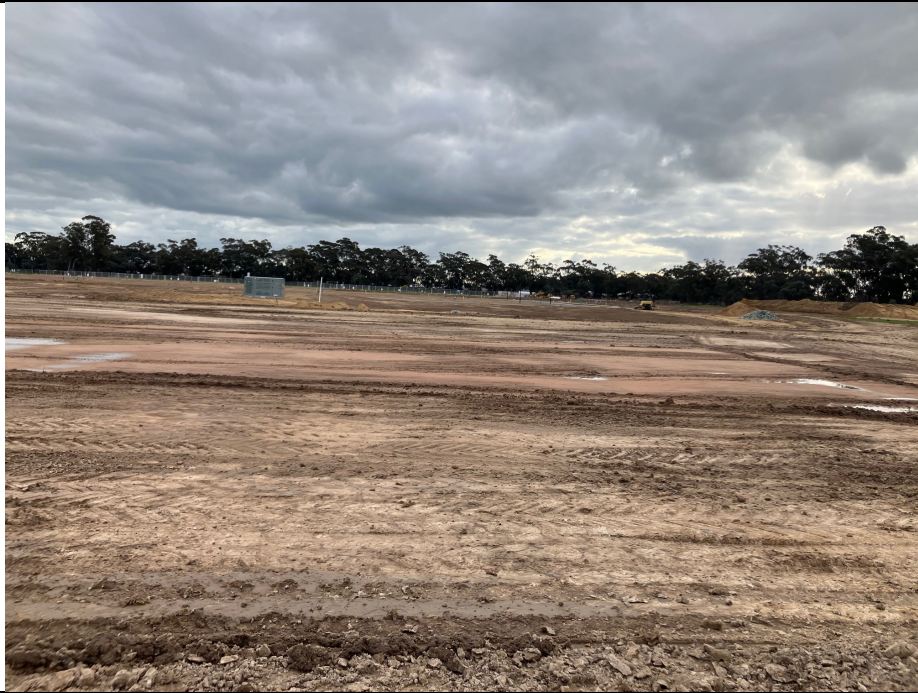
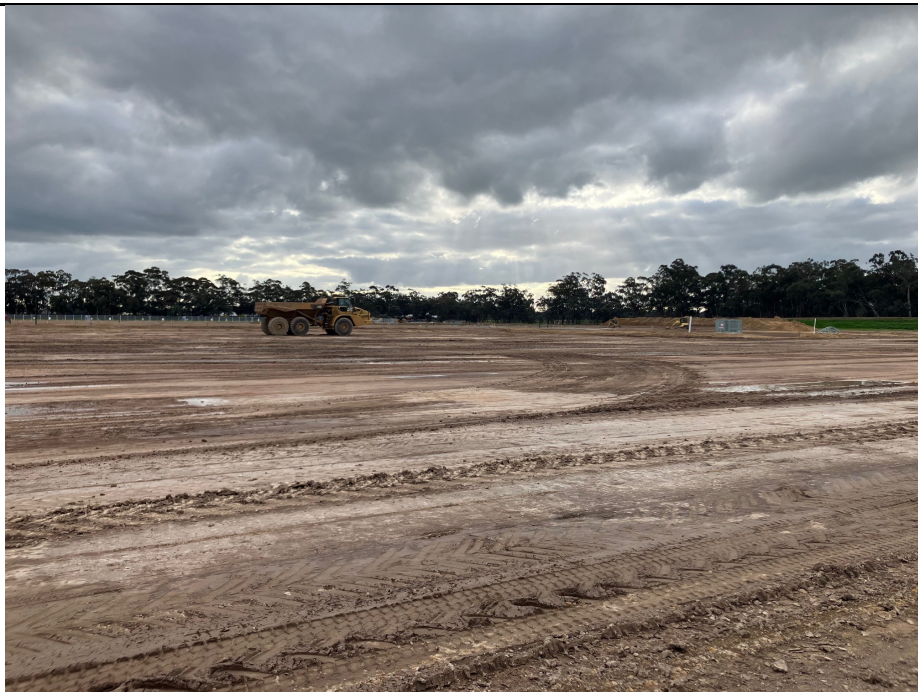
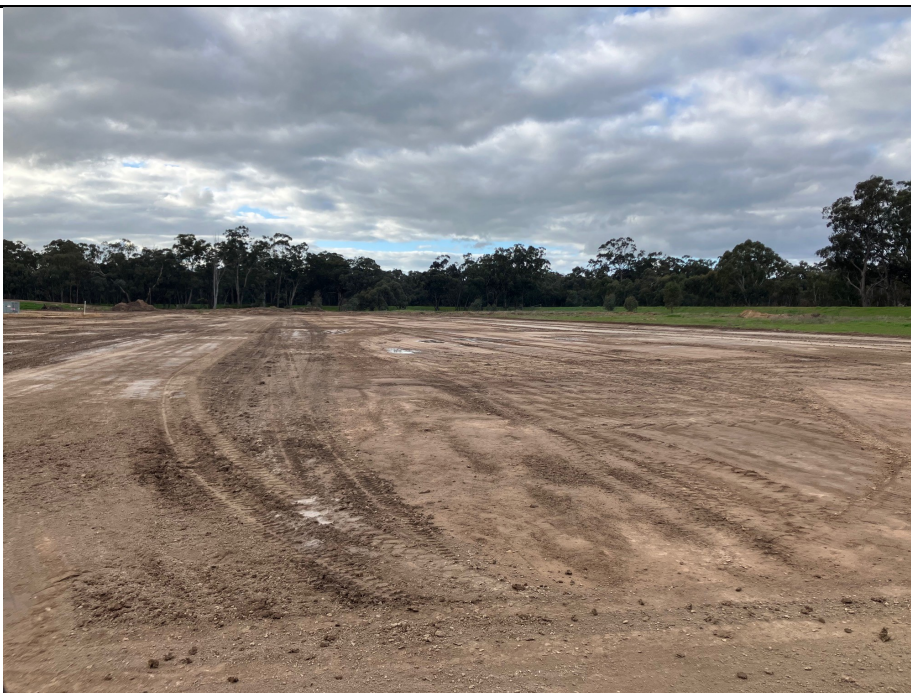
| | <b>Result:</b> | Stripping of topsoil and removal of all organic material from Stage 4 |

| | <b>Result:</b> | Yes |

| | <b>Result:</b> | Continue works |

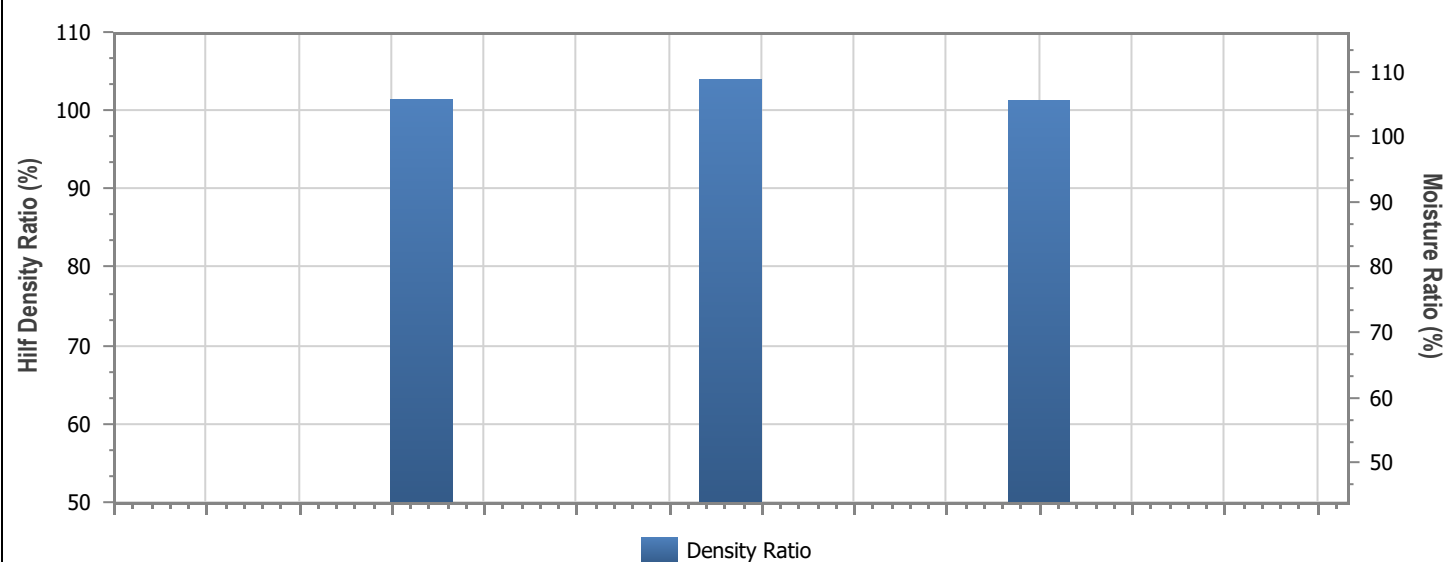
### LOT TEST RESULT SUMMARY

| Hilf Density Ratio (%) | 101.3 | 103.9 | 102.2 | 1.473 |

**Mean Density Ratio (%):** 102.2

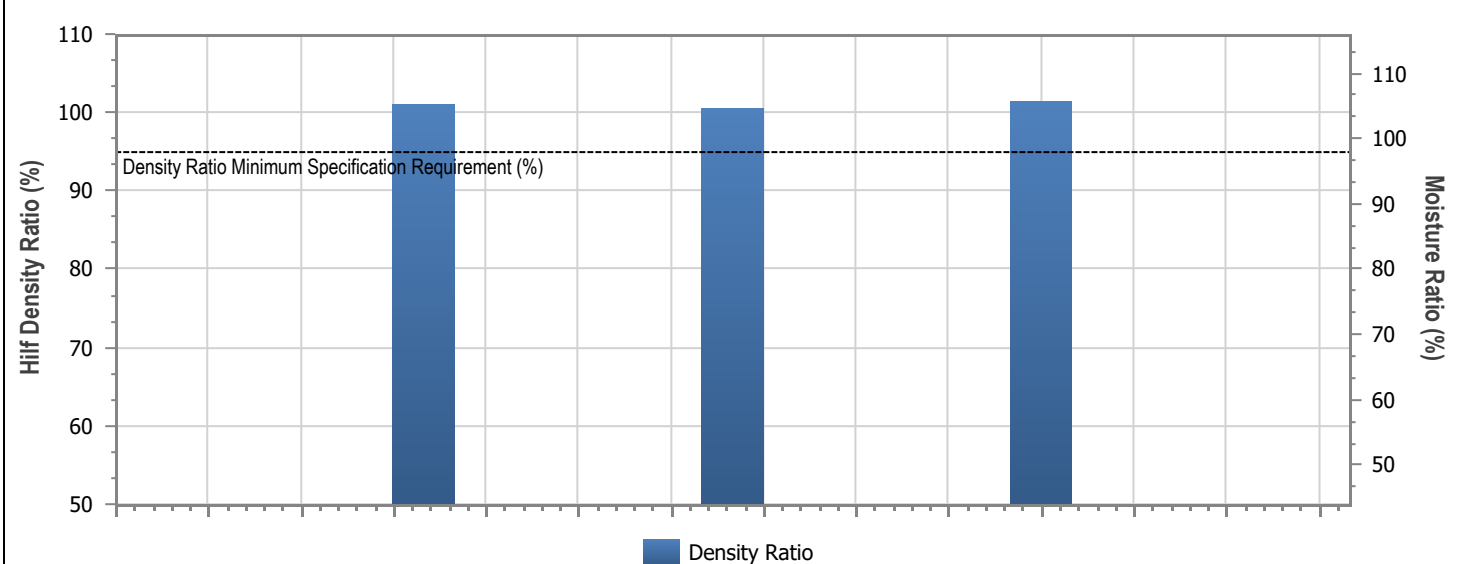
### LOT TEST RESULT SUMMARY

| Hilf Density Ratio (%) | 100.5 | 101.4 | 101.0 | 0.453 |

**Mean Density Ratio (%):** 101.0
