Level 1 Supervision & Inspection
Report

Maidens Green, Stage 1
Moama

23860/P/307

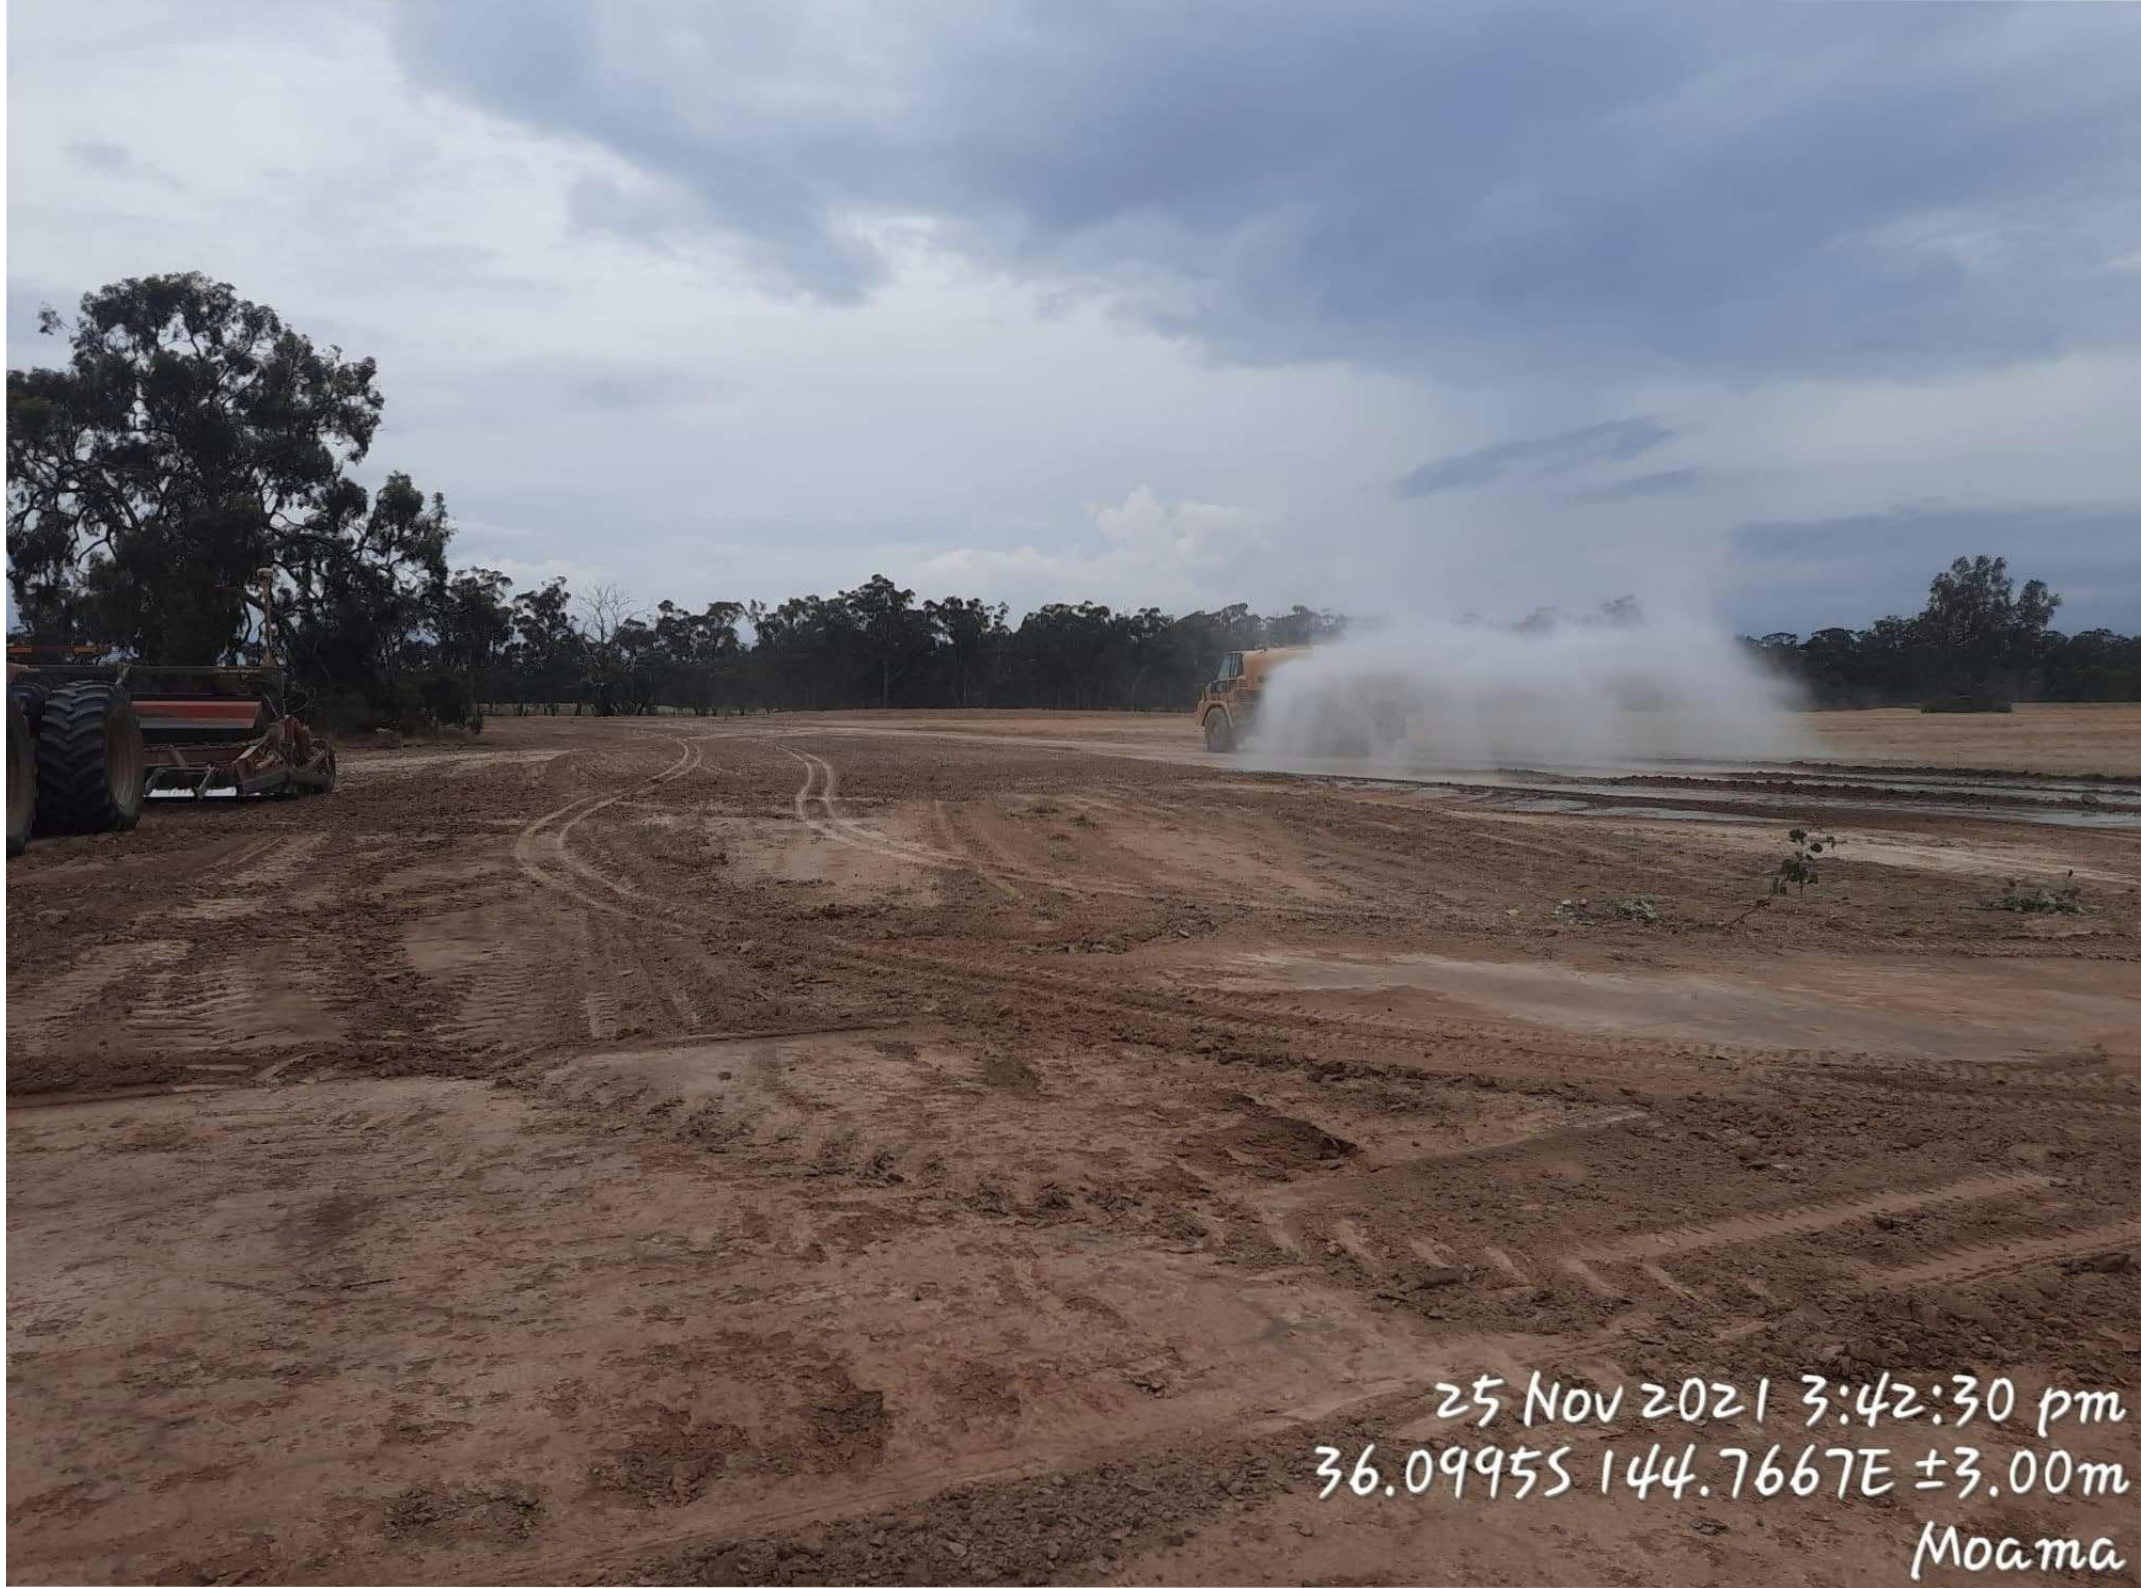
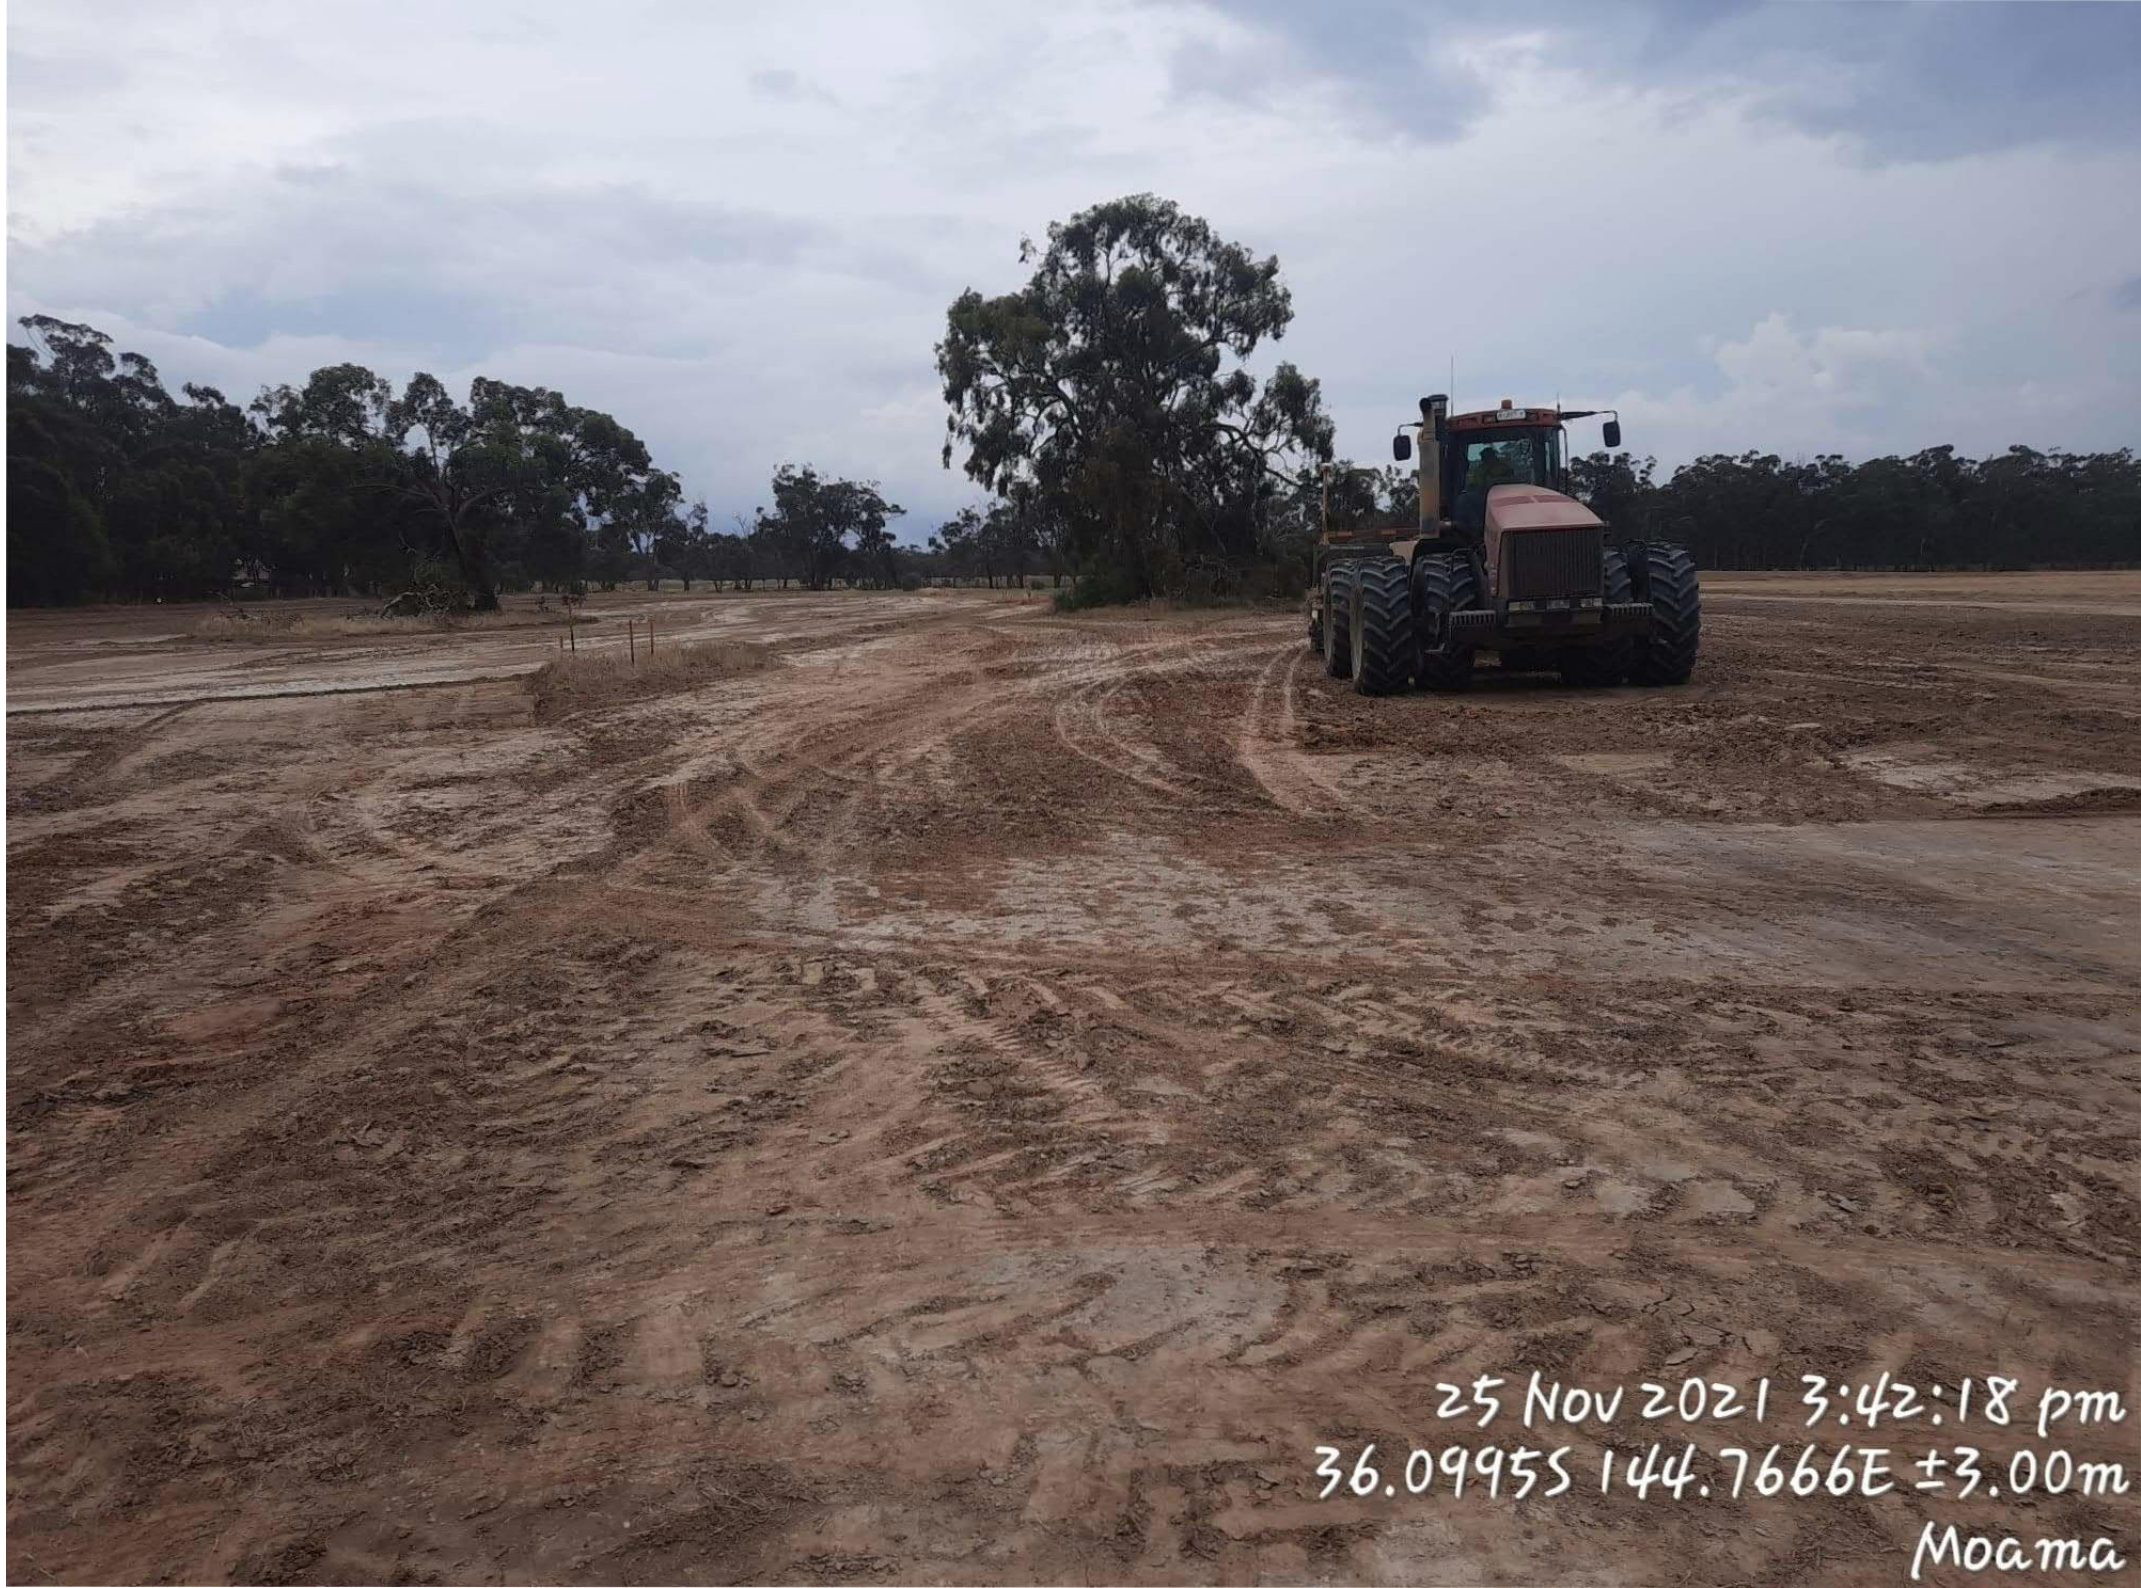
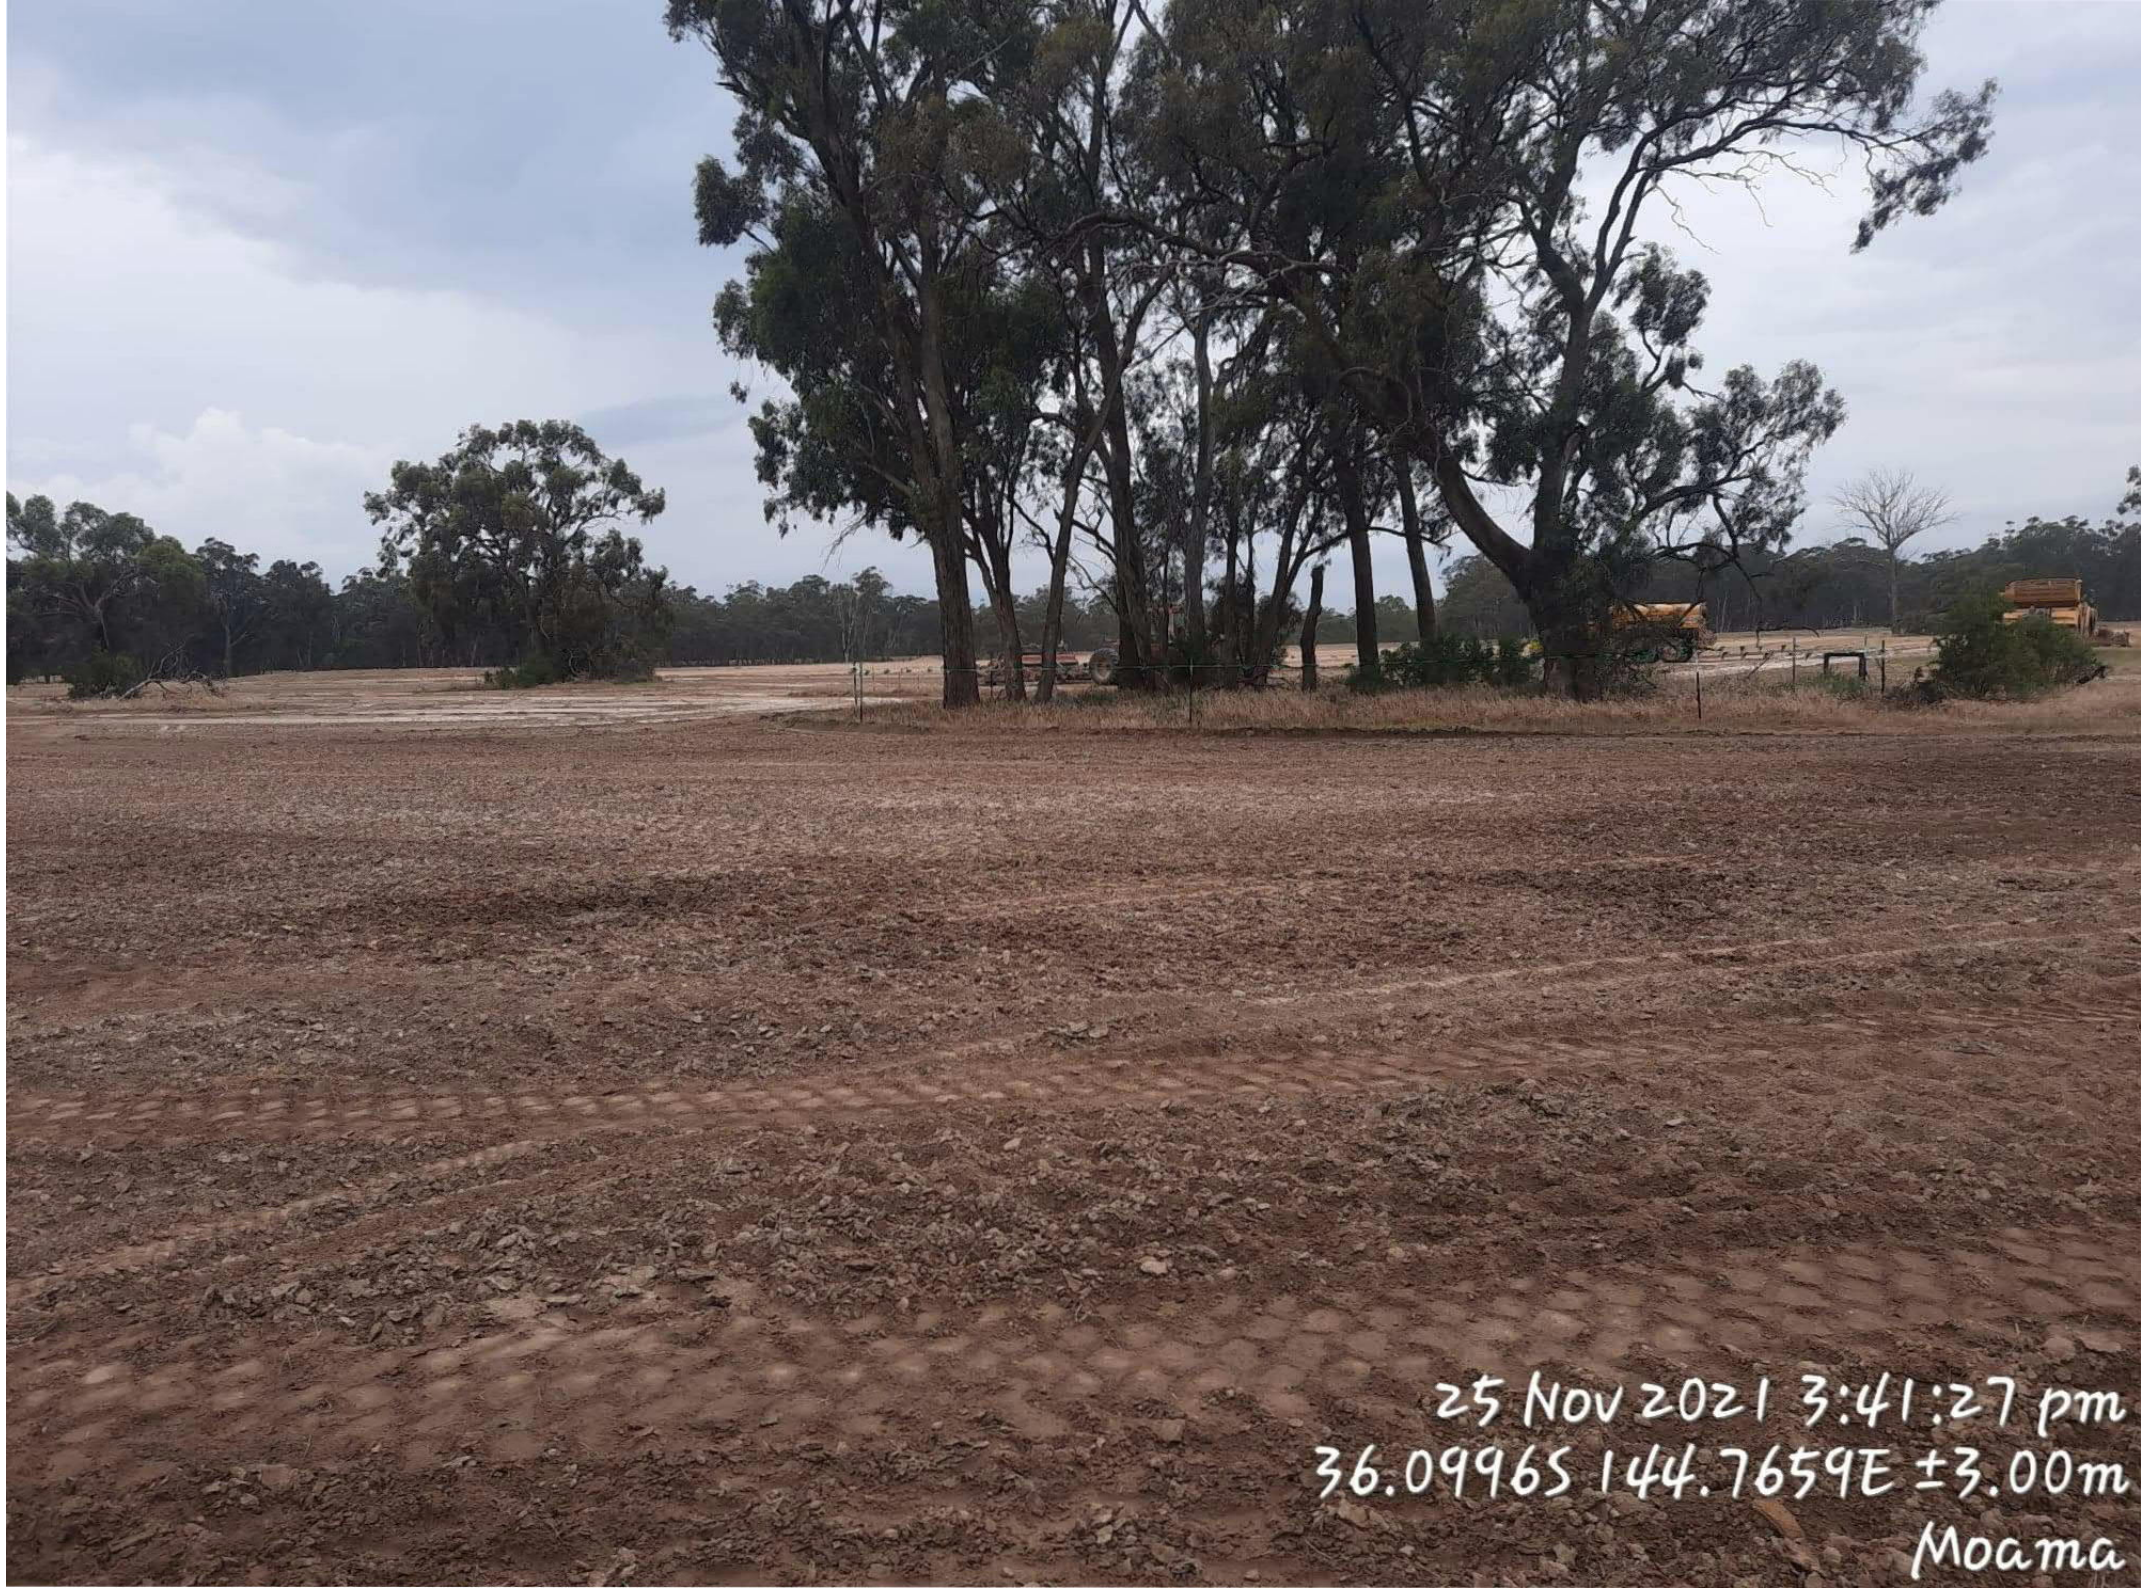
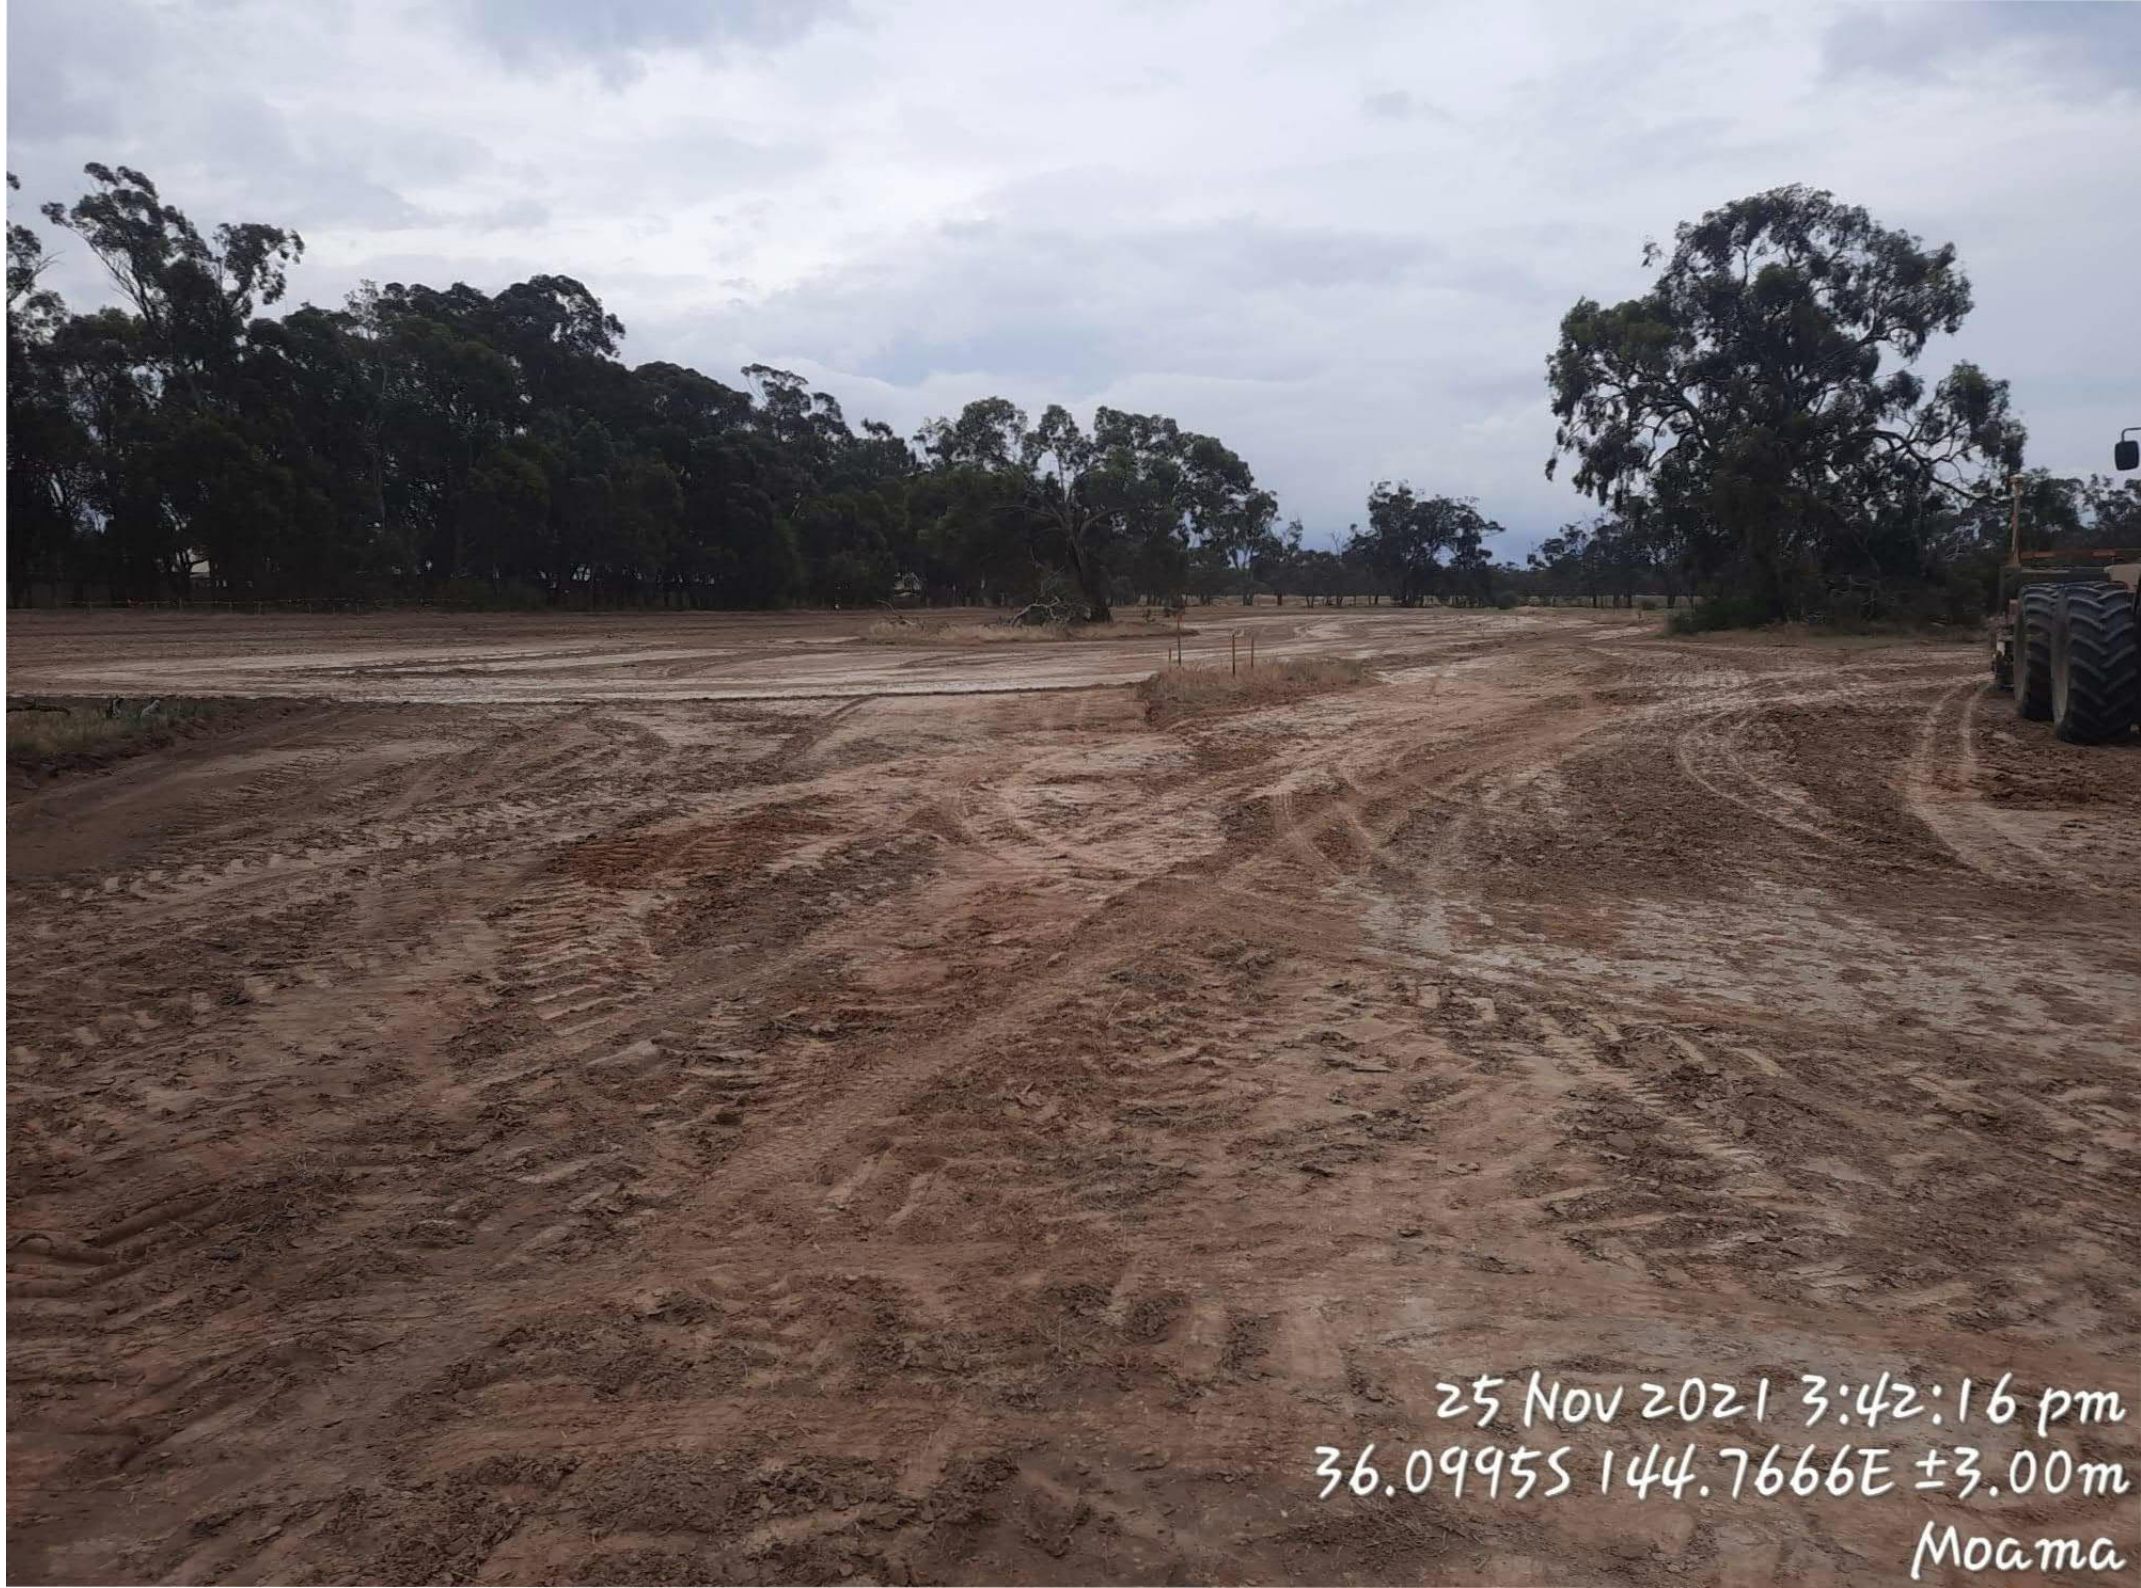
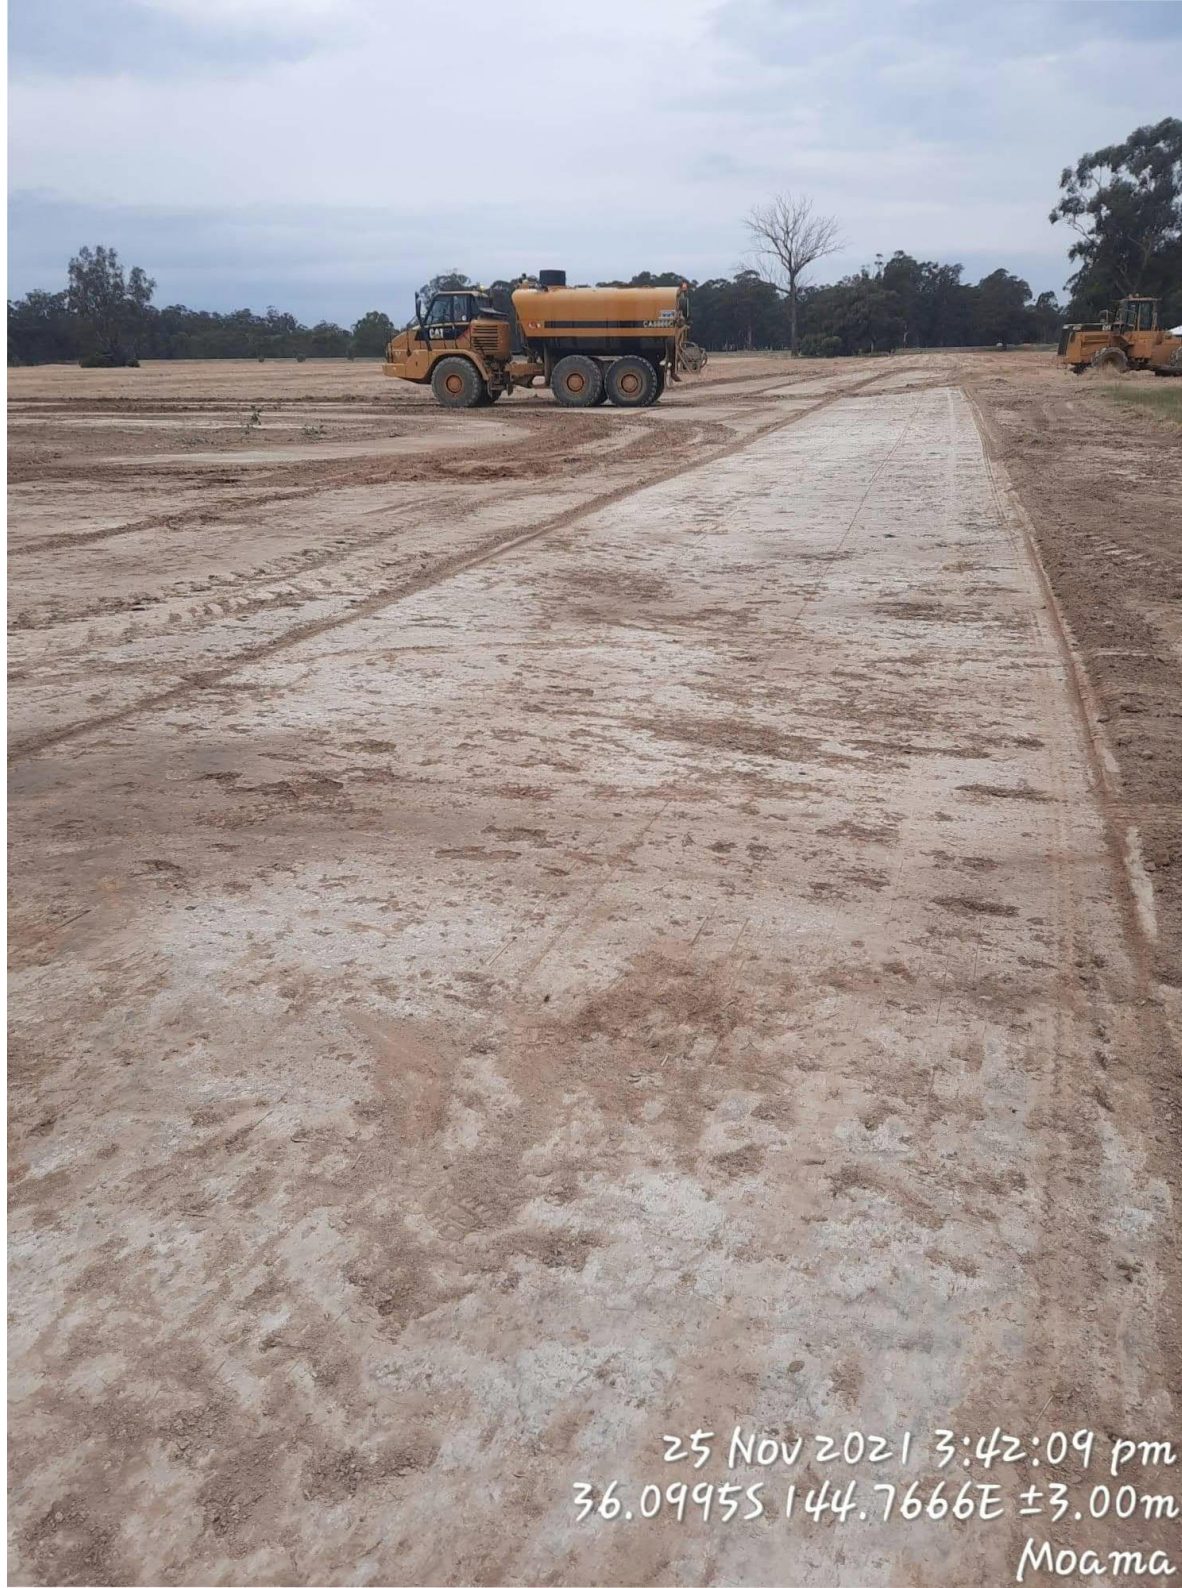
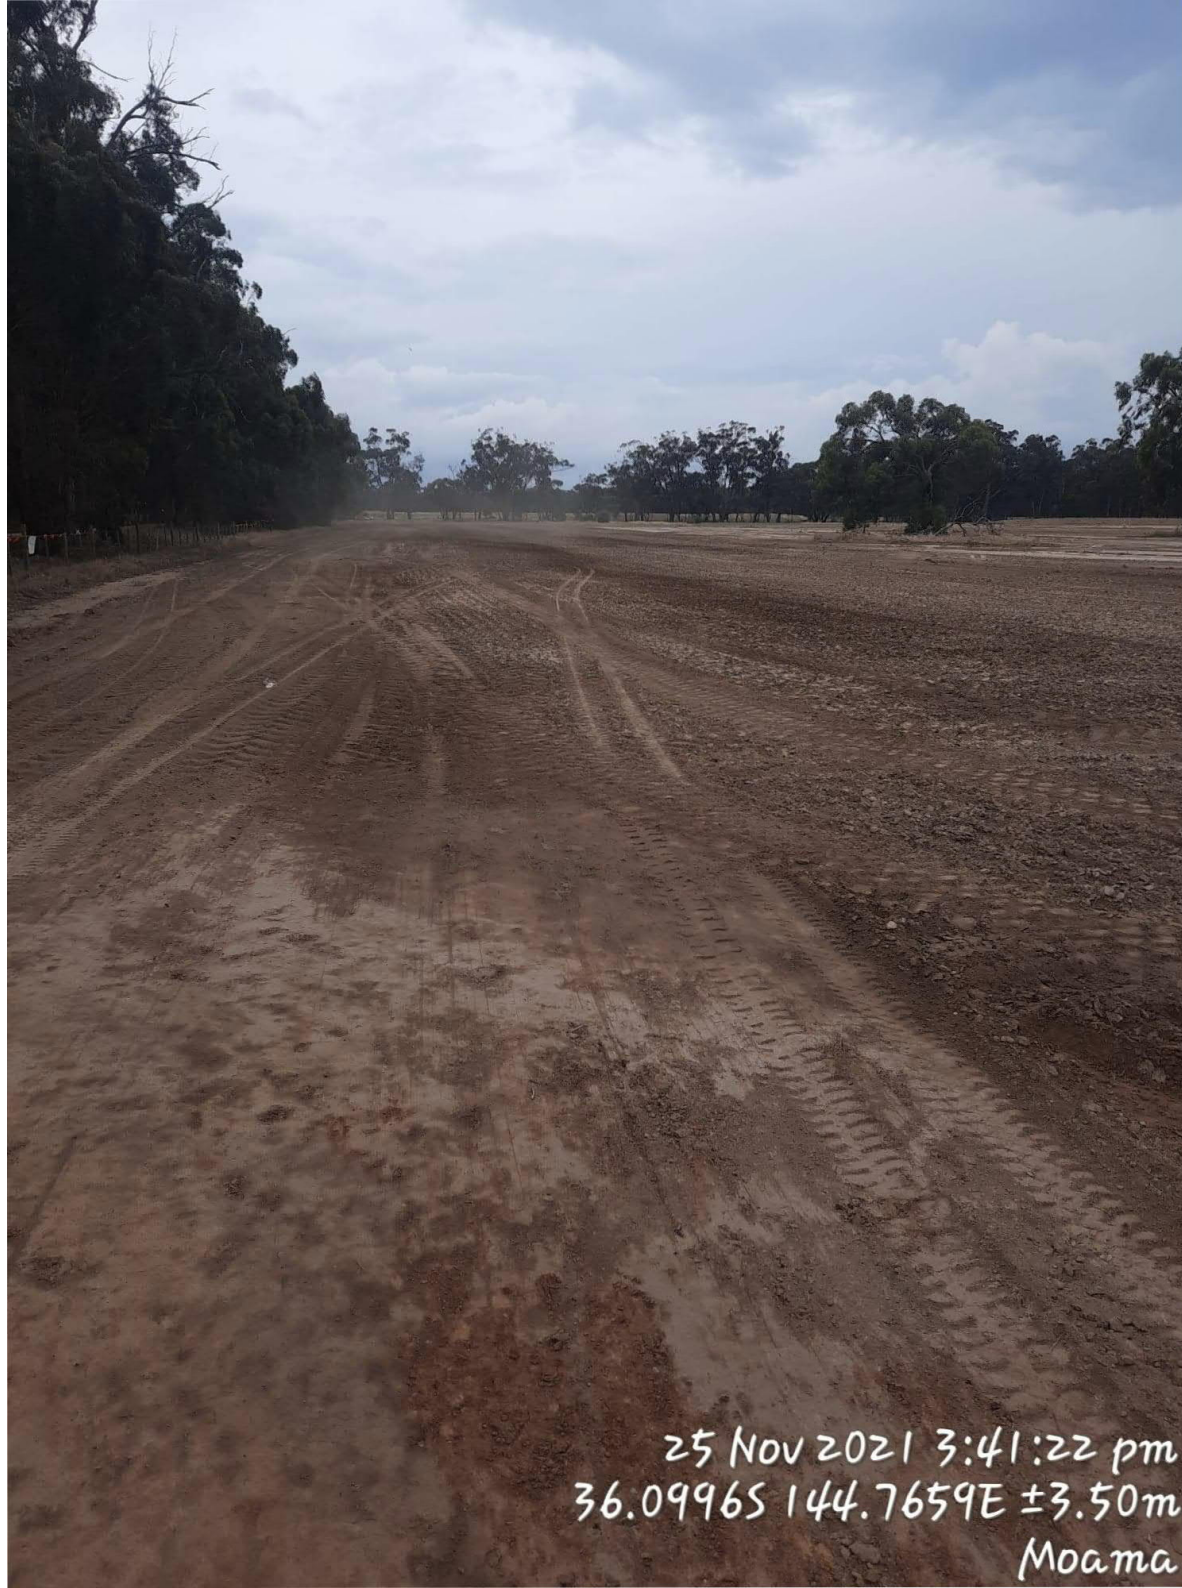
Site Images – Stripping Inspection

Works meeting geotechnical requirements	Element:	Refer to work type (e.g. stripping, subgrade compaction), basis of assessment (e.g. inspection, test reference numbers, and the like), extent of works apparently complying and requirements met.
	Result:	Site stripping deemed satisfactory with all organic matter removed. No soft areas were apparent while proof roll carried out with the present water cart.
