Level One Inspection & Testing Report

MAIDEN'S GREEN, MOAMA - STAGE 2 & 3

Prepared for Northern Constructions Group PTY LTD

15/08/23

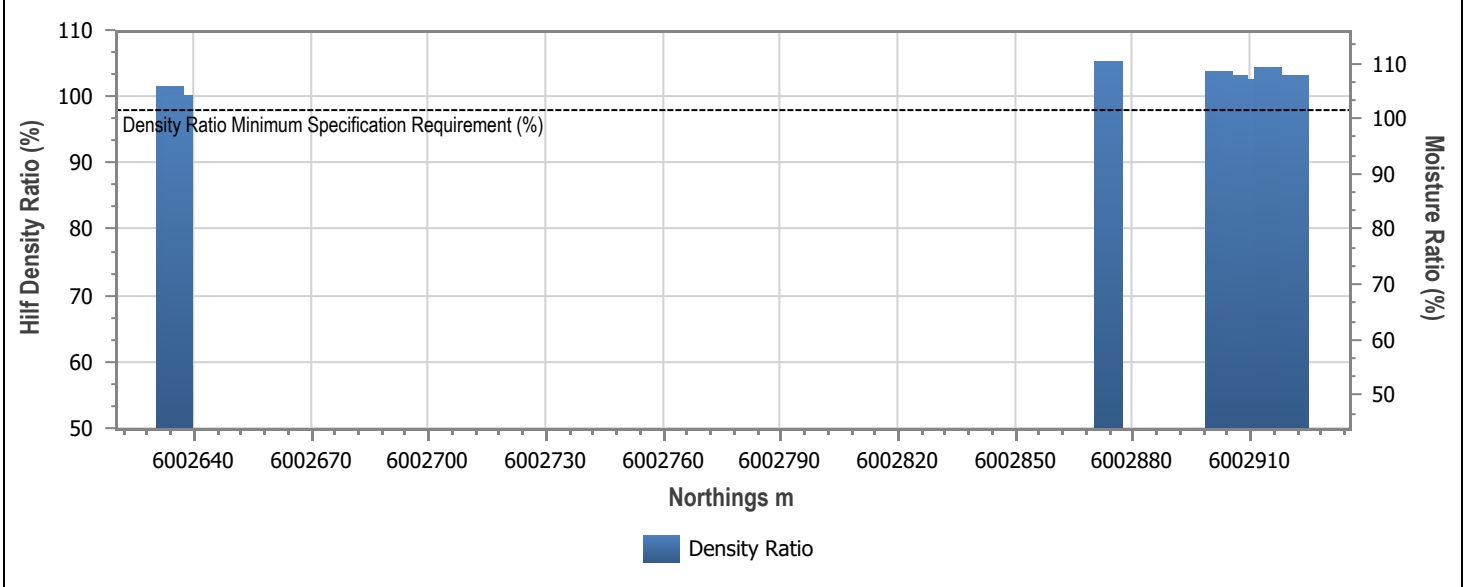
LOT TEST RESULT SUMMARY

Tests in Lot = 8	Lot Minimum	Lot Maximum	Lot Mean	Standard Deviation
Hiif Density Ratio (%)	100.1	105.3	103.0	1.638

Lot Number:	Allotment Fill - Stage 3
Mean Density Ratio (%):	103.0

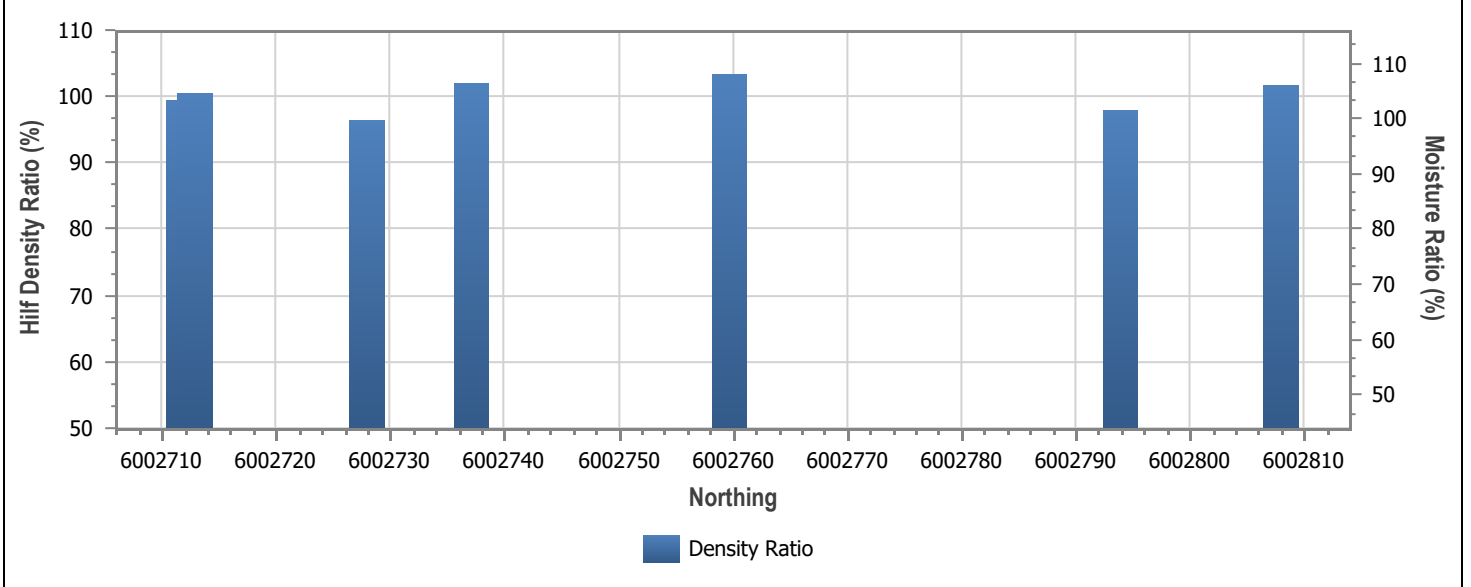
LOT TEST RESULT SUMMARY

Tests in Lot = 7	Lot Minimum	Lot Maximum	Lot Mean	Standard Deviation
Hiif Density Ratio (%)	96.4	103.3	100.1	2.410

Mean Density Ratio (%): 100.1

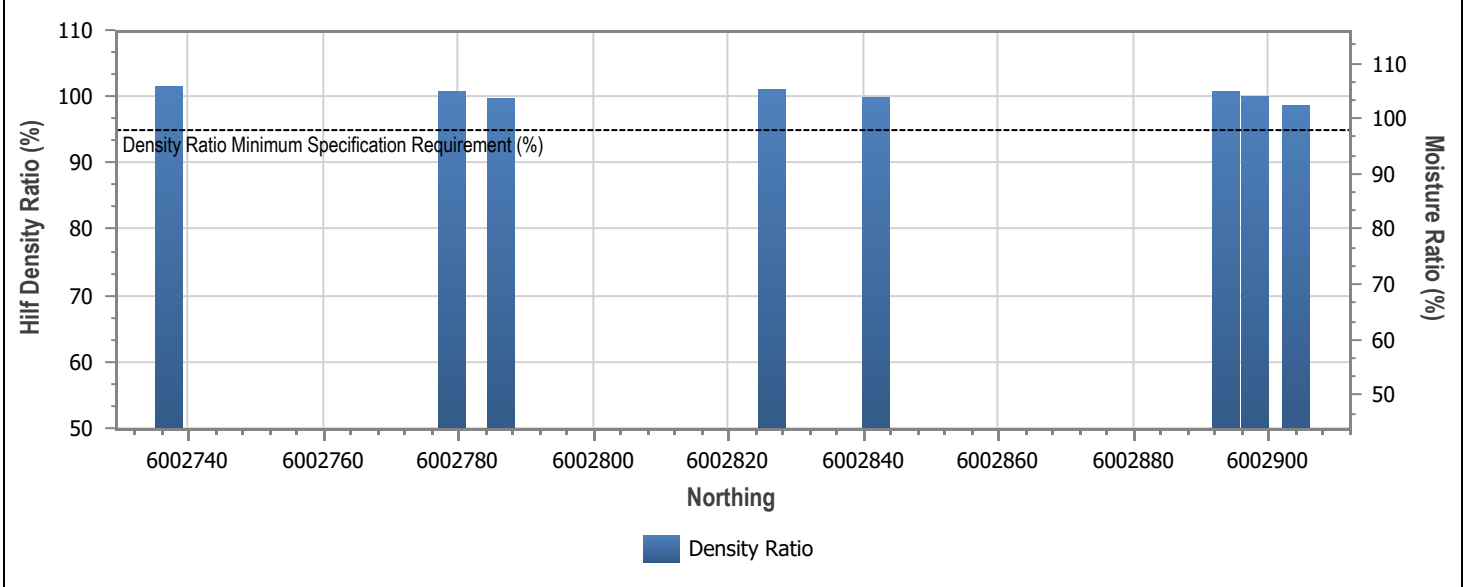
LOT TEST RESULT SUMMARY

Tests in Lot = 8	Lot Minimum	Lot Maximum	Lot Mean	Standard Deviation
Hiif Density Ratio (%)	98.7	101.5	100.3	0.887

Lot Number: -
Mean Density Ratio (%): 100.3

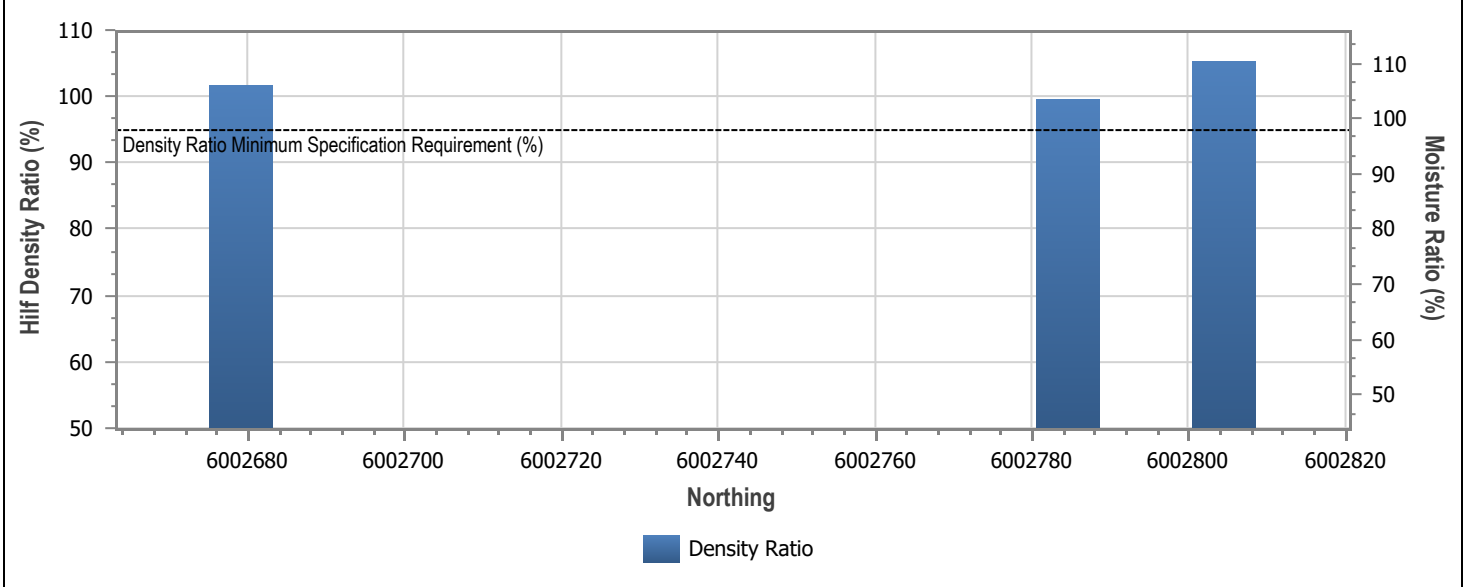
LOT TEST RESULT SUMMARY

Tests in Lot = 3	Lot Minimum	Lot Maximum	Lot Mean	Standard Deviation
Hiif Density Ratio (%)	99.5	105.3	102.1	2.937

Mean Density Ratio (%): 102.1

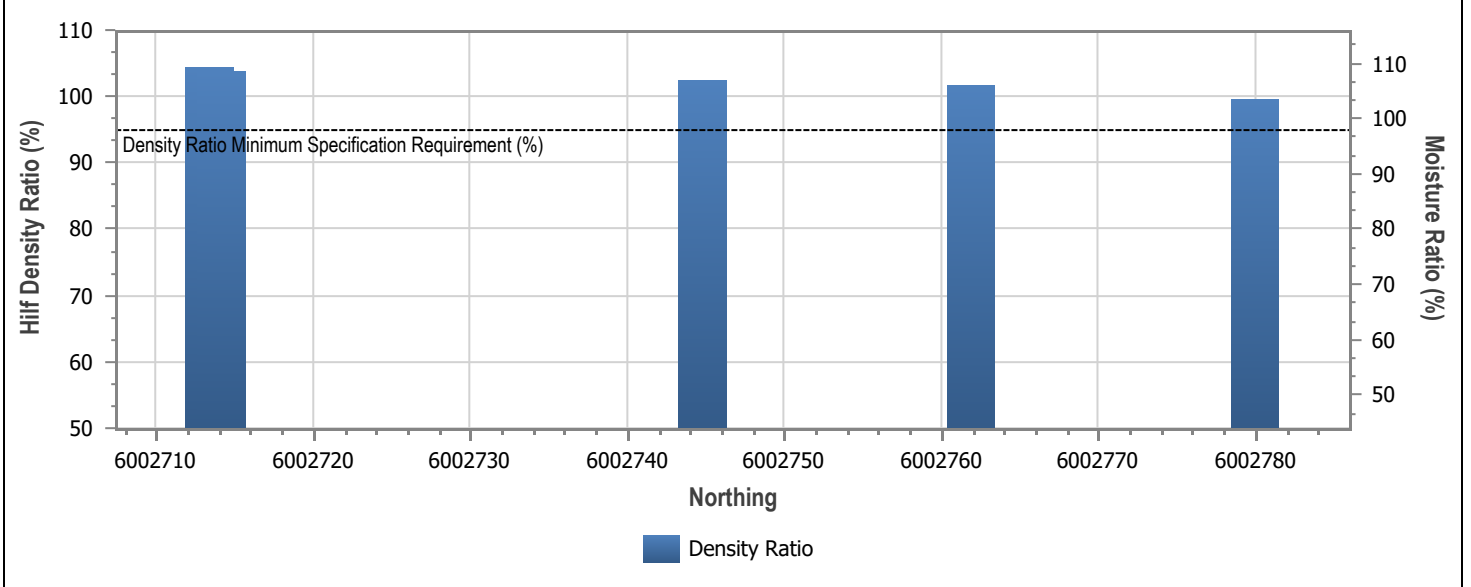
LOT TEST RESULT SUMMARY

Tests in Lot = 5	Lot Minimum	Lot Maximum	Lot Mean	Standard Deviation
Hiif Density Ratio (%)	99.5	104.4	102.3	1.936

Lot Number:	Allotment Fill - Stage 3
Mean Density Ratio (%):	102.3
