7th November 2022

Our Reference: 22331:NB1395

RE: LEVEL 1 EARTHWORKS INSPECTION AND TESTING REDSTONE – STAGE 7 (SUNBURY)

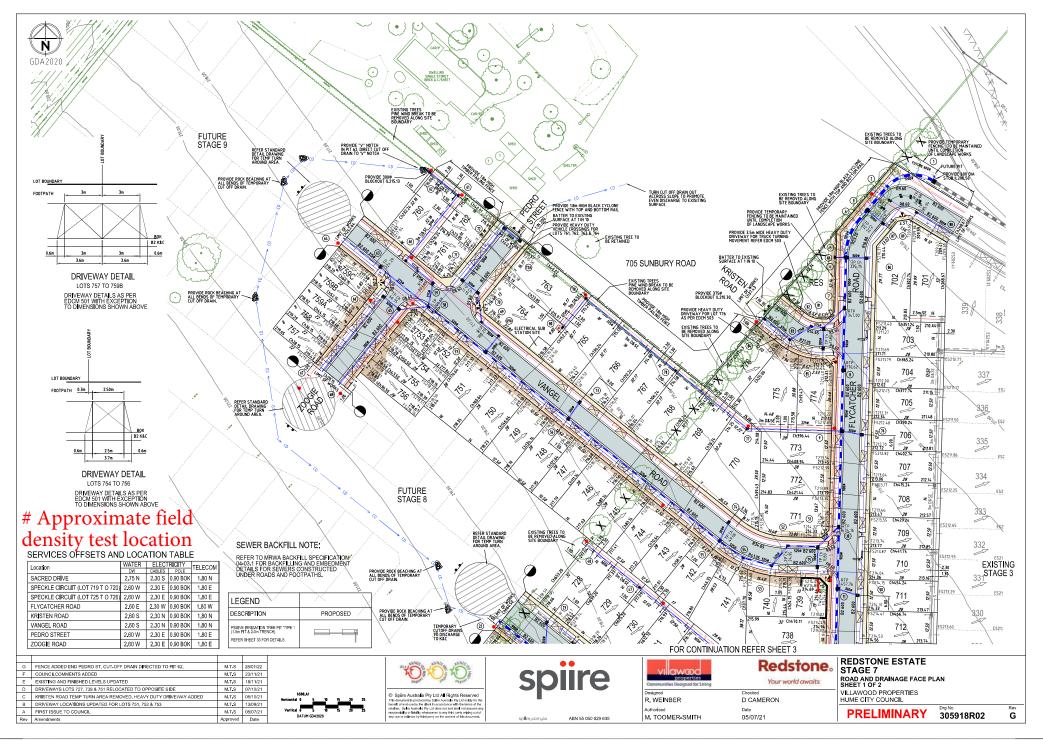
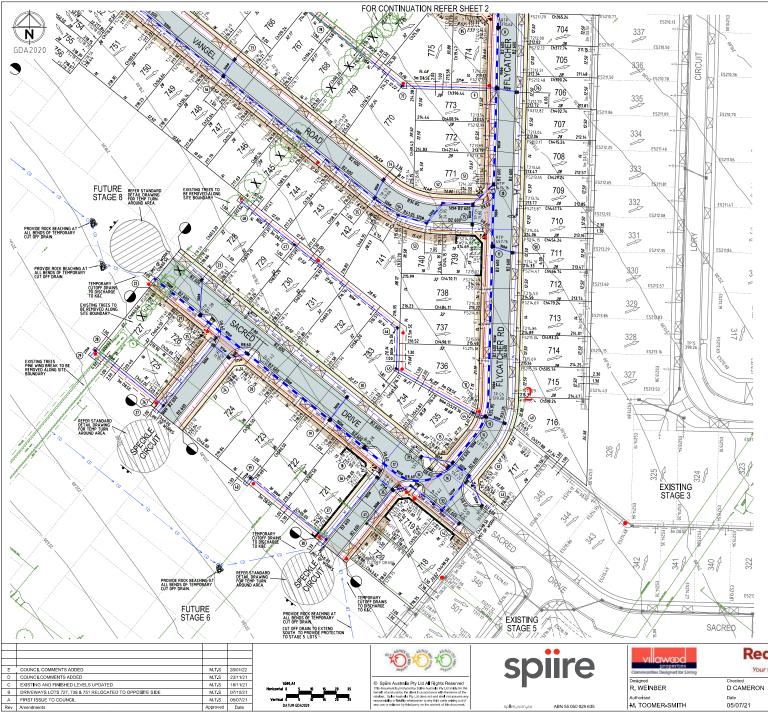
FIGURE 1 (1 of 2)

The site inspection and testing was performed by experienced geotechnicians from this office. Any areas that were deemed unsatisfactory were reworked and retested under their supervision. The testing was performed to the relevant Australian Standards and the accompanying test reports carry NATA endorsement. The attached compaction results, which were located randomly throughout the fill profile, are considered to be representative of the bulk fill materials that were placed across the reported allotments by Winslow Constructors during the aforementioned period. The approximate locations of the field density tests can be seen on the attached plan (Figure 1).

Approximate field density test location
