16<sup>th</sup> June 2023  
Ref : 7189

**,RE : SUPERVISION OF FILL PLACEMENT  
ESTUARY ESTATE II – STAGE 1**

## REPORT OF COMPACTION CONTROL (HILF RAPID METHOD)

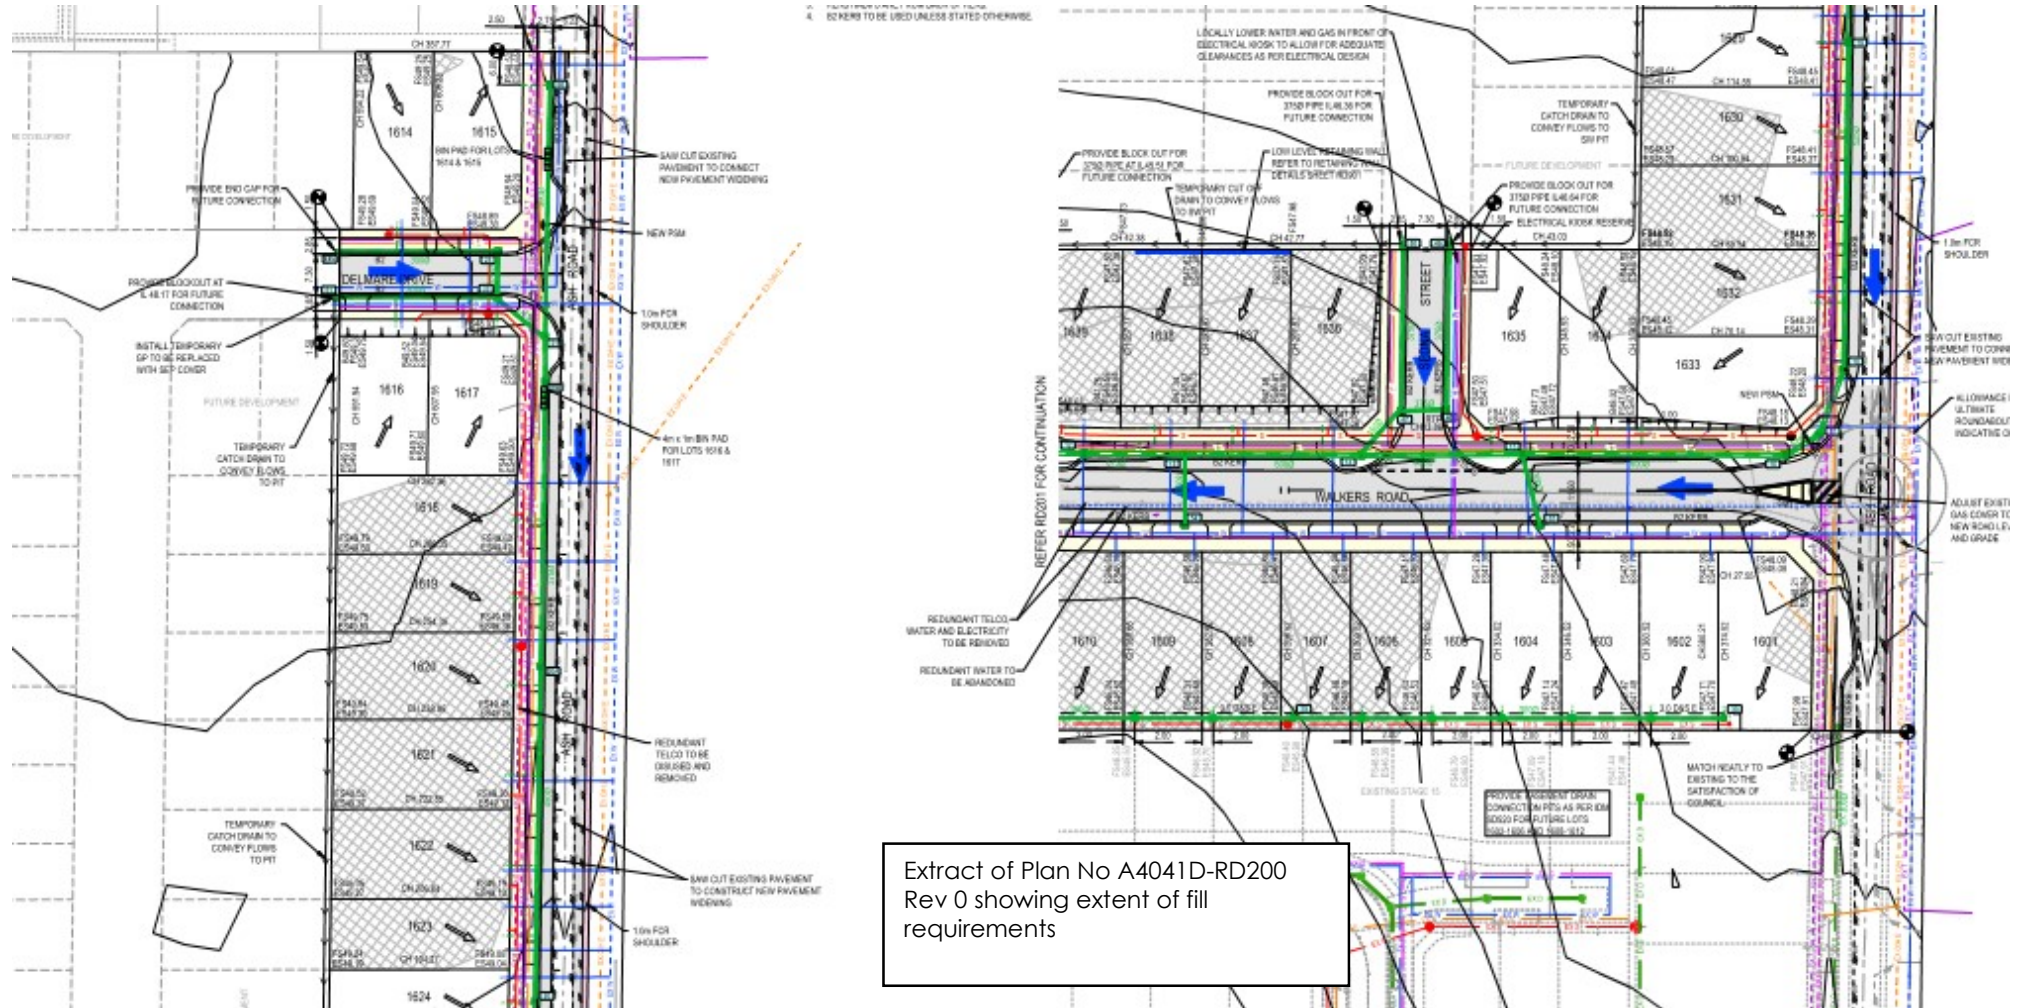
Extract of Plan No A4041D-RD200  
Rev 0 showing extent of fill  
requirements
