***Material Testing and Laboratory Services for the Construction Industry***

15<sup>th</sup> March 2025  
Ref : 7336

**,RE : SUPERVISION OF FILL PLACEMENT  
ESTUARY ESTATE II – STAGE 1  
LOTS 1906 TO 1918 AND 1926 TO 1937**

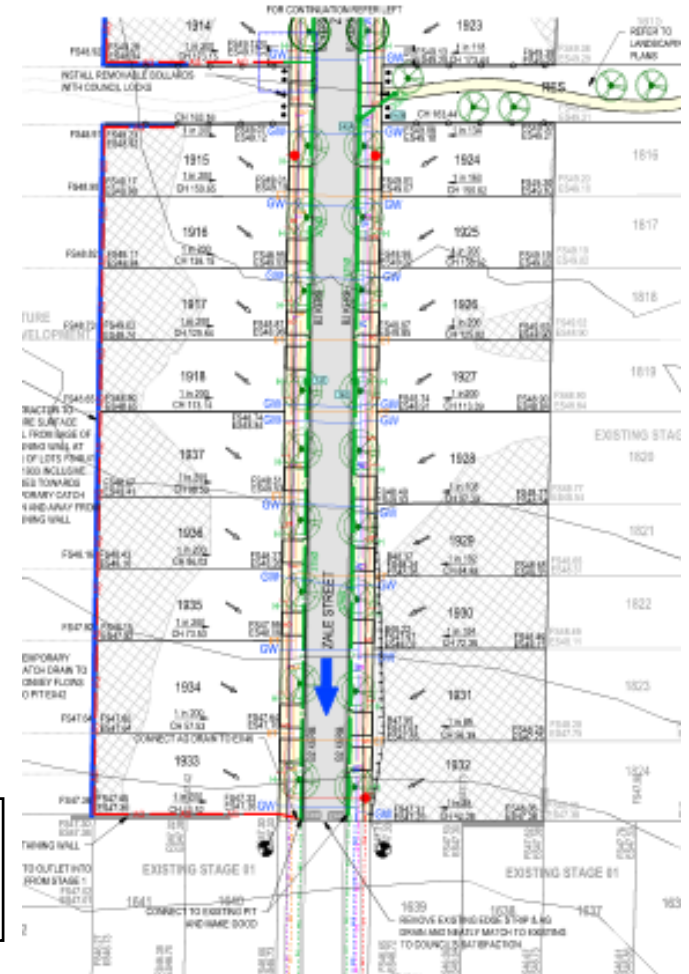
Extract of Plan No A4041D-RD200  
Rev 0 showing extent of fill  
requirements
