17th October 2024
Ref : 7544

**RE : SUPERVISION OF FILL PLACEMENT
ESTUARY ESTATE II – STAGE 4
LOTS 2011 – 2014 AND RESERVE**

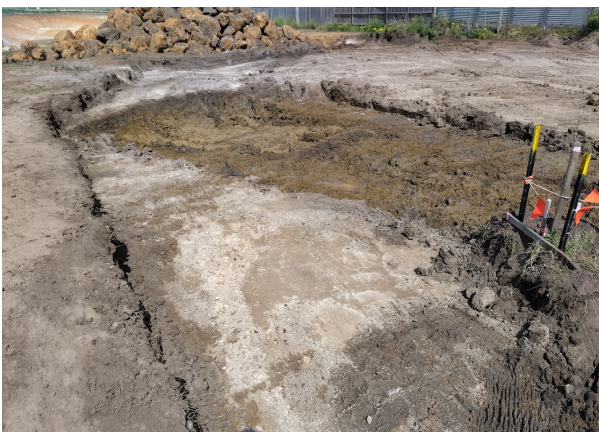
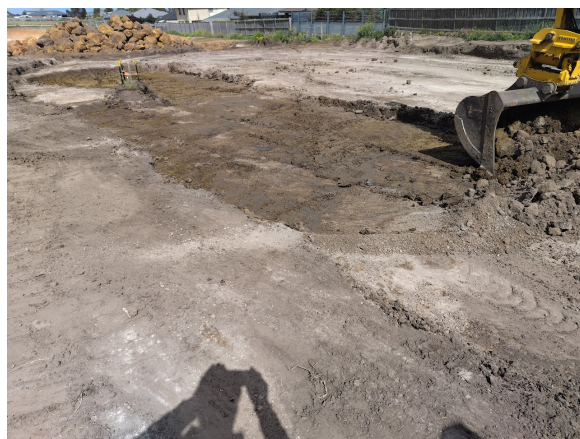
Following Proof Rolling with a loaded water cart, unsuitable material on which further clay fill could be placed was identified in the area of Lots 2013 and 2014. This unsuitable material was directed to be removed to expose firm natural ground.

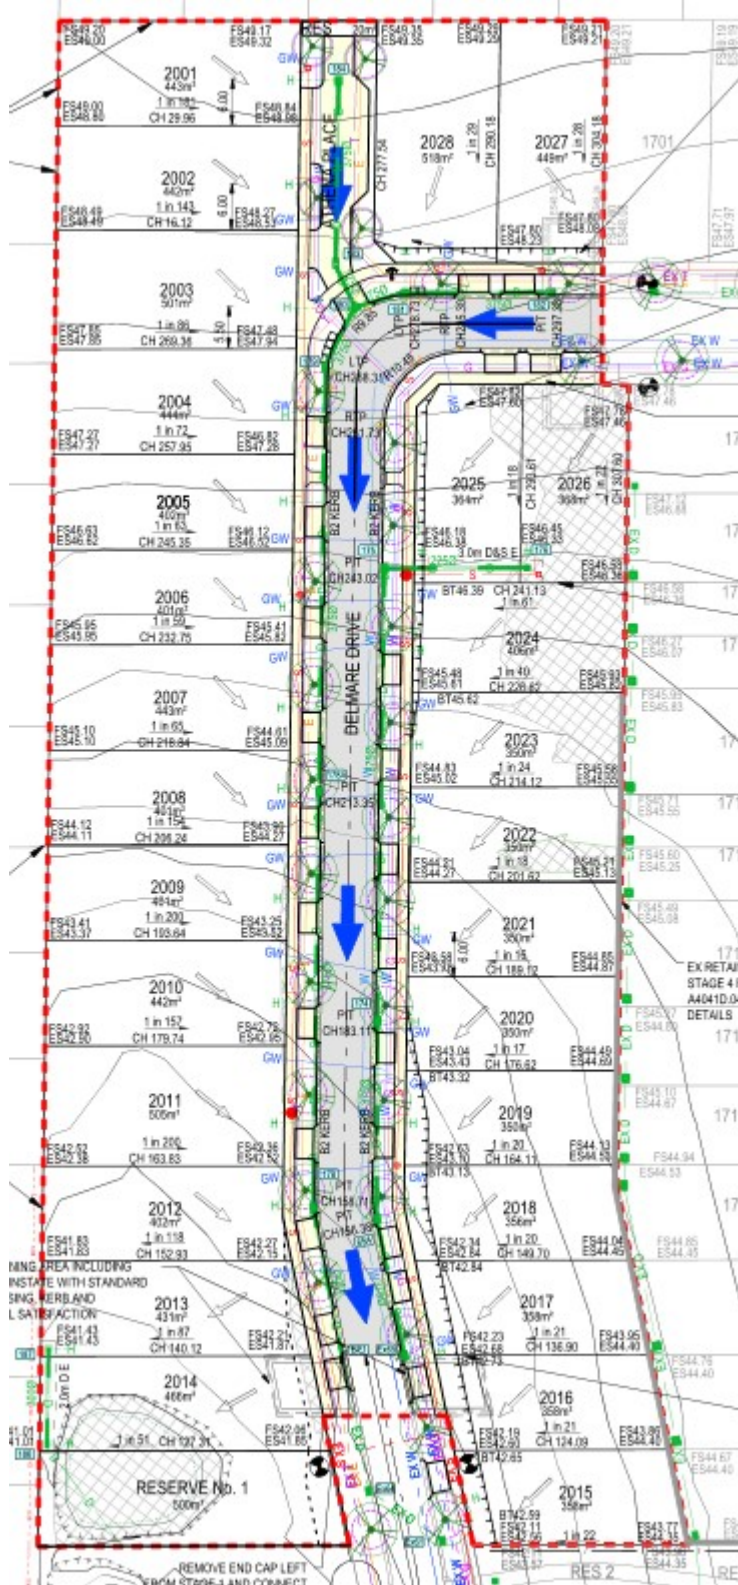
Extract Drawing A4041D-05 – RD200 Rev B
(preliminary) showing extent of fill required
on Lots

The construction Drawings for Stage Four required that fill was to be placed along the boundaries of Lots 2001 to 2014 and adjacent properties to the west to maintain a smooth transition in surface level between properties.

A inspection of the site showed that the extent of fill required was greater than 200mm in depth. To achieve the required final level, it was necessary to remove overlying topsoil and raise the underlying natural clay before reinstating the topsoil to final surface level.
