17<sup>th</sup> October 2024  
Ref : 7544

**,RE : SUPERVISION OF FILL PLACEMENT  
ESTUARY ESTATE II – STAGE 5  
LOTS 1710 – 1721, 1724 – 1730 INCLUSIVE**

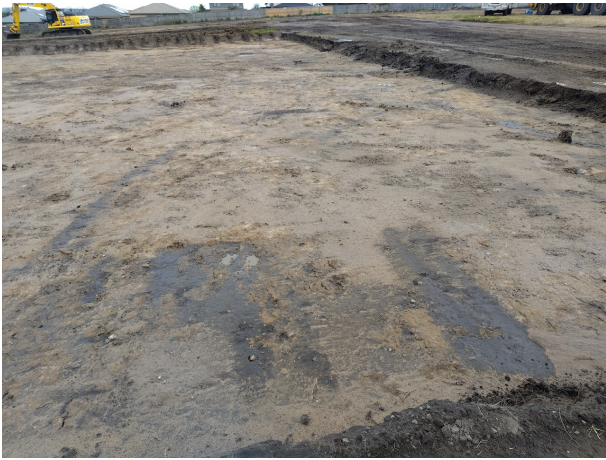
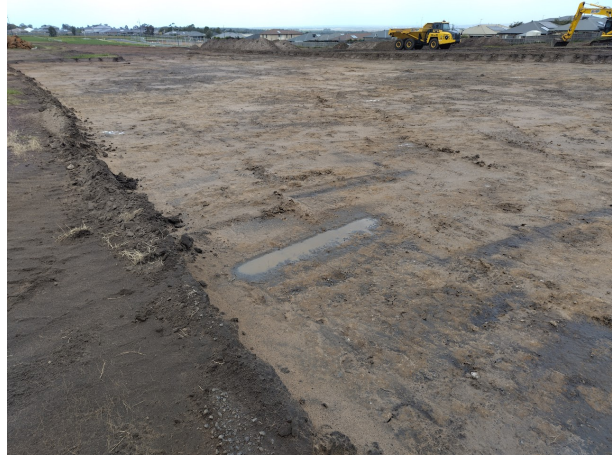
All overlying topsoils were removed by excavation to expose the underlying natural sandy Clays. In some instances, the overlying topsoil was found to be up to 500mm thick.

Following completion of the stripping and clearing operation, a visual inspection of the site was made and the fill area proof rolled using a fully laden water cart before approval to commence fill placement was granted.

Site stripped and cleared of topsoil  
prior to placing fill

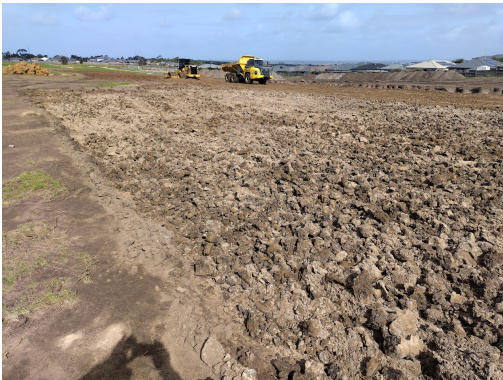
Fill area ripped prior to watering,  
compaction and placement of fill

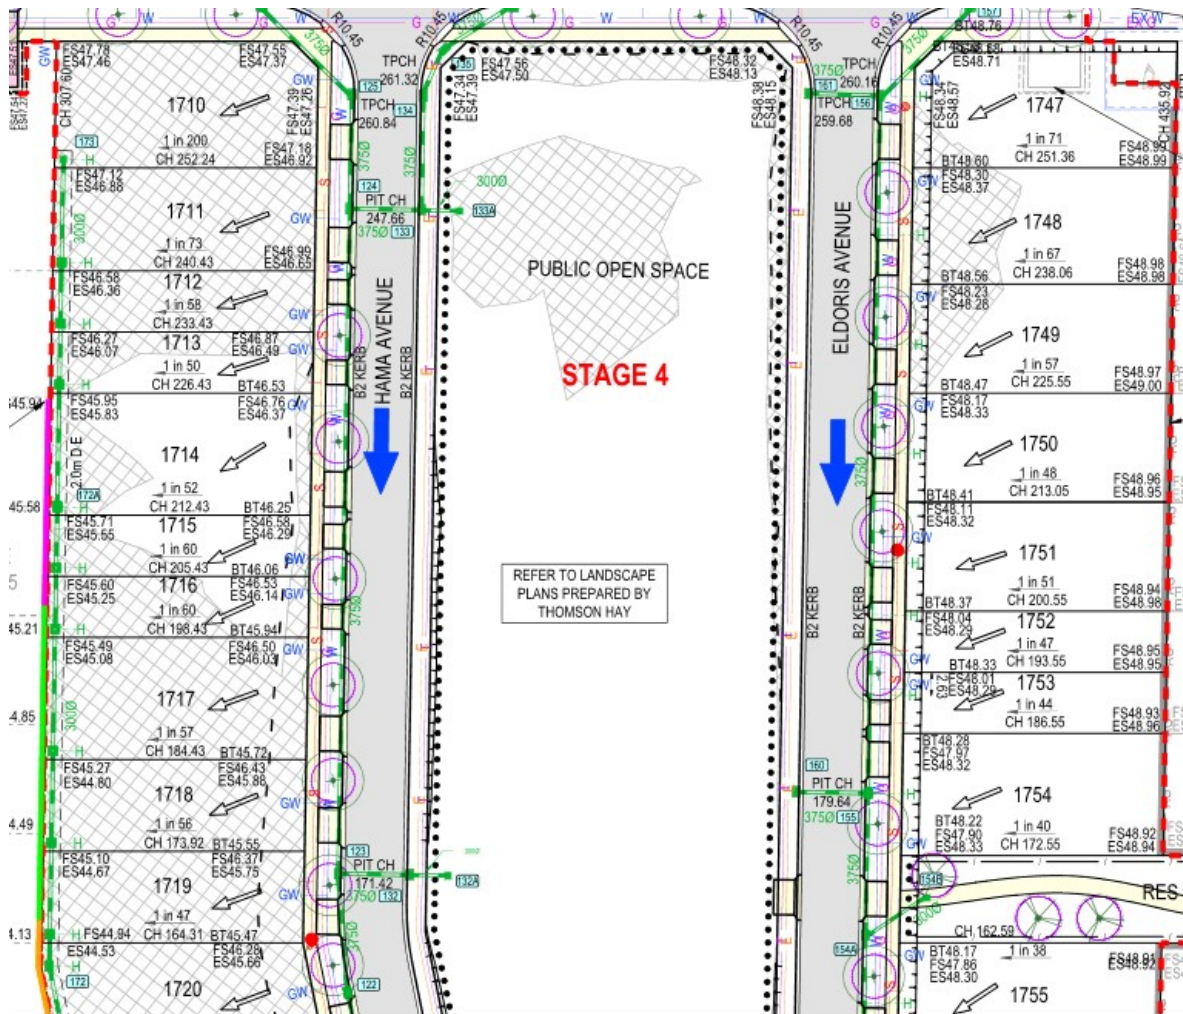
Extract Drawing A4041D-04 – RD200 Rev A  
(preliminary) showing extent of fill required on Lots

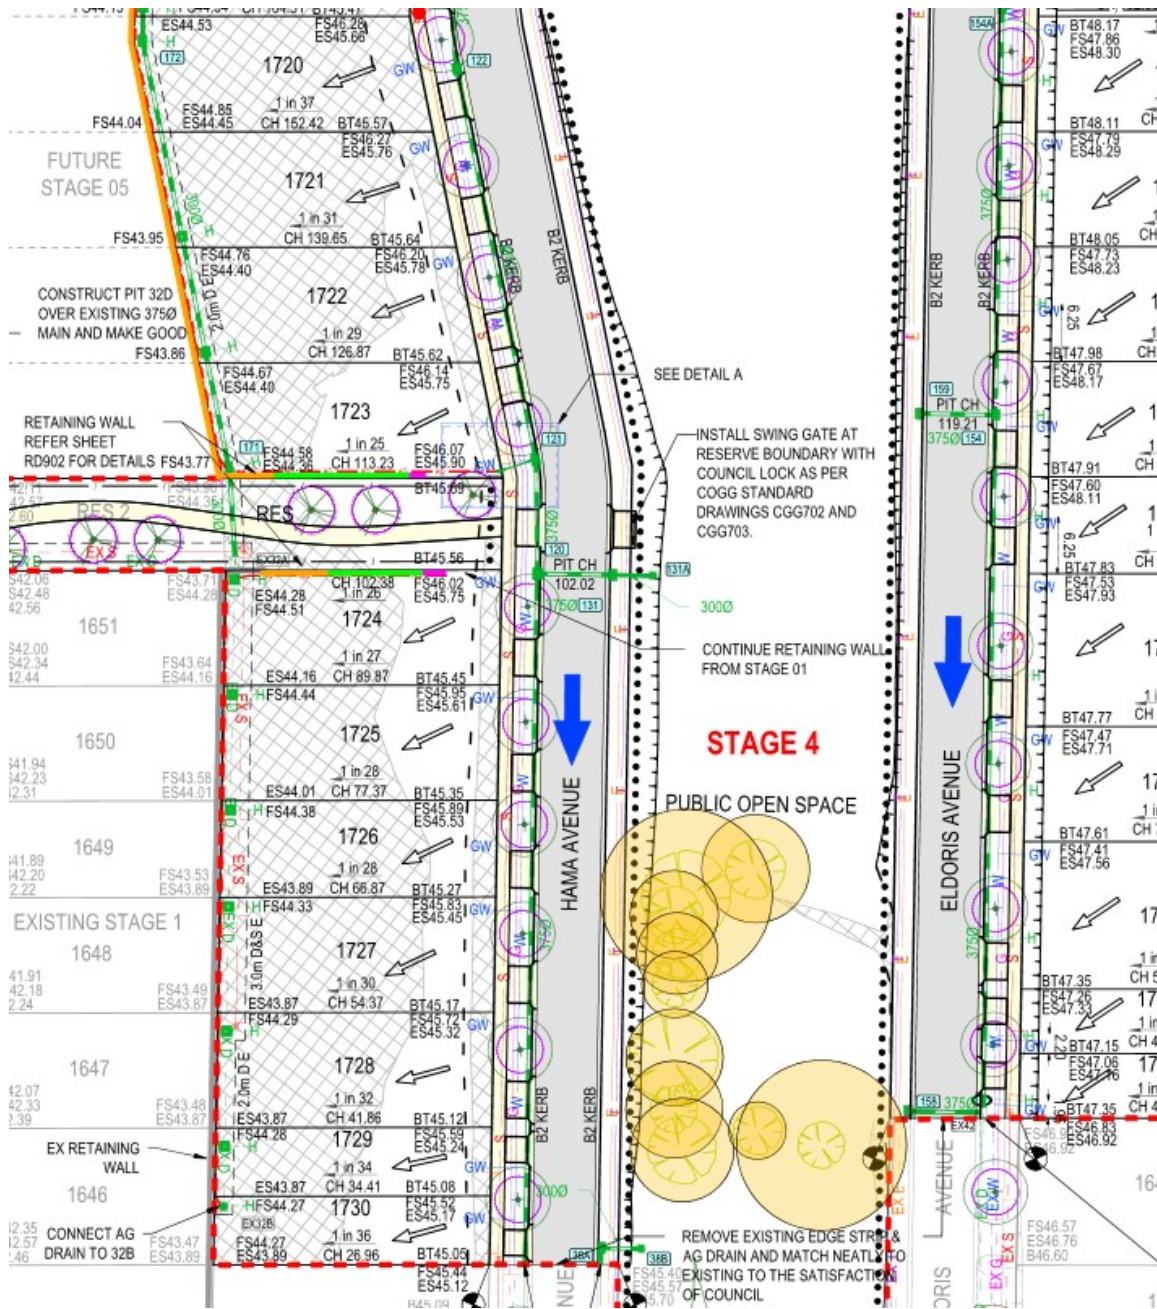
Extract Drawing A4041D-04 – RD200 Rev A  
(preliminary) showing extent of fill required on Lots
