Project No: 1120 0273-1 (SSI1)

Ref: Williams Walk - Stage 1, Rockbank

Bitu-Mill has engaged A&Y Associates to perform a stripped surface inspection to confirm the presence of appropriate founding materials and to ensure that all soft or wet material has been removed prior placement of fill.

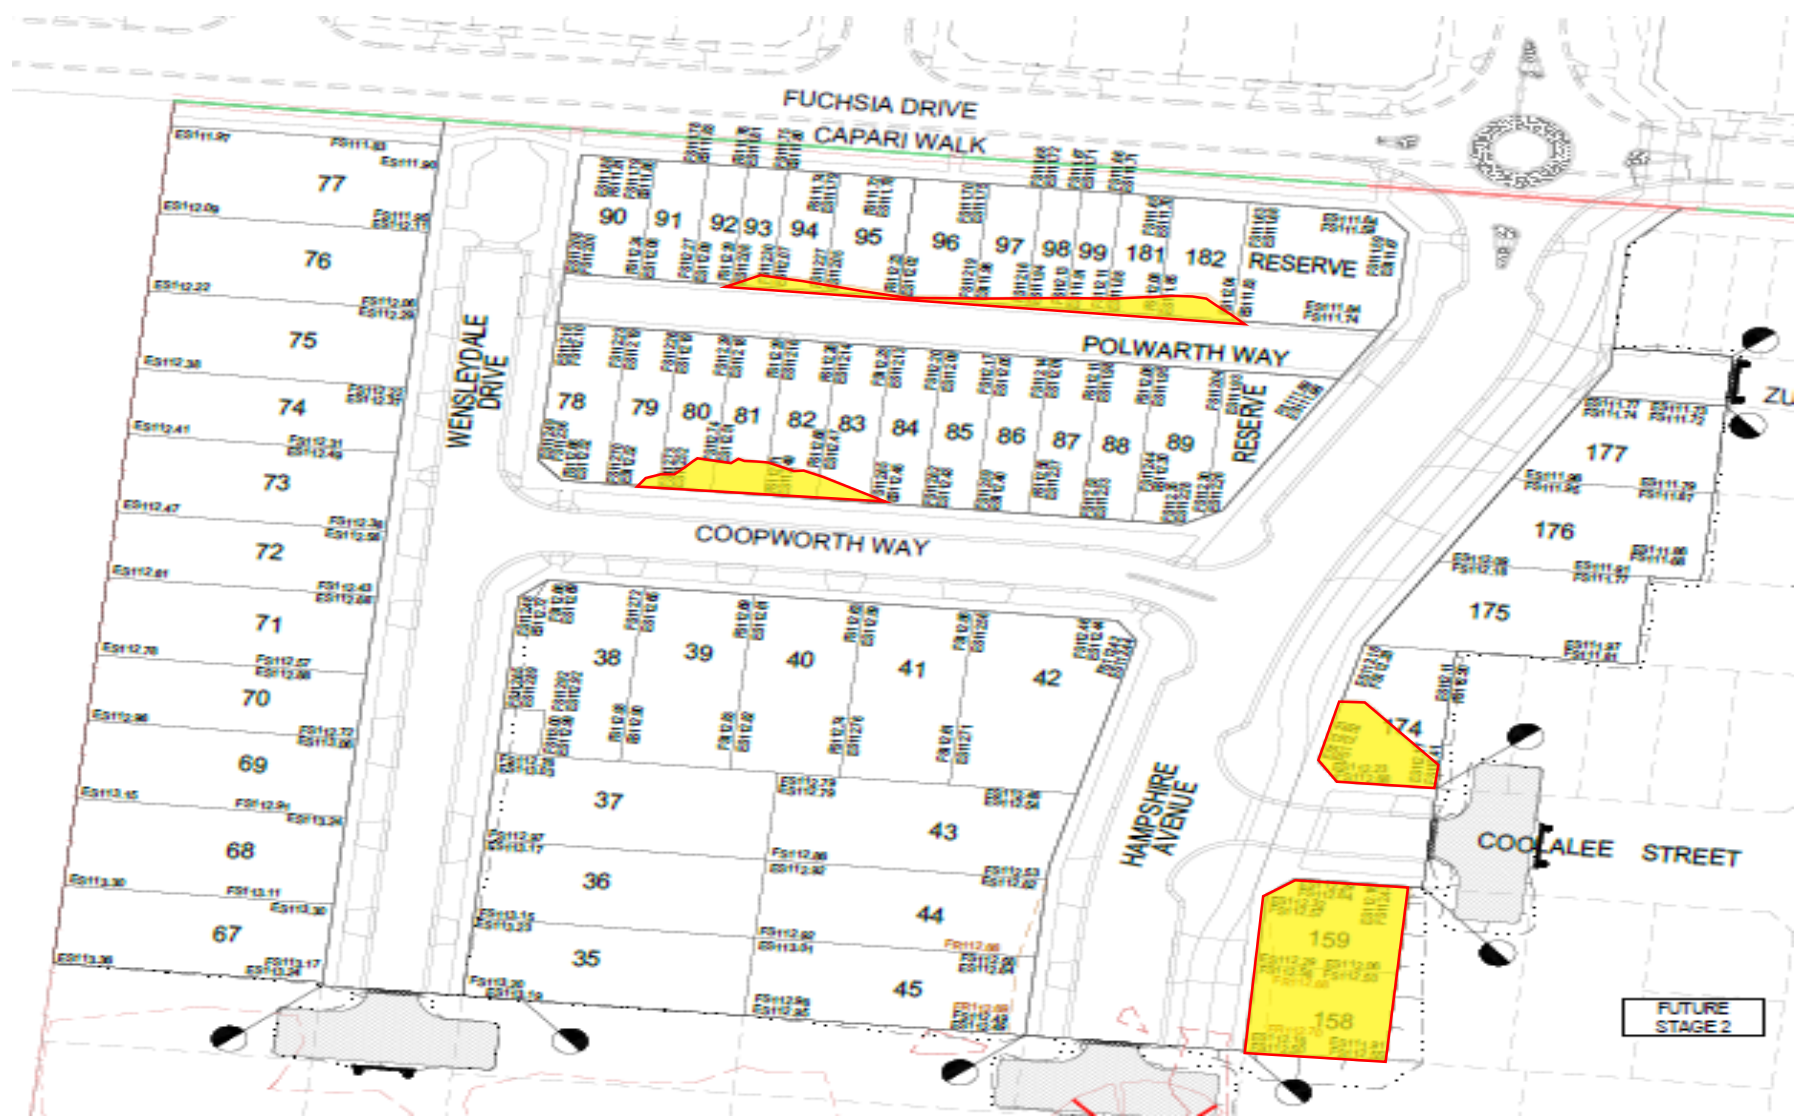
SITE PLAN SKETCH—NOT TO SCALE

- Lot 79 – 84
- Lot 93 – 99
- Lot 174
- Lot 158 – 159
- Lot 181 – 182

Area Inspected

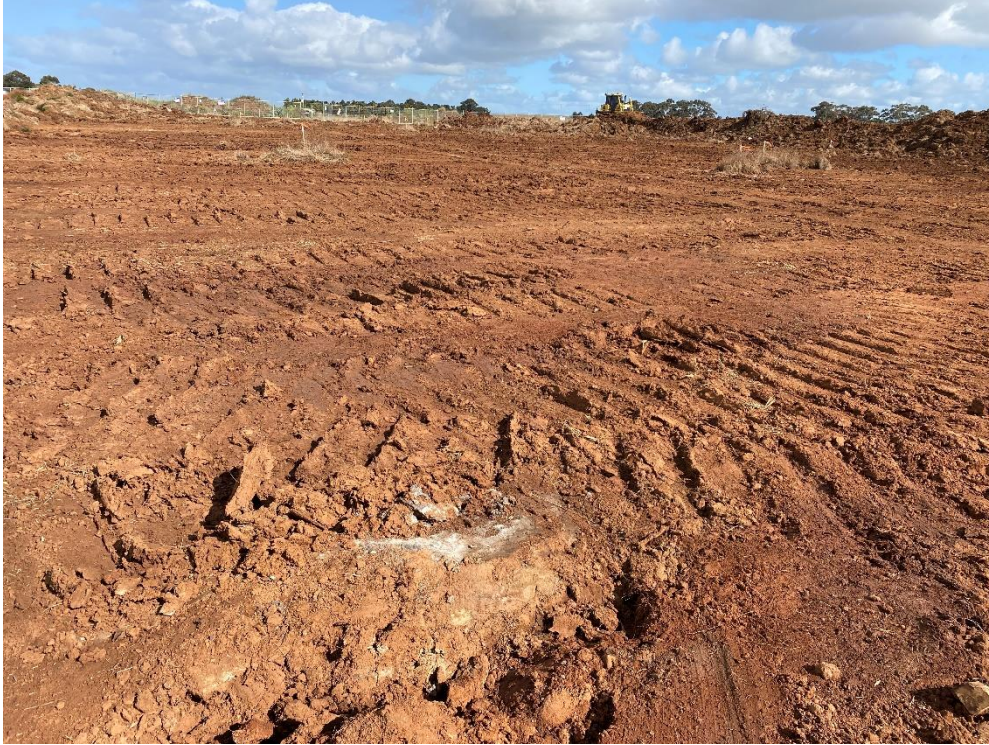
The inspection revealed that the site preparation was found to be sufficient as per AS3798. No wet or soft patches were found during the inspection. No evidence of deleterious material was found during the inspection.

Site Photo 1: Showing the stripped ground surface
