Level 1 Supervision & Inspection Report

RATHDOWNE ESTATE STAGE 20

Prepared for Winslow Constructors Pty Ltd

30/09/2025

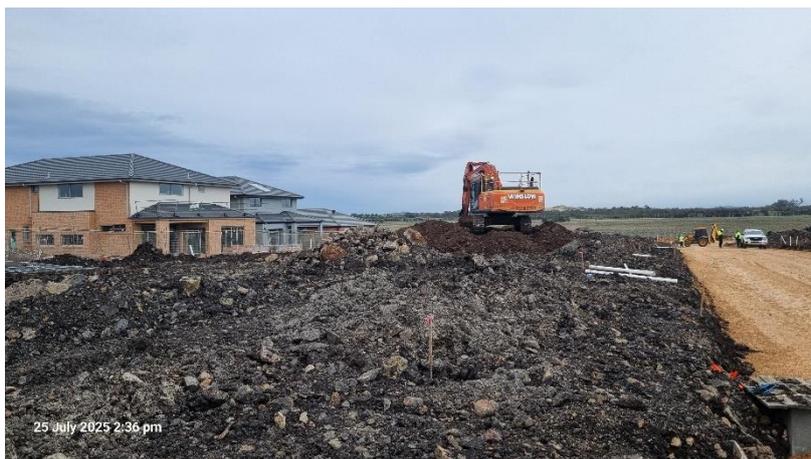
Figure 2. Oversize Aggregates on stockpile

During site visits conducted between July 25, 2025, and August 04, 2025, oversized aggregates or boulders were observed in stockpiles within the Lots of 2003 to 2006. These aggregates were sourced from Onsite – Clay Insitu Locations.

In accordance with AS 3798, the presence of boulders in sufficient proportions is not permitted in fills, as they may adversely impact compaction, moisture content for testing, and the overall quality of earthworks fills.

On July 25, 2025, discussions with the Foreman, focused on the extraction of oversized boulders from the fill. The operator confirmed that he separates the boulders from the stockpiles and relocates them to areas where oversized aggregates will not be included in the designated fill locations.

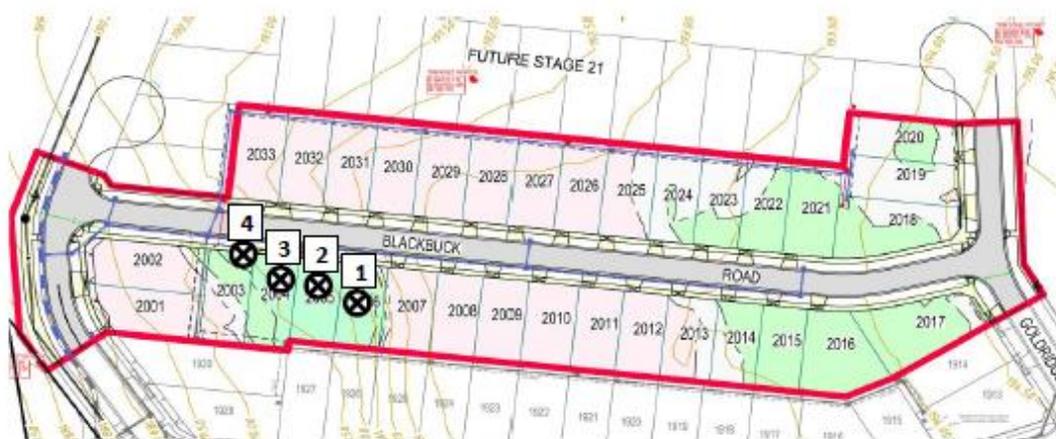
Site Location Sketch

Test site locations only
NOT TO SCALE
