Level 1 Supervision & Inspection Report

RATHDOWNE ESTATE STAGE 20

Prepared for Winslow Constructors Pty Ltd

30/09/2025

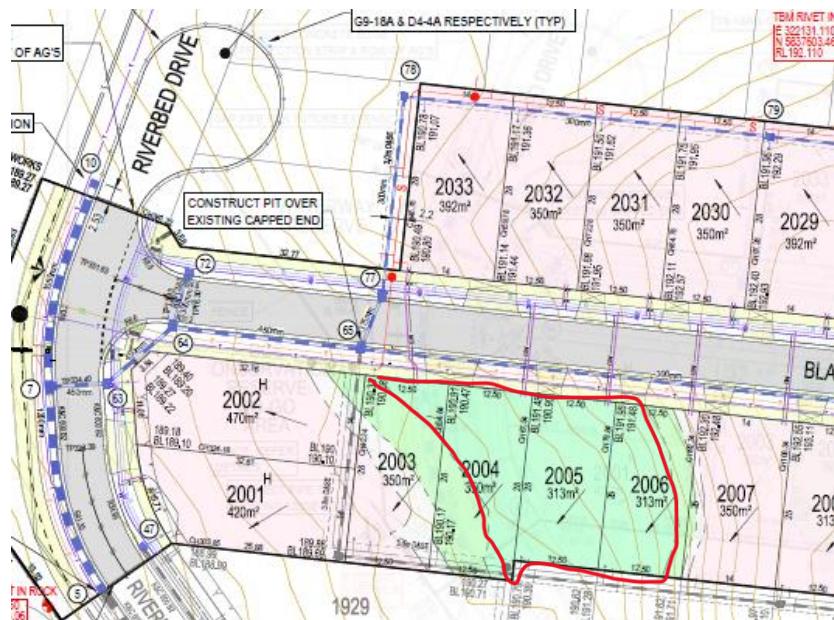
Figure 1. Level 1 supervision fill areas highlighted

The approximate location of the site is shown outlined in figure 1 below:

Figure 1. Fill areas highlighted in red – Rathdowne Estate – Stage 20

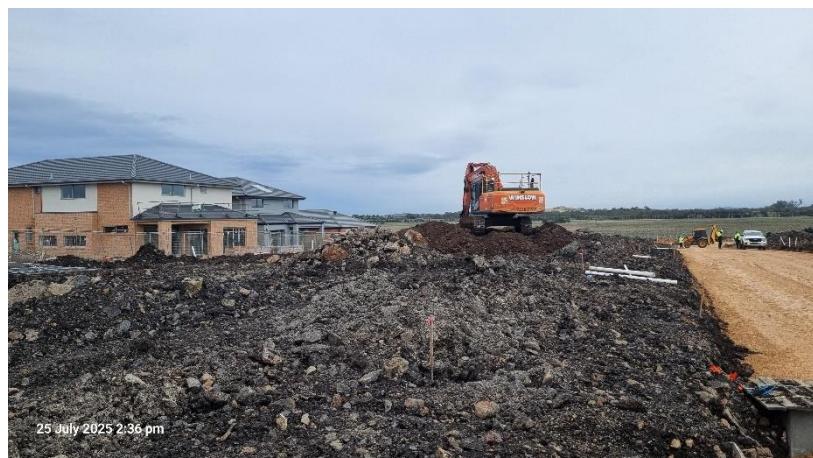
Figure 2. Oversize Aggregates on stockpile

During site visits conducted between July 25, 2025, and August 04, 2025, oversized aggregates or boulders were observed in stockpiles within the Lots of 2003 to 2006. These aggregates were sourced from Onsite – Clay In situ Locations.

In accordance with AS 3798, the presence of boulders in sufficient proportions is not permitted in fills, as they may adversely impact compaction, moisture content for testing, and the overall quality of earthworks fills.

On July 25, 2025, discussions with the Foreman, focused on the extraction of oversized boulders from the fill. The operator confirmed that he separates the boulders from the stockpiles and relocates them to areas where oversized aggregates will not be included in the designated fill locations.

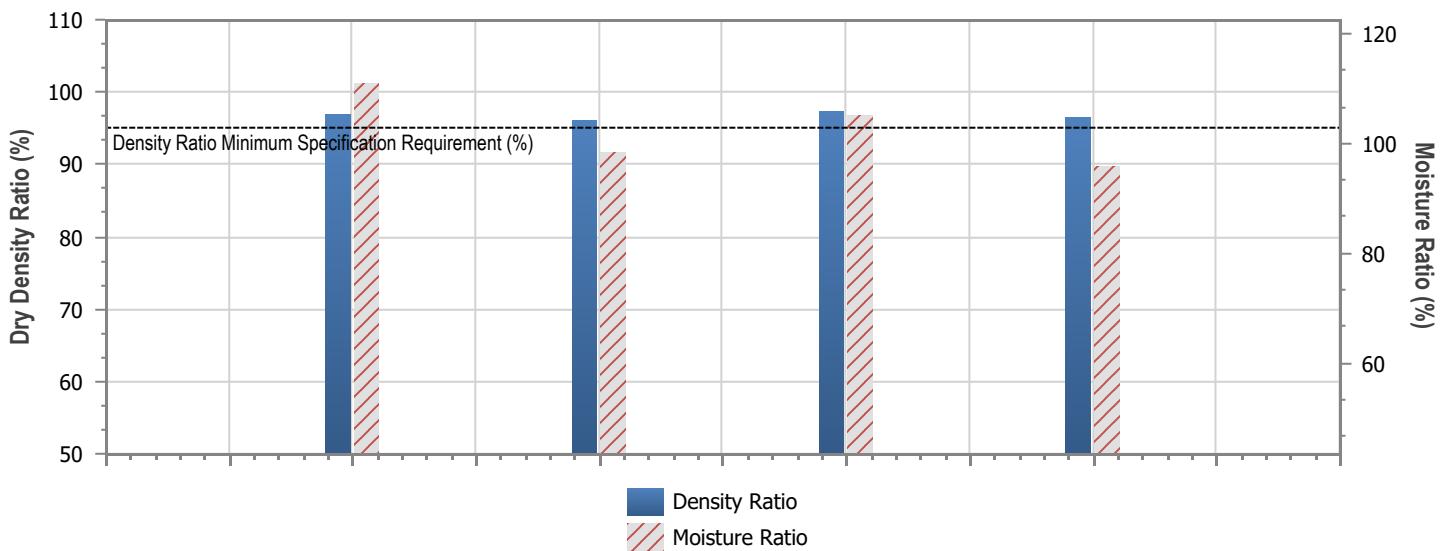
LOT TEST RESULT SUMMARY

Tests in Lot = 4	Lot Minimum	Lot Maximum	Lot Mean	Standard Deviation
Moisture Ratio (%)	95.8	111.0	102.6	6.881
Dry Density Ratio (%)	96.0	97.3	96.7	0.559
Lot Number: 2003				
Mean Moisture Ratio (%): 102.6				
Mean Density Ratio (%): 96.7

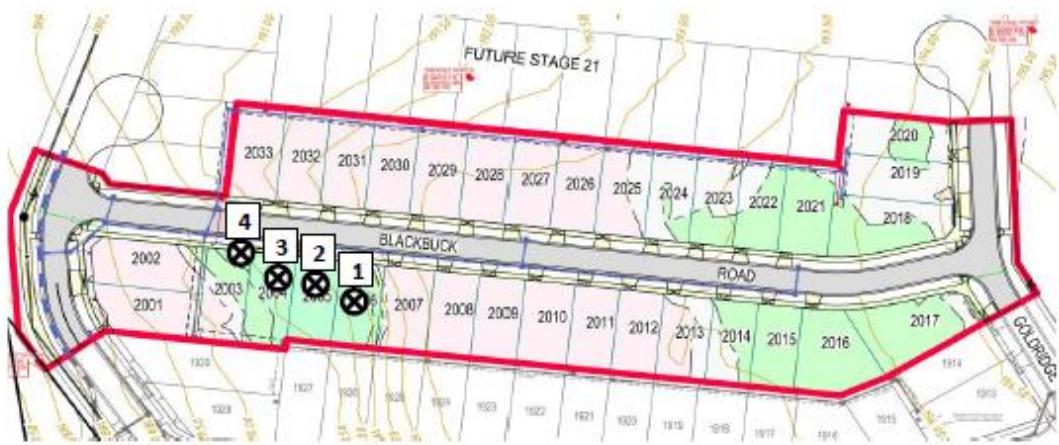
Site Location Sketch

Test site locations only
NOT TO SCALE
