Level 1 Inspection and Testing Report

Alamora Estate, Stage 17, Tarneit

CTCE Ref: 25065.0R_V1

Level 1 Inspection and Testing Alamora Estate, Stage 17, Tarneit

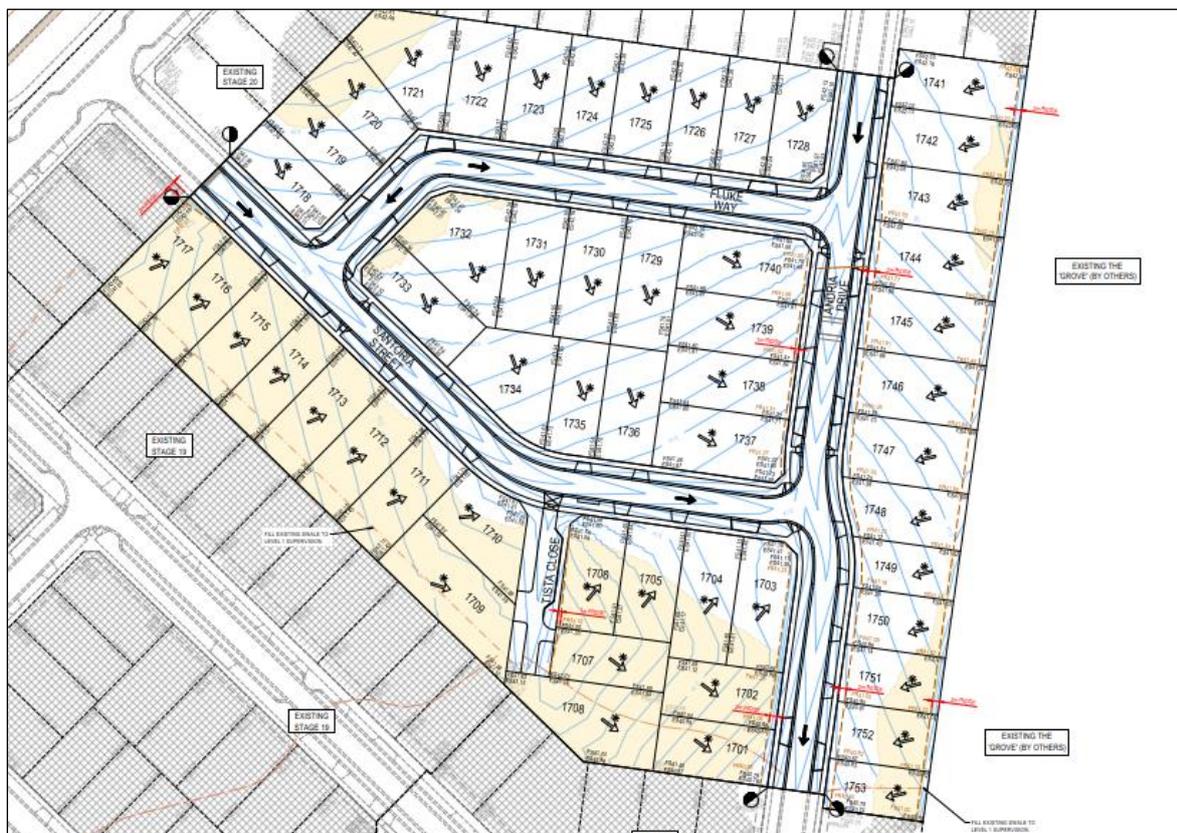
Figure 1: Site Overview & Bulk Earthworks Zone (Source: Creo 200282.17 R202 Rev 0)

This report presents the Level 1 Inspection & Testing results which commenced on 28 May 2025 and was completed on 3 June 2025. The filling works generally took place on the shaded areas shown on Figure 1 below:

It should be noted that some areas required < 50 mm to < 150 mm of fill, and these areas did not require Level 1 Inspection & Testing services.

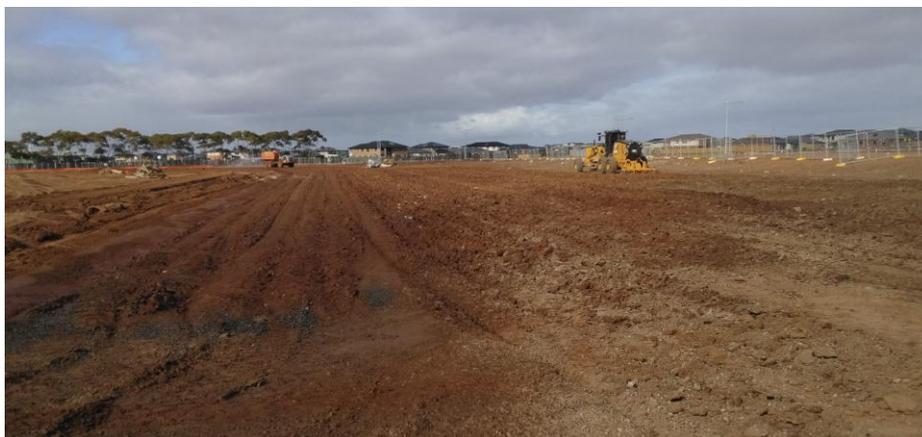
Figure 1: Subgrade Preparation Works (Source: C&T)

The fill placement zones generally required stripping of topsoil, vegetation and organics. Scrapers and graders were used to carry out the site stripping until a base comprising residual Newer Volcanic Group Silty CLAY / CLAY (CH), high plasticity, brown to dark brown was achieved. The subgrade was scarified using an onsite grader, moisture conditioned and compacted, followed by a proof roll using a fully loaded water cart which showed no deflections, springing or rutting. The subgrade was deemed suitable for subsequent fill placement.

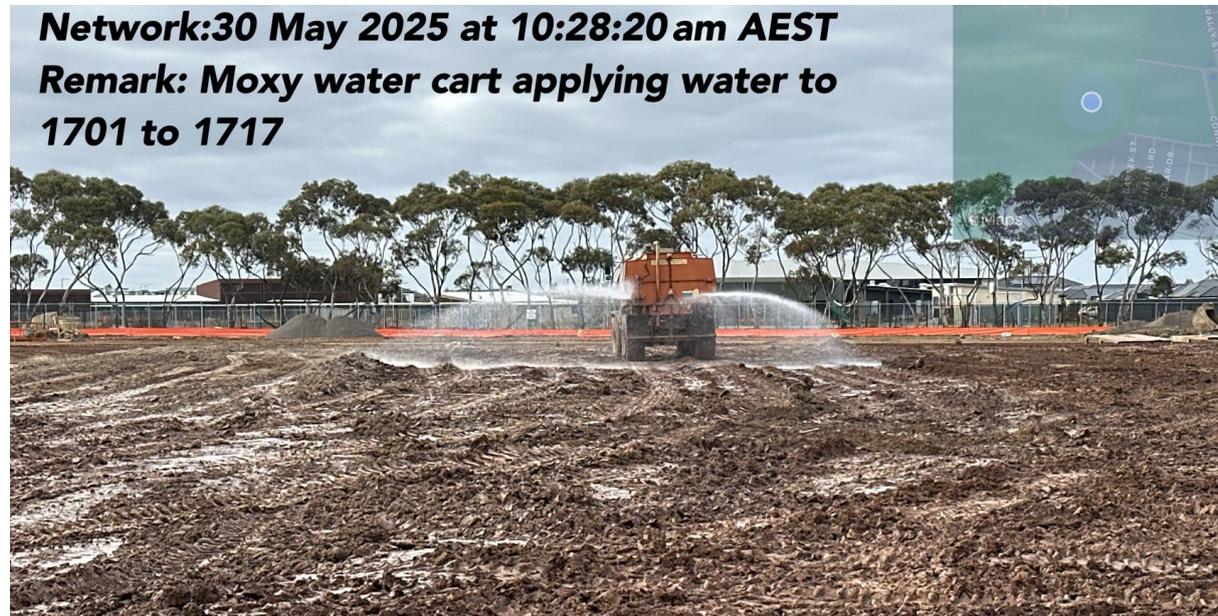
Figure 2: Fill Being Moisture Conditioned During Placement (Source: C&T)

The fill materials were spread into loose layers averaging around 50 mm to 150 mm thick. Each layer was compacted using the 815 compactor, applying a minimum of 10 to 15 passes per layer observed. A water cart was used to moisture condition the fill material during placement. Field density testing was carried out on each composite 150 mm thick layer.

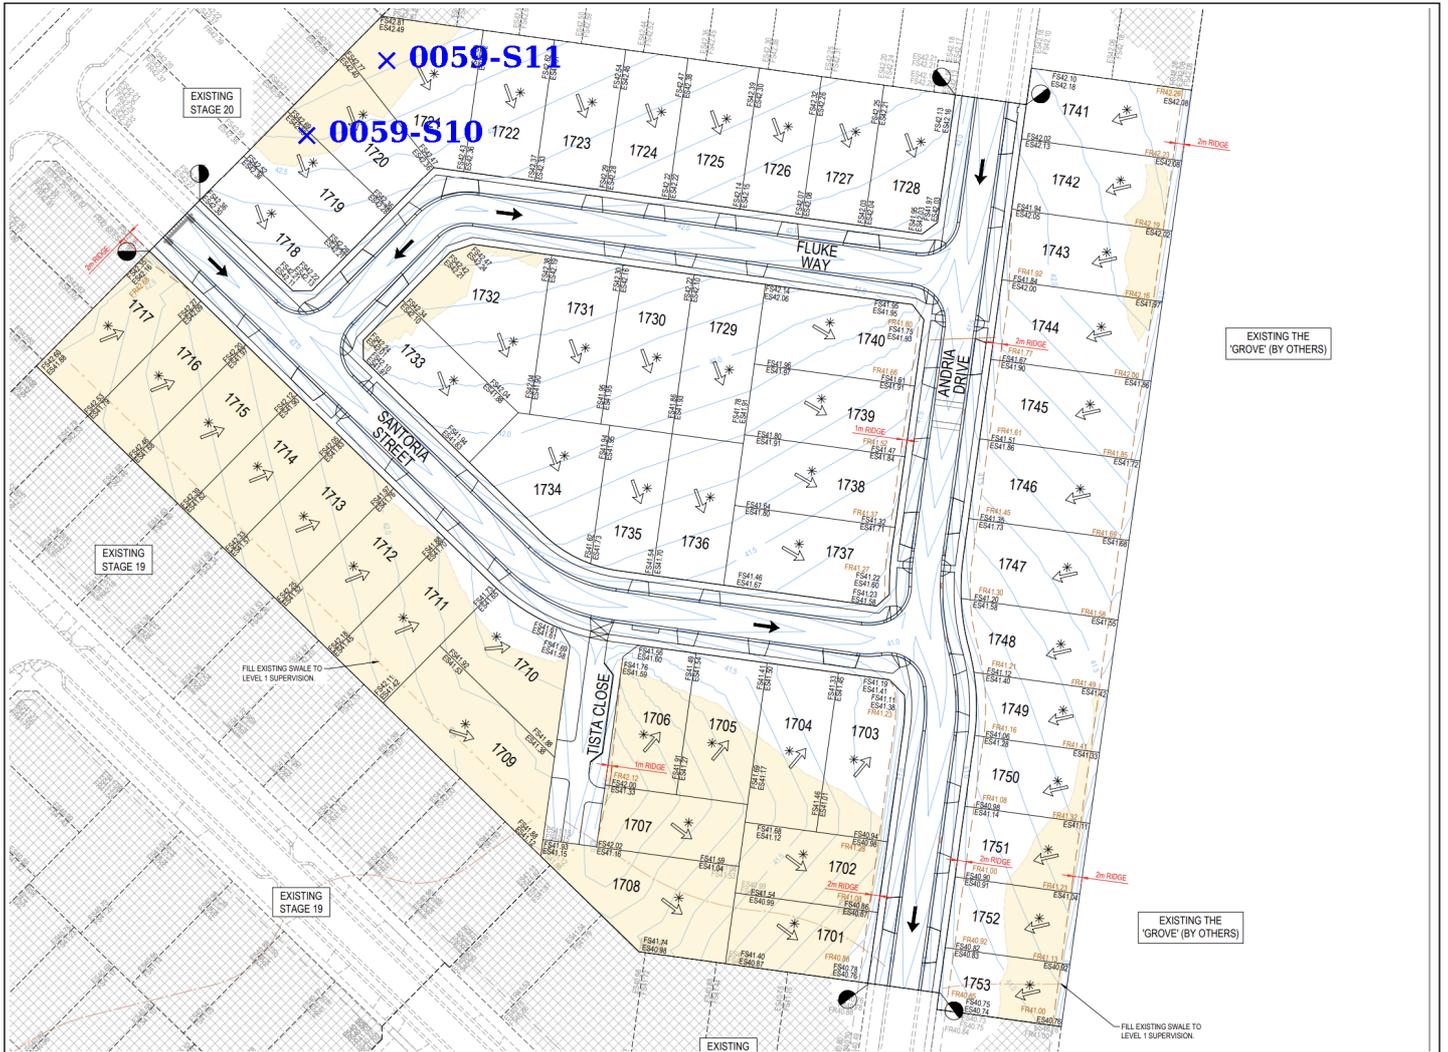
Sample Locations Plan

Compaction Control AS 1289 5.7.1 & 5.8.1 & 2.1.1			
Sample Number	0059-S10	0059-S11	
Date Tested	03/06/2025	03/06/2025	
Time Tested	12:00	12:10	
Test Request #/Location	Lots 1719/1720	Lot 1721	
Easting	292213	292224	
Northing	5807936	5807950	
Layer / Reduced Level	FSL	FSL	
Thickness of Layer (mm)	200	200	
Soil Description	gravelly CLAY, med-high plast, red/brown	gravelly CLAY, med-high plast, red/brown	
Test Depth (mm)	175	175	
Sieve used to determine oversize (mm)	19.0	19.0	
Percentage of Wet Oversize (%)	0	0	
Field Wet Density (FWD) t/m ³	1.90	1.88	
Field Moisture Content %	34.1	33.6	
Field Dry Density (FDD) t/m ³	1.42	1.41	
Peak Converted Wet Density t/m ³	1.90	1.88	
Adjusted Peak Converted Wet Density t/m ³	**	**	
Moisture Variation (Wv) %	-2.5	-3.0	
Adjusted Moisture Variation %	**	**	
Hilf Density Ratio (%)	100.0	100.0	
Compaction Method	Standard	Standard	
Remarks	**	**

x - approximate test location
