LEVEL ONE

SURVEILLANCE

AND INSPECTION REPORT

Project Name: Armstrong Estate - Stage 27

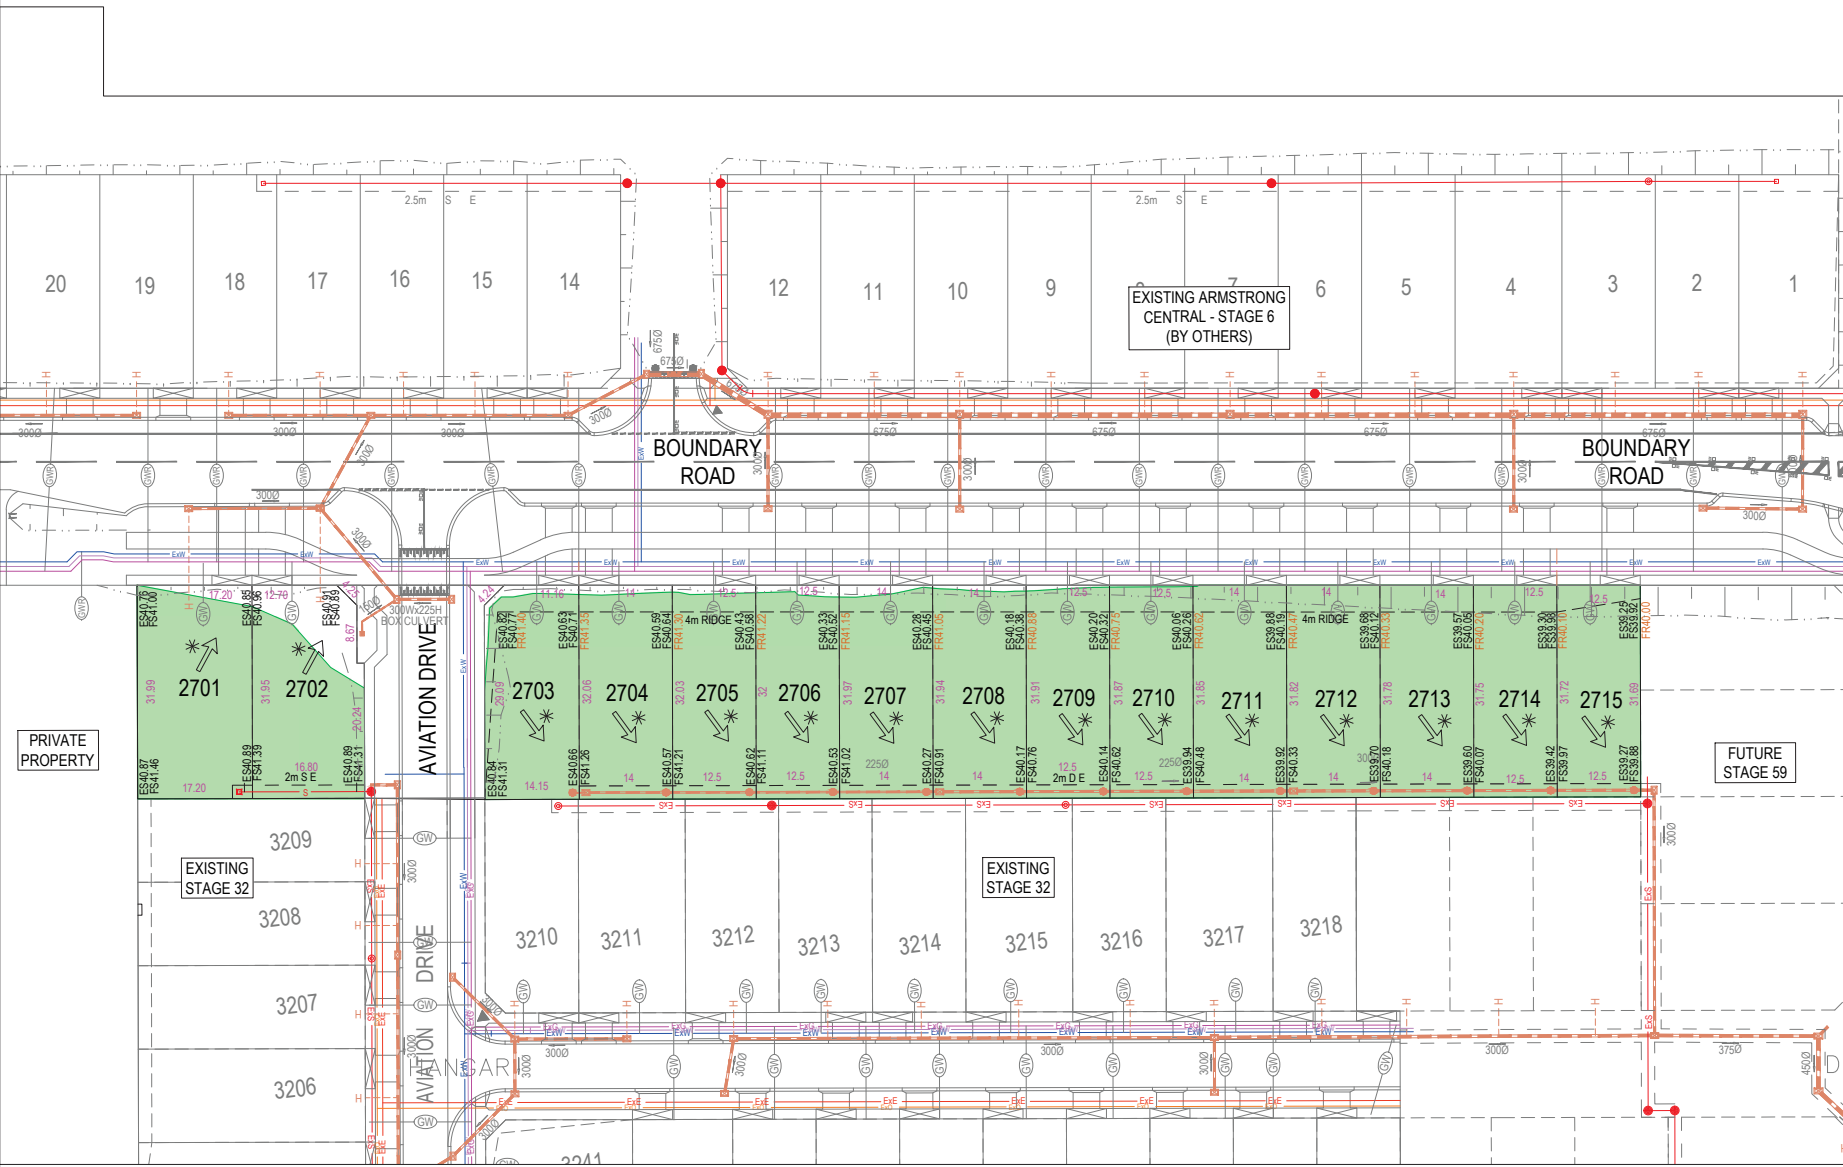
**NOTE:**  
1. ALL ROAD AND DRAINAGE INFRASTRUCTURE WAS PROVIDED AS A PART OF STAGE 6 ARMSTRONG CENTRAL WORKS, THE WORKS REQUIRED IS LIMITED TO LOT FILLING ONLY.

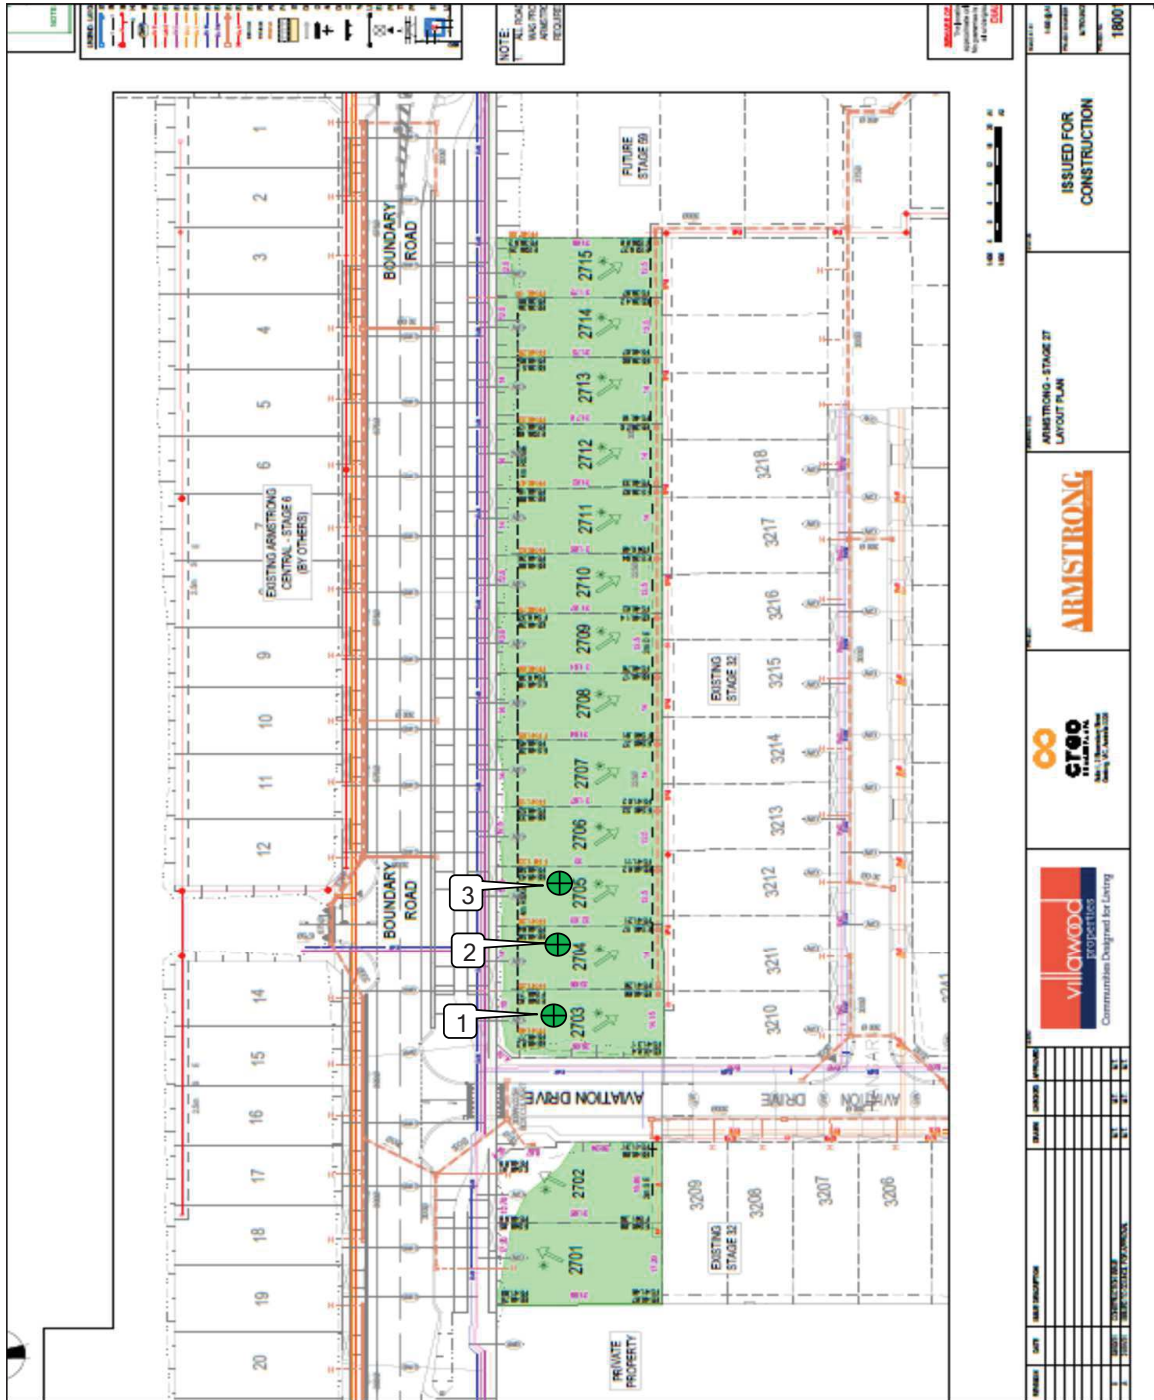
**Sketch indicating approx. compaction test locations**

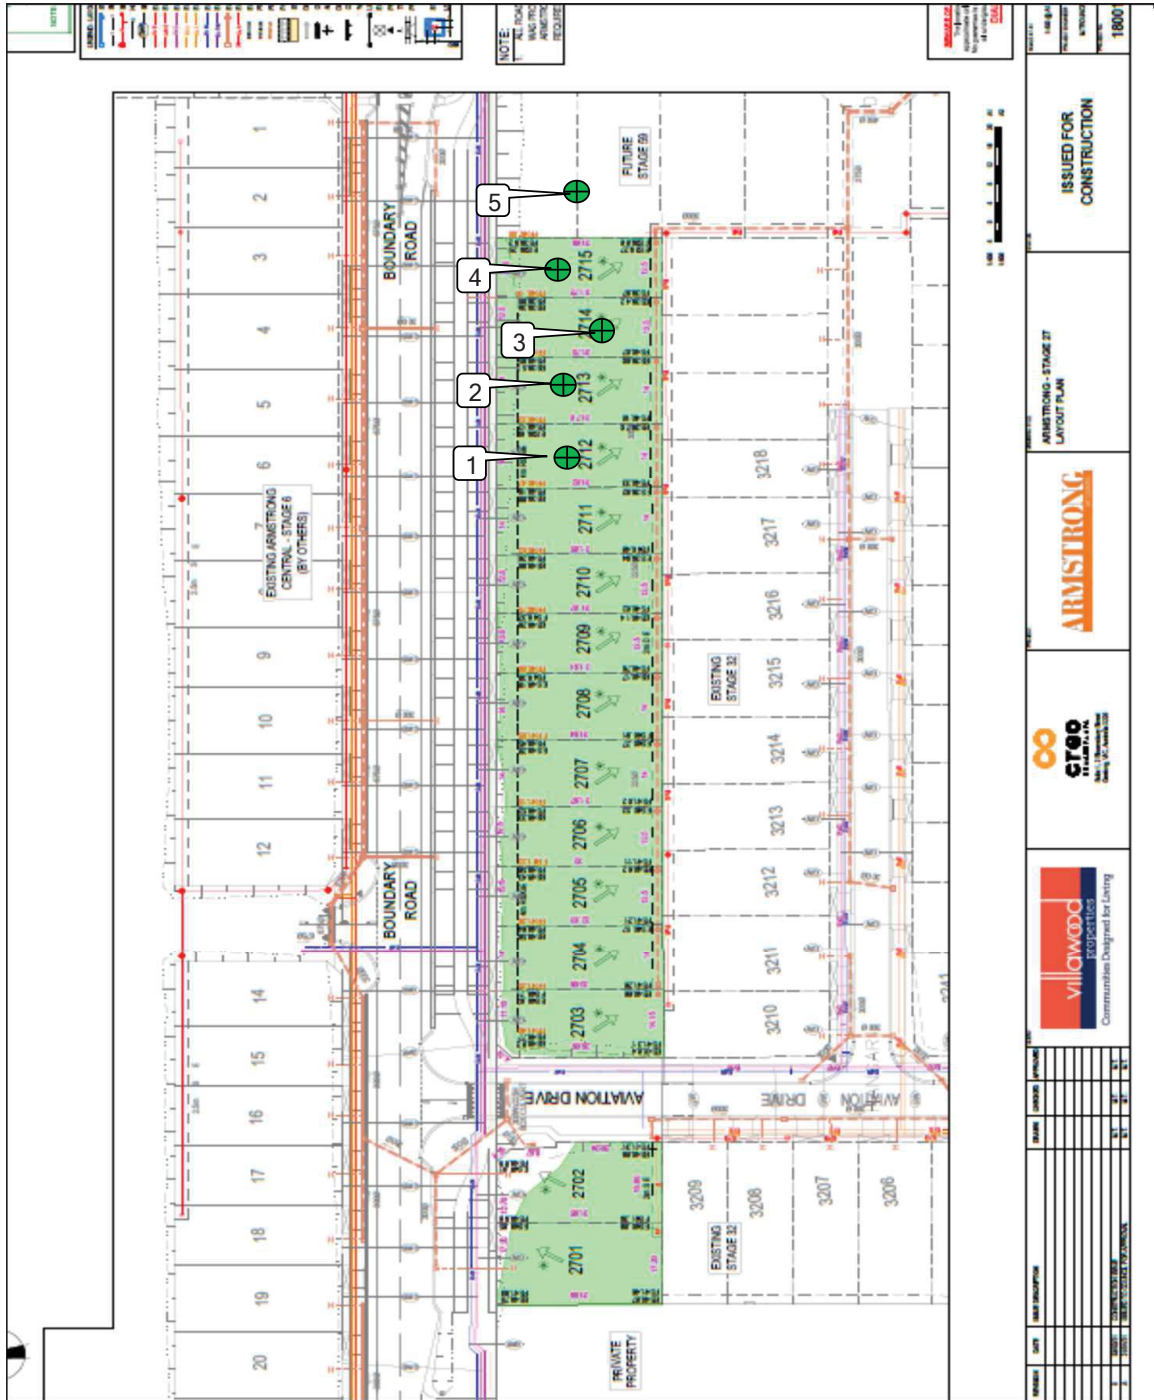
<b>CLIENT:</b> DRAPERS	<b>DATE:</b> 19/04/2020	<b>JOB No.:</b> 1861/304
<b>LOCATION:</b> Armstrong Estate Stage 27	<b>OPERATOR:</b> TI	<b>CHECKED:</b> KK
<b>Sketch indicating approx. compaction test locations</b>	<b>SCALE:</b> NTS	<b>FIGURE No:</b> -
