Reference  
No.: 9206-011

SURVEILLANCE

AND INSPECTION REPORT

Project Name: Armstrong Estate, Stage 53B

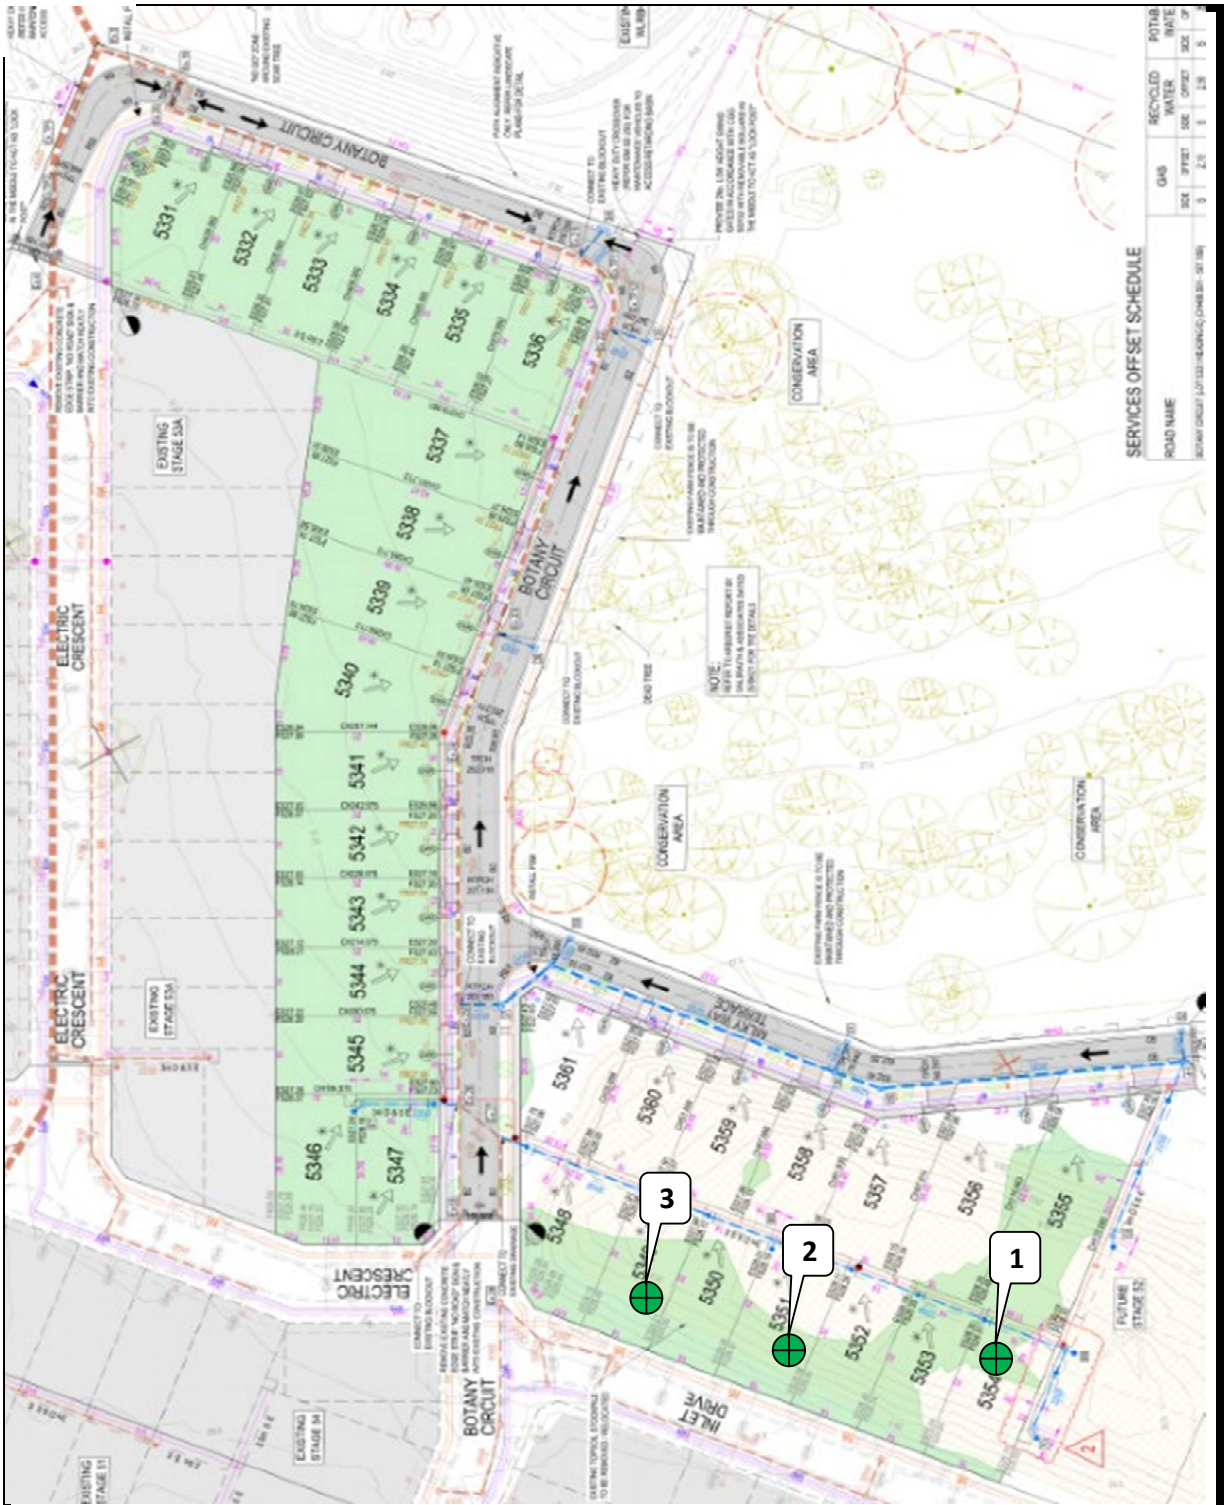
**Sketch indicating compaction test locations**

A total of thirteen compaction tests were performed on the fill construction. Results are presented in Appendix B of this report.

**DATE: 19/03/2024**

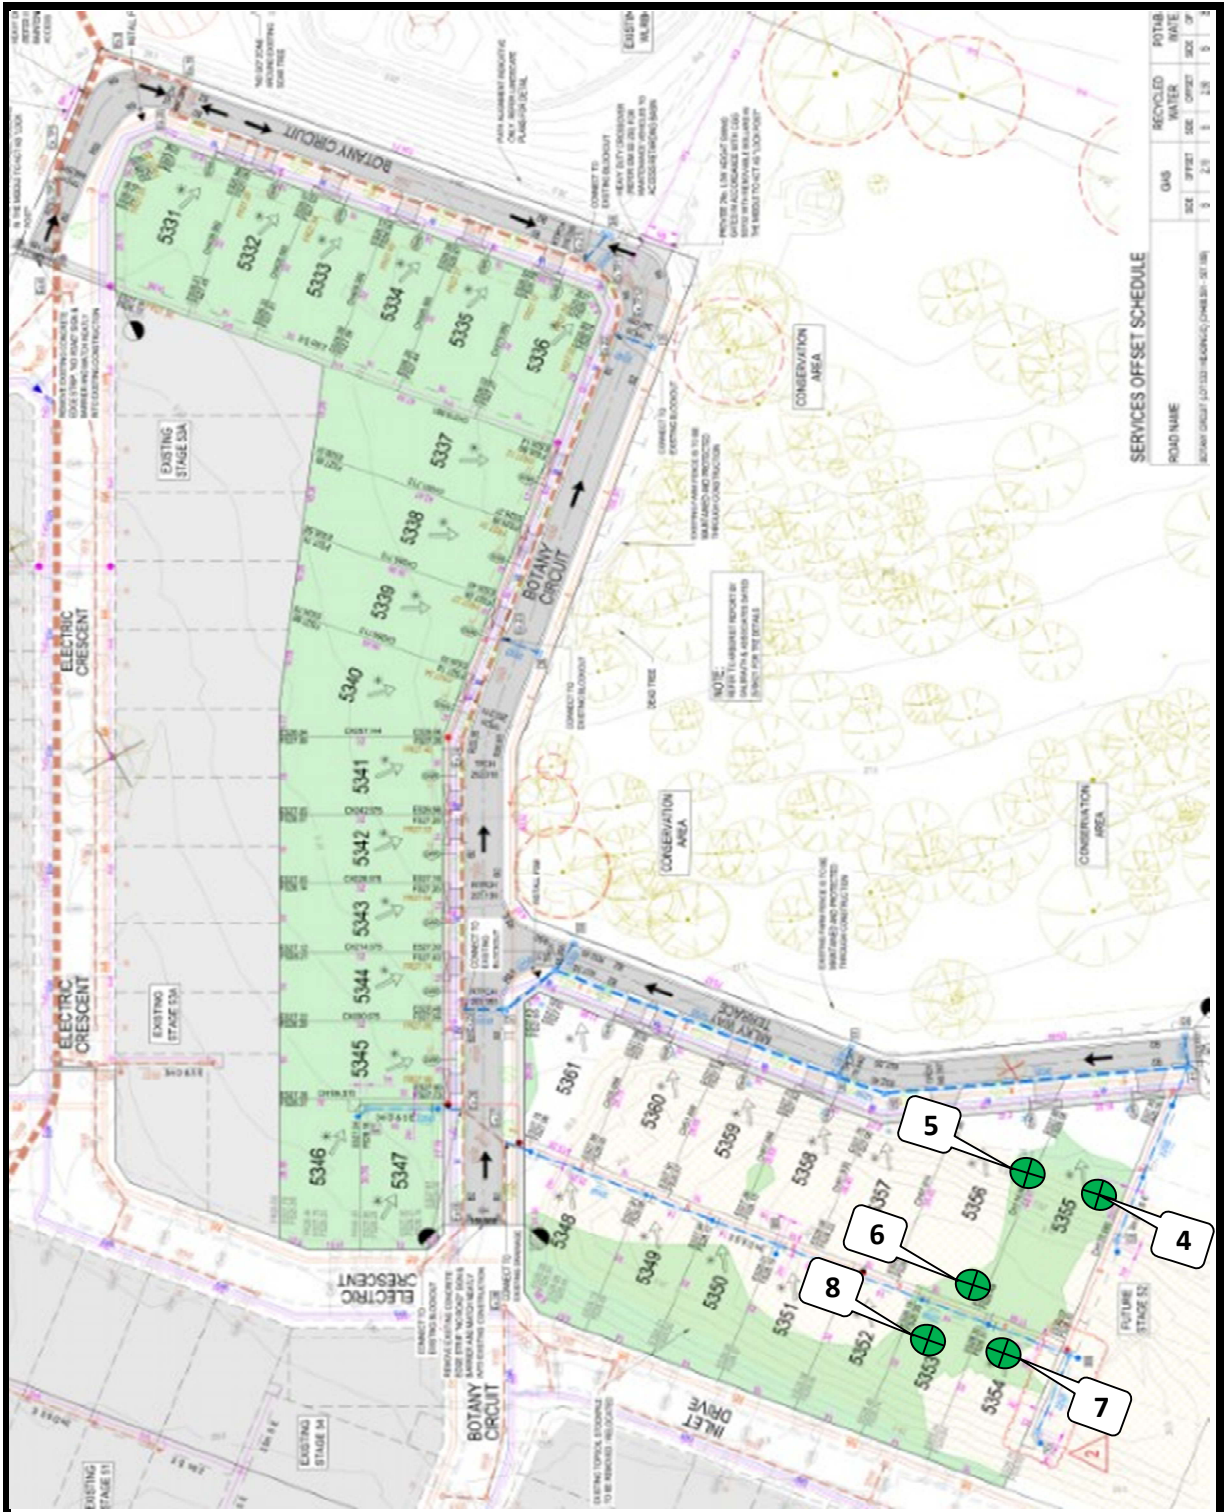
**Sketch indicating compaction test locations**

**DATE: 20/03/2024**

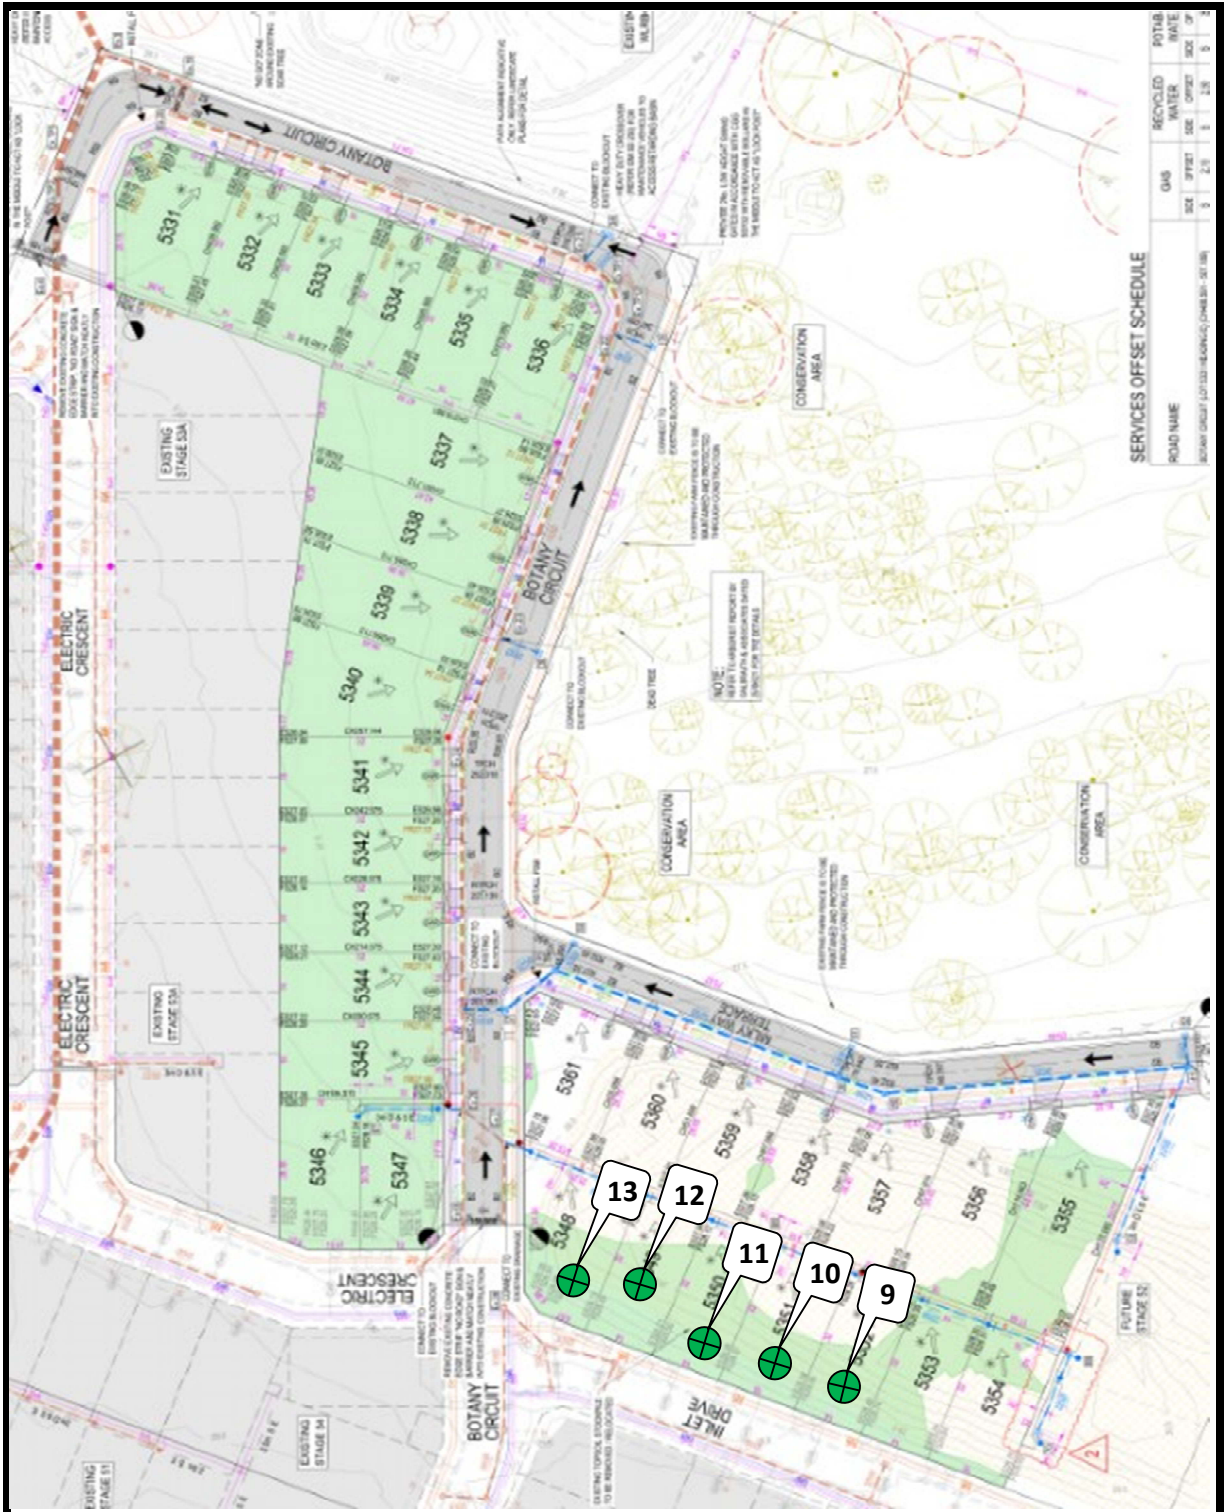
**Sketch indicating compaction test locations**

**DATE: 21/03/2024**
