LEVEL ONE

SURVEILLANCE

AND INSPECTION REPORT

Project Name: Sanctuary Estate Stage 3

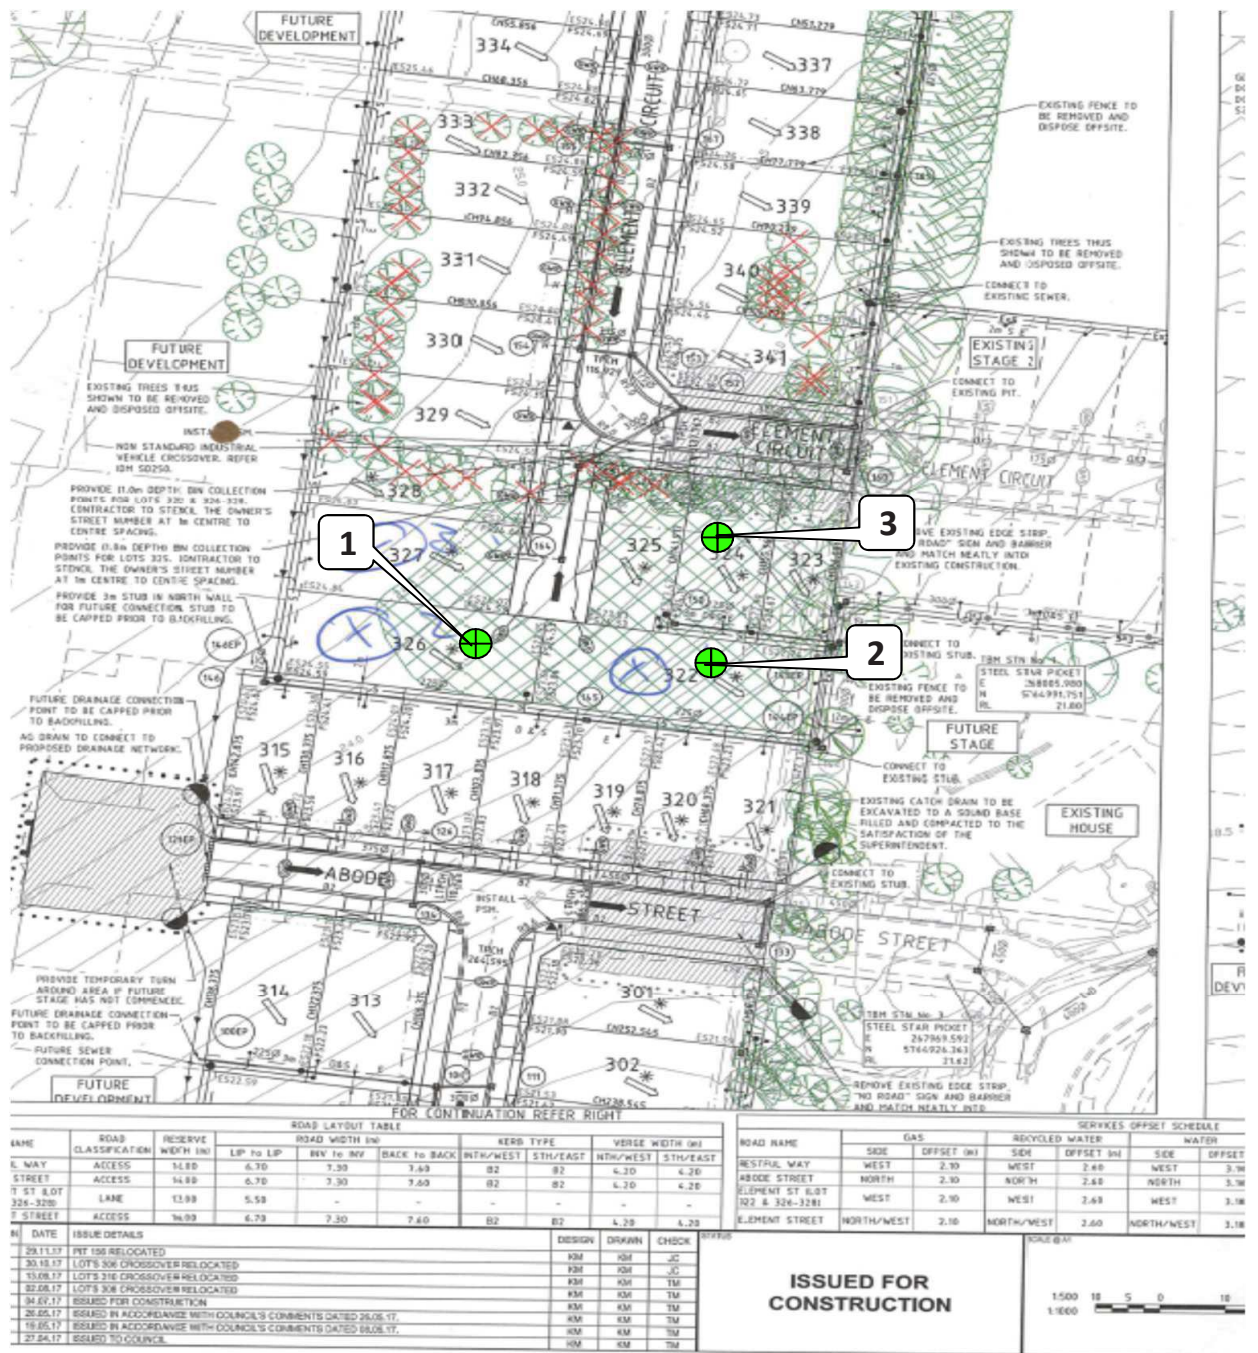
Sketch indicating compaction test locations

CLIENT: DRAPERS

LOCATION: Sanctuary Estate Stage 2

DATE: 19/12/17

JOB No.: 1897/604
