LEVEL 1 INSPECTION & TESTING CORIDALE ESTATE STAGE 5 LARA

Prepared for Creo Consultants Pty Ltd

Report Reference: GSSW1123.1 AA

Date: 16 June 2021

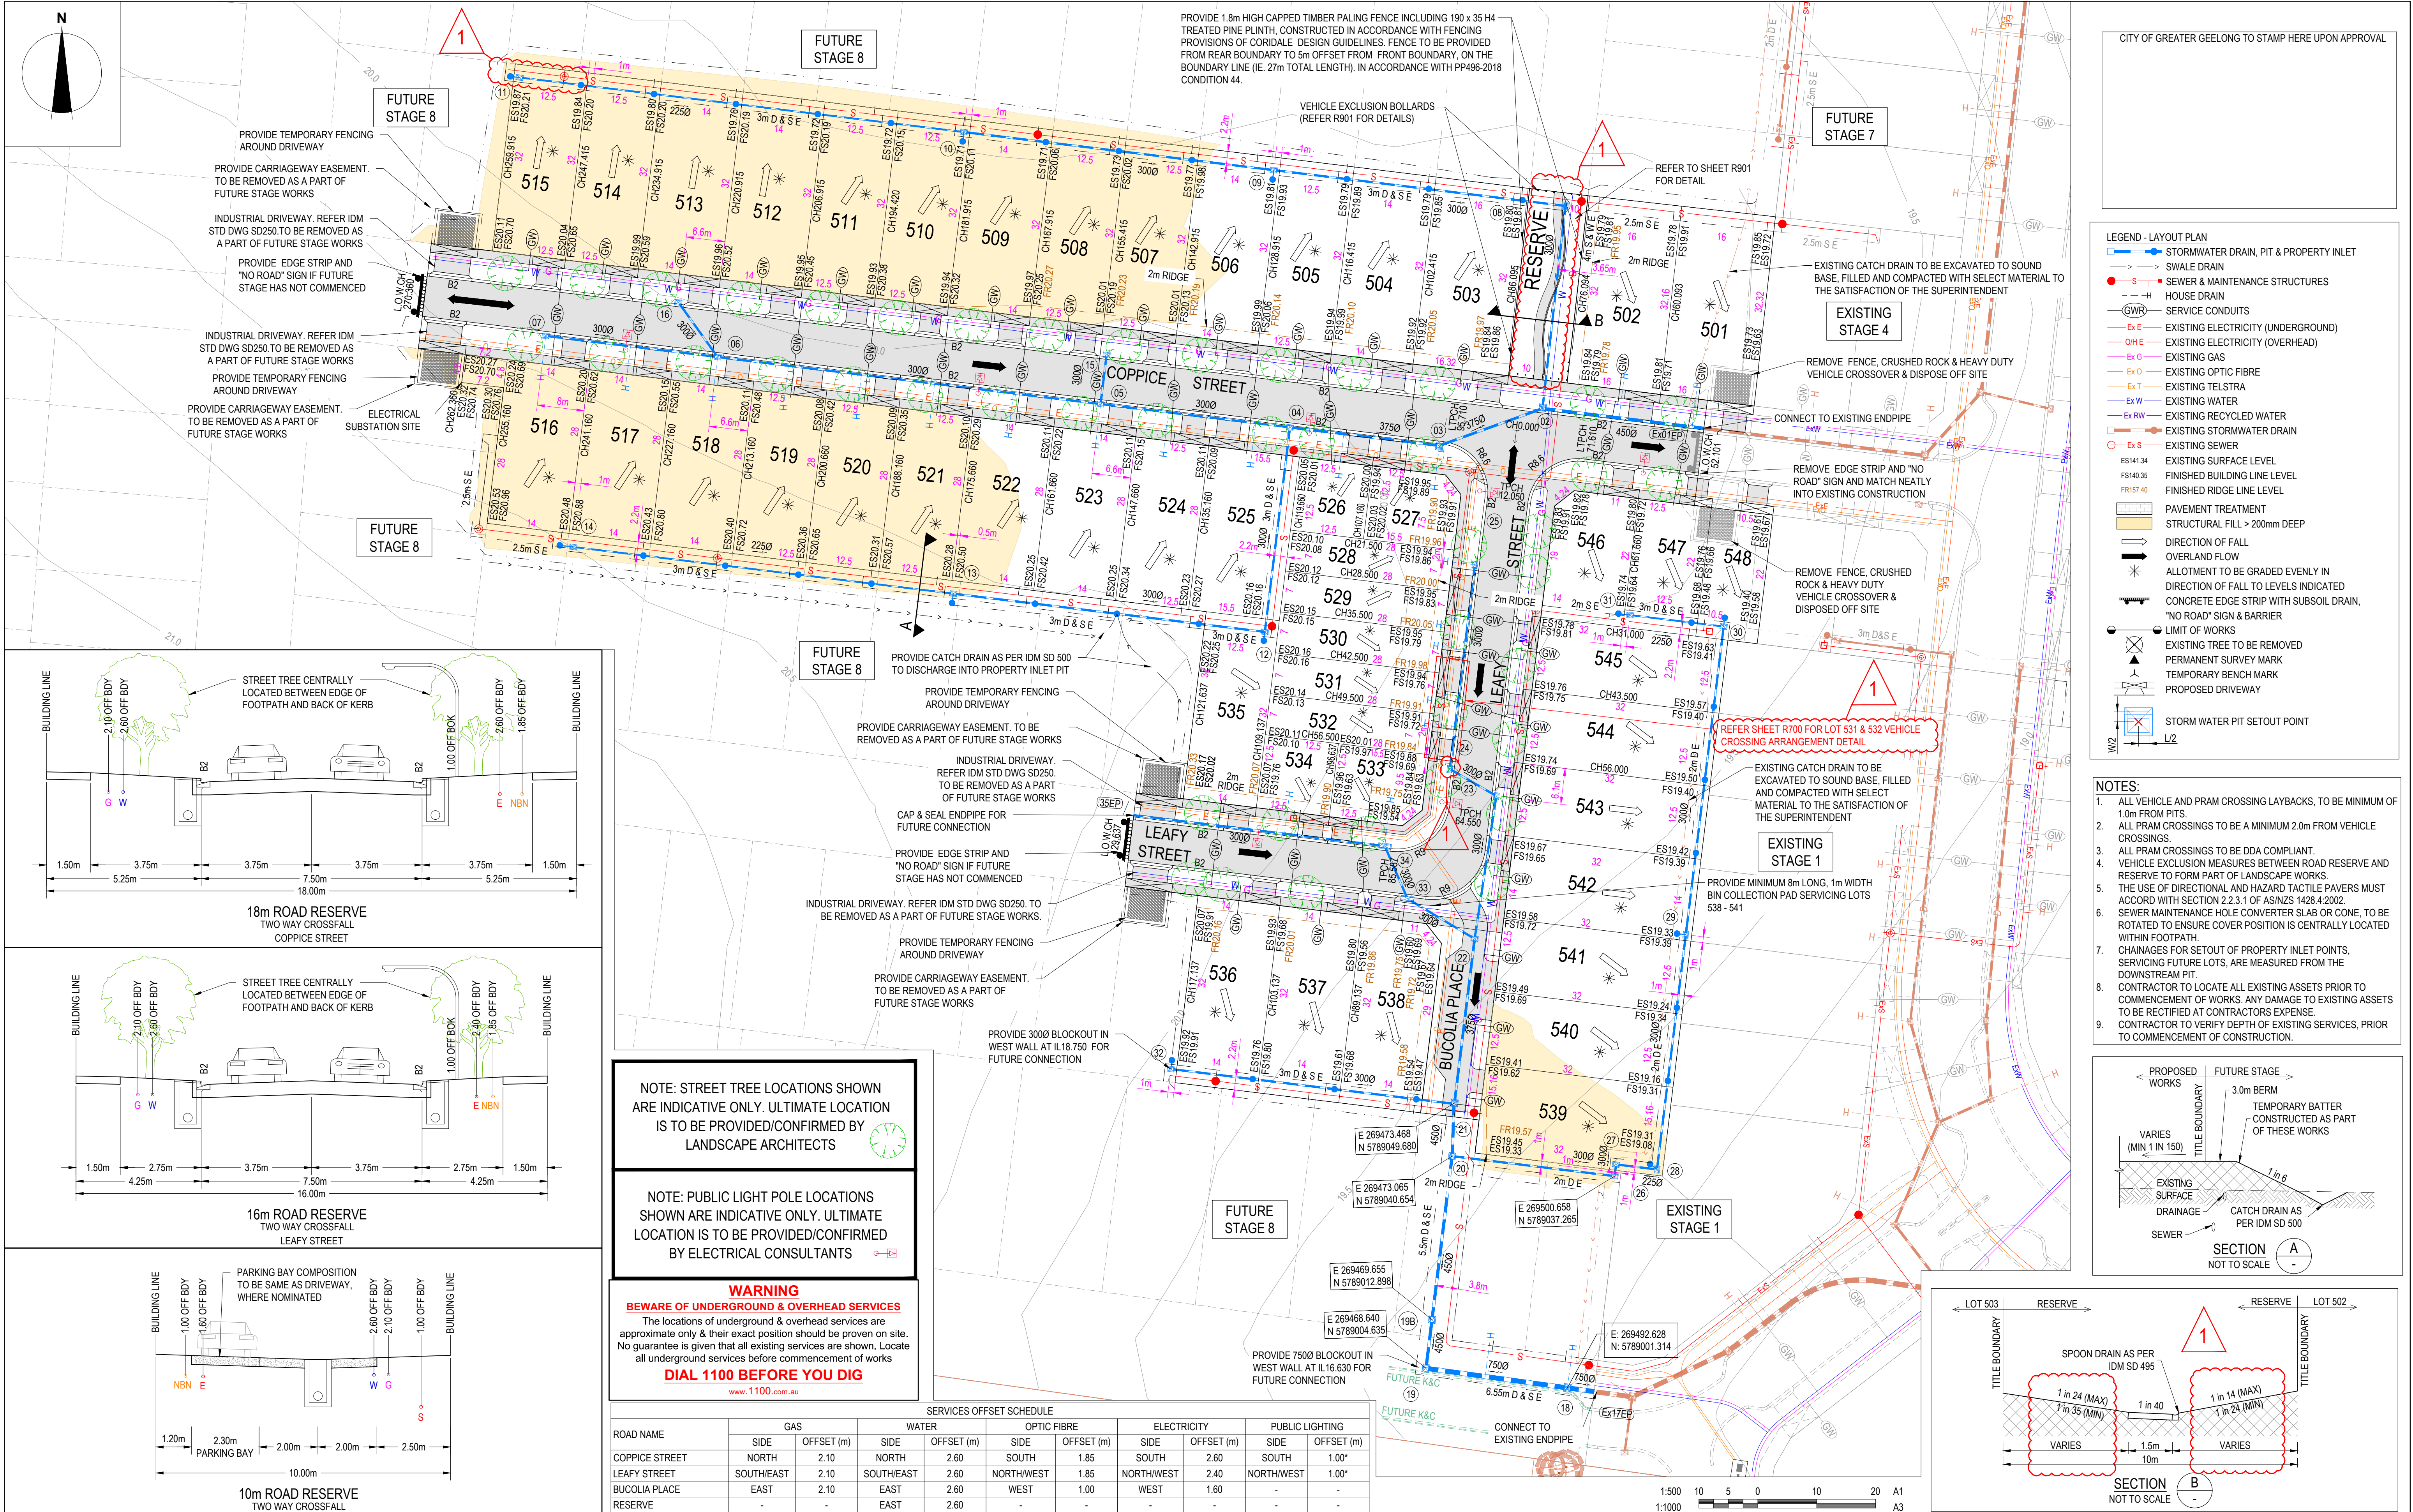
FIGURE 1

Ground Science provided Level 1 Inspection and Testing services for the construction of fill in areas requiring greater than 200mm of fill to achieve finished levels. The bulk earthworks were separated into 2 locations. The fill area to the north of the stage was completed first and the fill area inside lots 539 and 540 were completed after the rest of the stage. It is understood the reason for the delay was due to the small size and location relative to other fill areas, with other works being prioritised over it. The areas requiring Level 1 Inspection & Testing are shown on the supplied construction drawing, on Figure 1, prepared by Creo Consultants Pty Ltd (Coridale Estate - Stage 5 Layout Plan – 1 [No. 180014.5 R200 Rev 1]).

Coridale Estate - Stage 5 Layout Plan – 1 [No. 180014.5 R200 Rev 1]

Observations were made by a Ground Science staff member that filling had been complete up to the nominated finished levels designated on Figure 1 as per confirmation provided from the contractor's site foreman. We understand that the observed final levels are the constructed finished surface levels of the controlled fill. The overall fill depths are estimated using onsite visual tactile methods and may not be a true representation of fill depths given that conditions on site may change over time. True fill depths should be obtained from the contractor's survey data.

Ground Science Staff have undertaken Level 1 Inspection and Testing services of the construction of the controlled fill in the areas designated on Figure 1. Ground Science field staff have also observed that the prepared subgrade provided an adequate base for the subsequent placement of controlled fill.

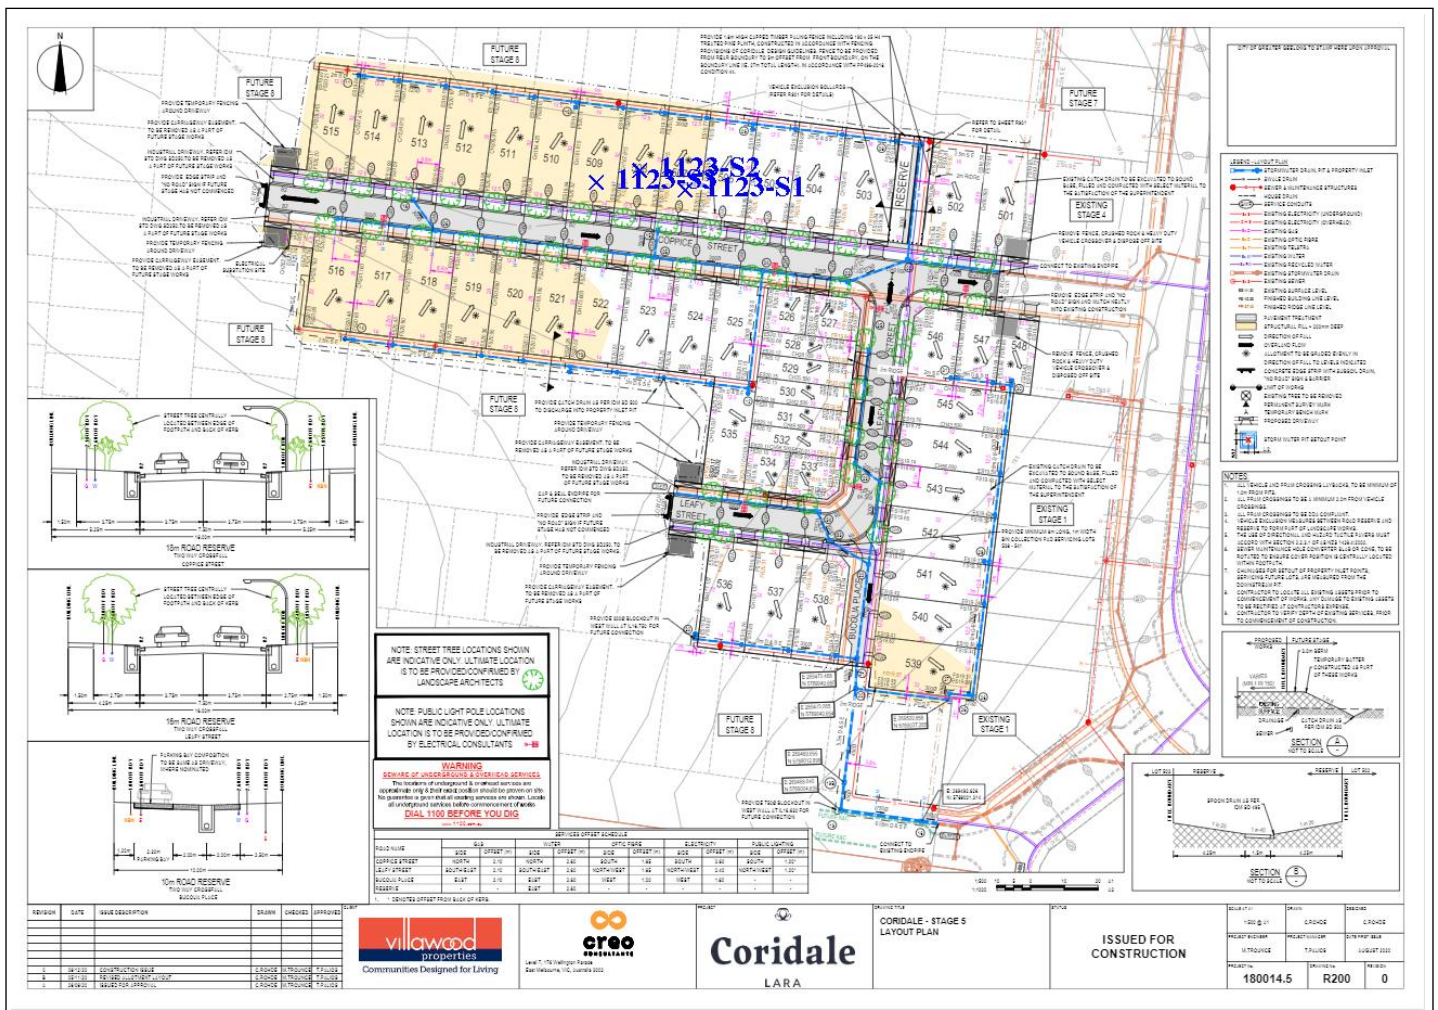
Sample Locations Plan

Sample Number	1123-S1	1123-S2	1123-S3
Date Tested	10/02/2021	10/02/2021	10/02/2021
Time Tested	15:48	15:56	16:06
Test Request #/Location	Coridale Estate Stage 5 Lot 509	Coridale Estate Stage 5 Lot 508	Coridale Estate Stage 5 Lot 507
Latitude	-38.015587	-38.015595	-38.015574
Longitude	144.373142	144.37349	144.373721
Layer / Reduced Level	1	1	1
Thickness of Layer (mm)	200	200	200
Soil Description	CLAY with gravel, brown, high plasticity	CLAY with gravel, brown, high plasticity	CLAY with gravel, brown, high plasticity
Test Depth (mm)	175	175	175
Sieve used to determine oversize (mm)	19.0	19.0	19.0
Percentage of Wet Oversize (%)	0	0	6
Field Wet Density (FWD) t/m ³	1.76	1.76	1.83
Field Moisture Content %	22.2	25.3	24.3
Field Dry Density (FDD) t/m ³	1.44	1.40	1.48
Peak Converted Wet Density t/m ³	1.73	1.75	**
Adjusted Peak Converted Wet Density t/m ³	**	**	1.72
Moisture Variation (Wv) %	6.0	5.0	**
Adjusted Moisture Variation %	**	**	6.0

Hilf Density Ratio (%)	102.0	100.0	107.0
Compaction Method	Standard	Standard	Standard
Report Remarks	**	**	**

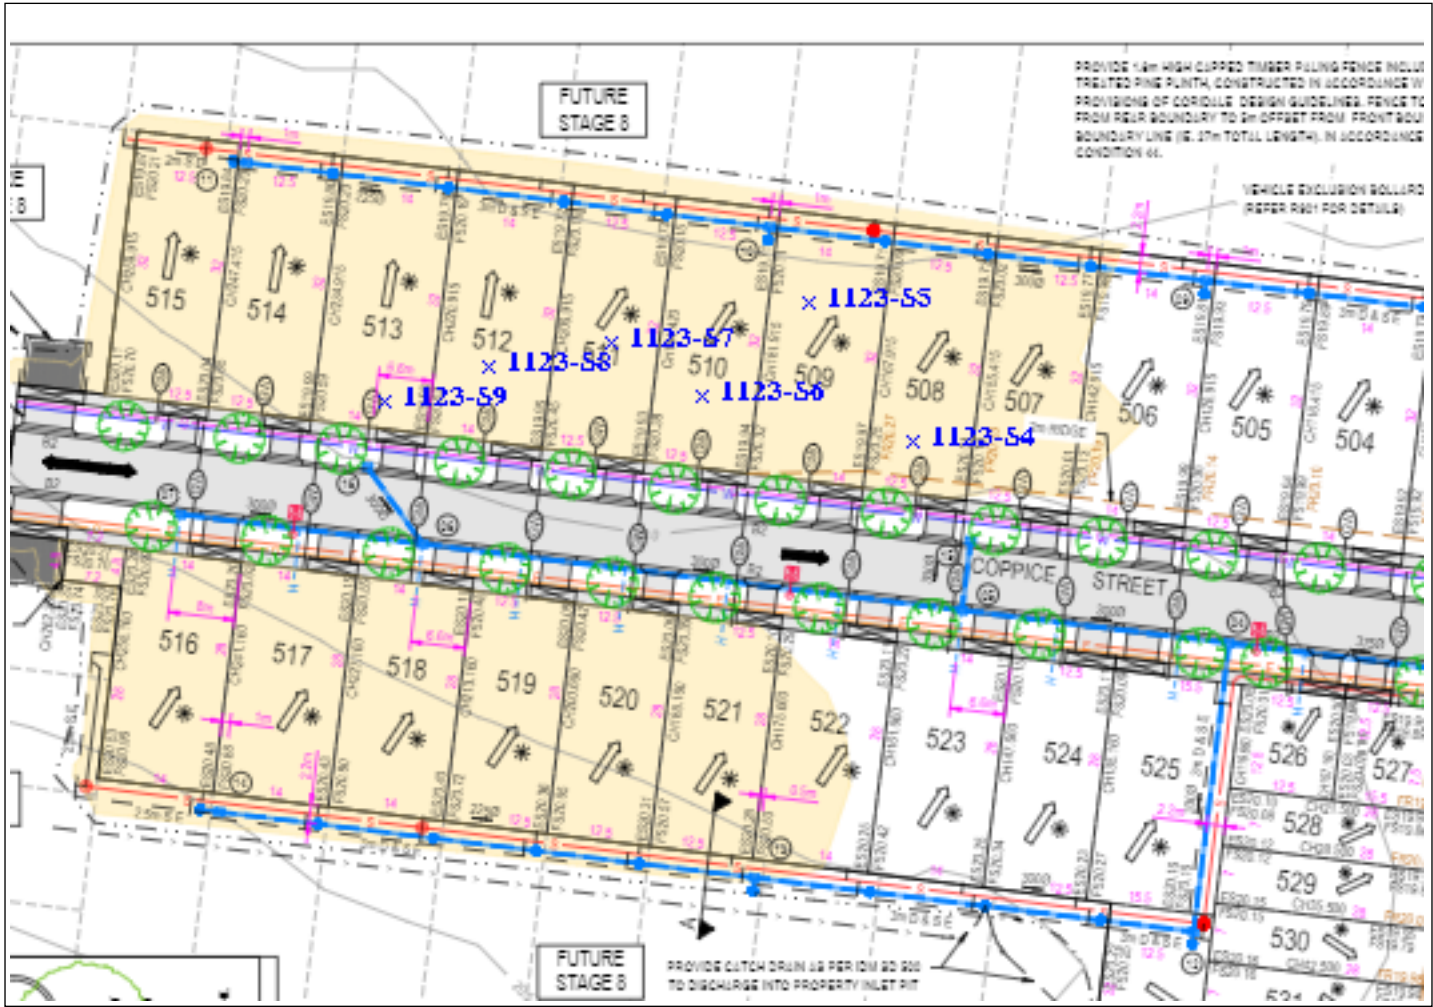
Sample Locations Plan

Sample Number	1123-S4	1123-S5	1123-S6	1123-S7	1123-S8	1123-S9
Date Tested	12/02/2021	12/02/2021	12/02/2021	12/02/2021	12/02/2021	12/02/2021
Time Tested	09:01	09:18	09:23	09:37	09:56	10:04
Test Request #/Location	Coridale Estate Stage 5 Lot 508	Coridale Estate Stage 5 Lot 509	Coridale Estate Stage 5 Lot 510	Coridale Estate Stage 5 Lot 511	Coridale Estate Stage 5 Lot 512	Coridale Estate Stage 5 Lot 513
Latitude	-38.015614	-38.015574	-38.015692	-38.015575	-38.015565	-38.015568
Longitude	144.373315	144.373171	144.373077	144.372894	144.372755	144.373014
Layer / Reduced Level	1	1	1	1	1	1
Thickness of Layer (mm)	200	200	200	200	200	200
Soil Description	CLAY with gravel, brown, high plasticity	CLAY with gravel, brown, high plasticity	CLAY with gravel, brown, high plasticity	CLAY with gravel, brown, high plasticity	CLAY with gravel, brown, high plasticity	CLAY with gravel, brown, high plasticity
Test Depth (mm)	175	175	175	175	175	175

Sieve used to determine oversize (mm)	19.0	19.0	19.0	19.0	19.0	19.0
Percentage of Wet Oversize (%)	0	0	0	7	0	0
Field Wet Density (FWD) t/m ³	1.86	1.79	1.92	1.82	1.84	1.84
Field Moisture Content %	28.0	28.0	25.7	22.5	26.3	34.6
Field Dry Density (FDD) t/m ³	1.45	1.40	1.53	1.48	1.45	1.37
Peak Converted Wet Density t/m ³	1.79	1.84	1.86	**	1.82	1.82
Adjusted Peak Converted Wet Density t/m ³	**	**	**	1.90	**	**
Moisture Variation (Wv) %	2.5	0.5	3.0	**	2.5	-1.0
Adjusted Moisture Variation %	**	**	**	1.5	**	**
Hilf Density Ratio (%)	104.0	97.5	103.5	96.0	100.5	101.0
Compaction Method	Standard	Standard	Standard	Standard	Standard	Standard
Report Remarks	**	**	**	**	**	**

Field density and compaction control testing report sheets are presented in Appendix B. It should be noted that the tests are a representation of the fill placed and support the visual assessment of the works completed. No areas failed to reach the required density ratio. Three test areas (#1, #2, & #3) failed to meet the required moisture condition. These areas were subsequently reworked, recompacted and retested (#4, #5, & #6) with compliant test results achieved.

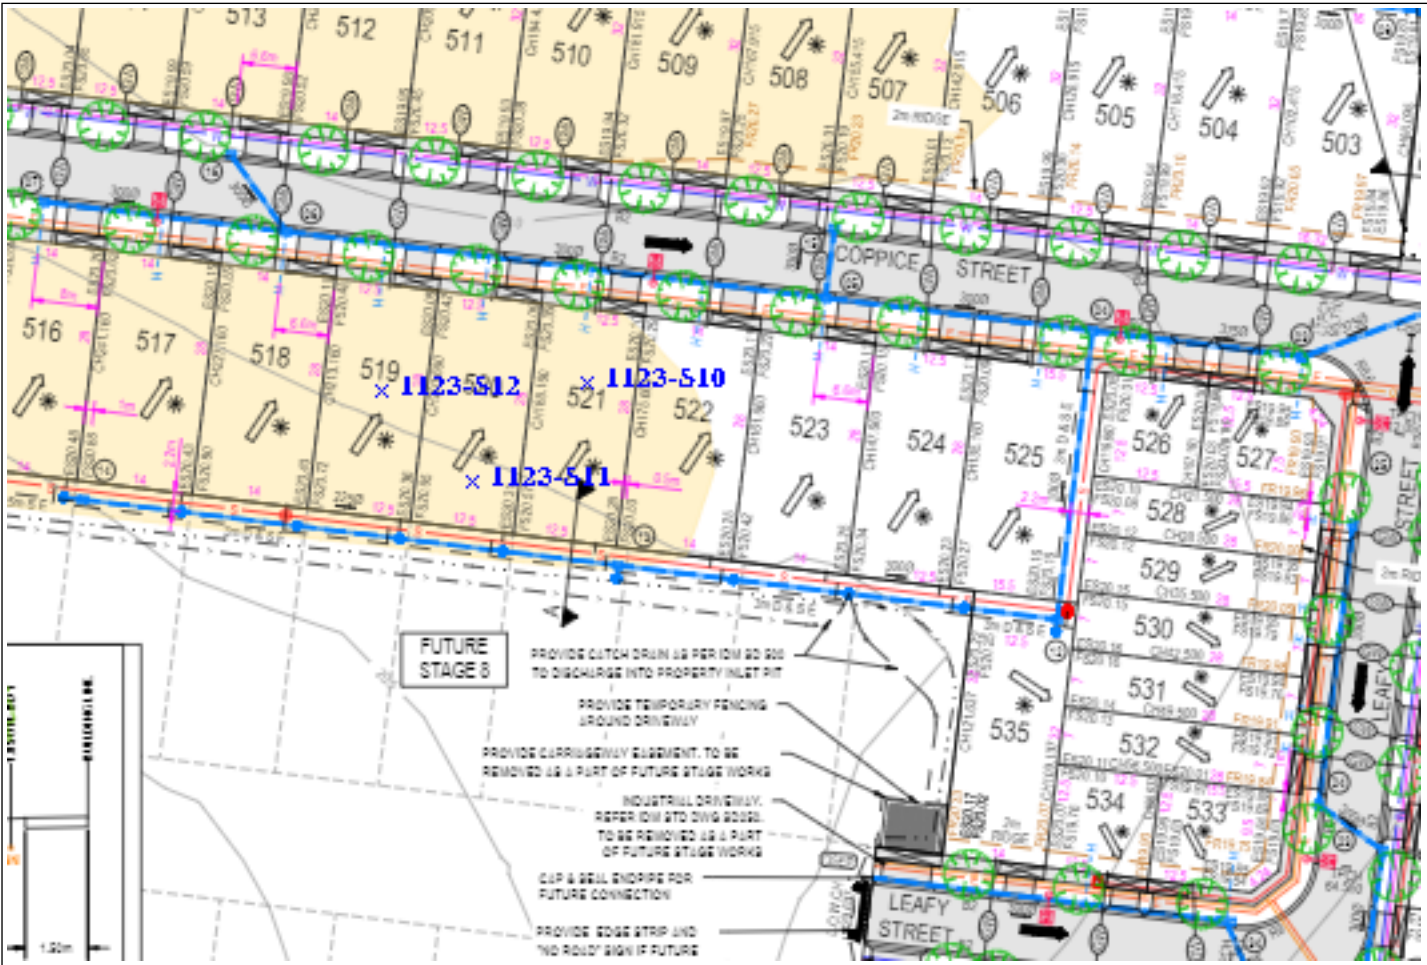
Sample Number	1123-S10	1123-S11	1123-S12
Date Tested	13/02/2021	13/02/2021	13/02/2021
Time Tested	11:19	11:28	11:38
Test Request #/Location	Coridale Estate Stage 5 Lot 521	Coridale Estate Stage 5 Lot 520	Coridale Estate Stage 5 Lot 519
Latitude	-38.015934	-38.016013	-38.015885
Longitude	144.373046	144.372821	144.372671
Layer / Reduced Level	1	1	1
Thickness of Layer (mm)	200	200	200
Soil Description	CLAY with gravel, brown, high plasticity	CLAY with gravel, brown, high plasticity	CLAY with gravel, brown, high plasticity
Test Depth (mm)	175	175	175
Sieve used to determine oversize (mm)	19.0	19.0	19.0
Percentage of Wet Oversize (%)	5	0	0
Field Wet Density (FWD) t/m ³	1.91	1.88	1.90
Field Moisture Content %	29.3	32.6	26.0
Field Dry Density (FDD) t/m ³	1.48	1.42	1.51
Peak Converted Wet Density t/m ³	**	1.93	1.92
Adjusted Peak Converted Wet Density t/m ³	1.94	**	**
Moisture Variation (Wv) %	**	-3.0	-0.5
Adjusted Moisture Variation %	-0.5	**	**

Hilf Density Ratio (%)	99.0	97.5	99.0
Compaction Method	Standard	Standard	Standard
Report Remarks	**	**	**

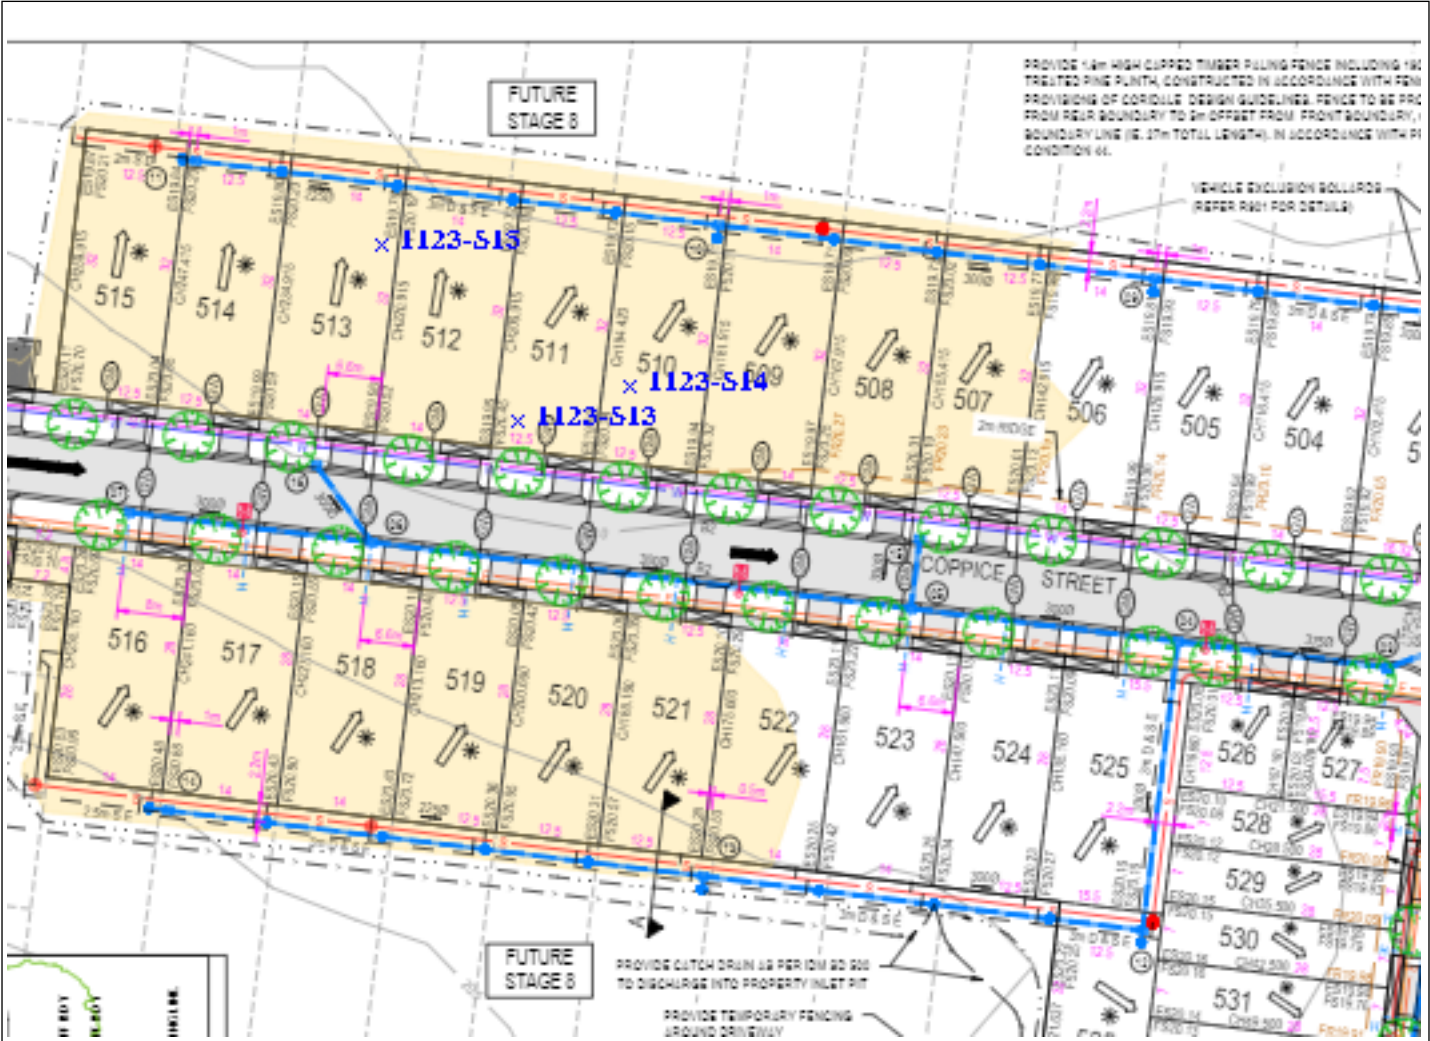
Sample Number	1123-S13	1123-S14	1123-S15
Date Tested	15/02/2021	15/02/2021	15/02/2021
Time Tested	14:28	14:42	14:59
Test Request #/Location	Coridale Estate Stage 5 Lot 511	Coridale Estate Stage 5 Lot 510	Coridale Estate Stage 5 Lot 513
Latitude	-38.015619	-38.015485	-38.015359
Longitude	144.372713	144.382973	144.372634
Layer / Reduced Level	2	2	2
Thickness of Layer (mm)	200	200	200
Soil Description	CLAY with gravel, brown, high plasticity	CLAY with gravel, brown, high plasticity	CLAY with gravel, brown, high plasticity
Test Depth (mm)	175	175	175
Sieve used to determine oversize (mm)	19.0	19.0	19.0
Percentage of Wet Oversize (%)	0	0	0
Field Wet Density (FWD) t/m ³	2.07	1.90	1.85
Field Moisture Content %	19.8	16.6	20.5
Field Dry Density (FDD) t/m ³	1.73	1.63	1.54
Peak Converted Wet Density t/m ³	1.92	1.90	1.91
Adjusted Peak Converted Wet Density t/m ³	**	**	**
Moisture Variation (Wv) %	0.5	2.0	3.0
Adjusted Moisture Variation %	**	**	**

Hilf Density Ratio (%)	108.0	100.0	97.0
Compaction Method	Standard	Standard	Standard
Report Remarks	**	**	**
