ARMSTRONG ESTATE
STAGE 32

MT. DUNEED

LEVEL 1
SURVEILLANCE
& COMPACTION CONTROL
OF EARTHWORKS

RE: Armstrong Estate Stage 32 - Earthworks

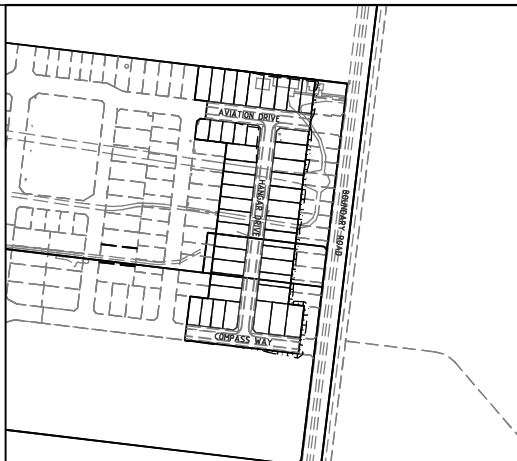
APPENDIX A

(1). Standard Faceplan Layout Drawing No. M100611.32-BE01 – Rev. A

General site works involved the placement of fill, using on-site derived clays, to bring the fill area to the required finished levels as indicated on the faceplan drawings.
