Our Reference: 21516:NB1174

RE: LEVEL 1 EARTHWORKS INSPECTION AND TESTING
RATHDOWNE – STAGE 9 (WOLLERT)

RATHDOWNE ESTATE STAGE 9
LAYOUT PLAN & SERVICE OFFSET TABLE

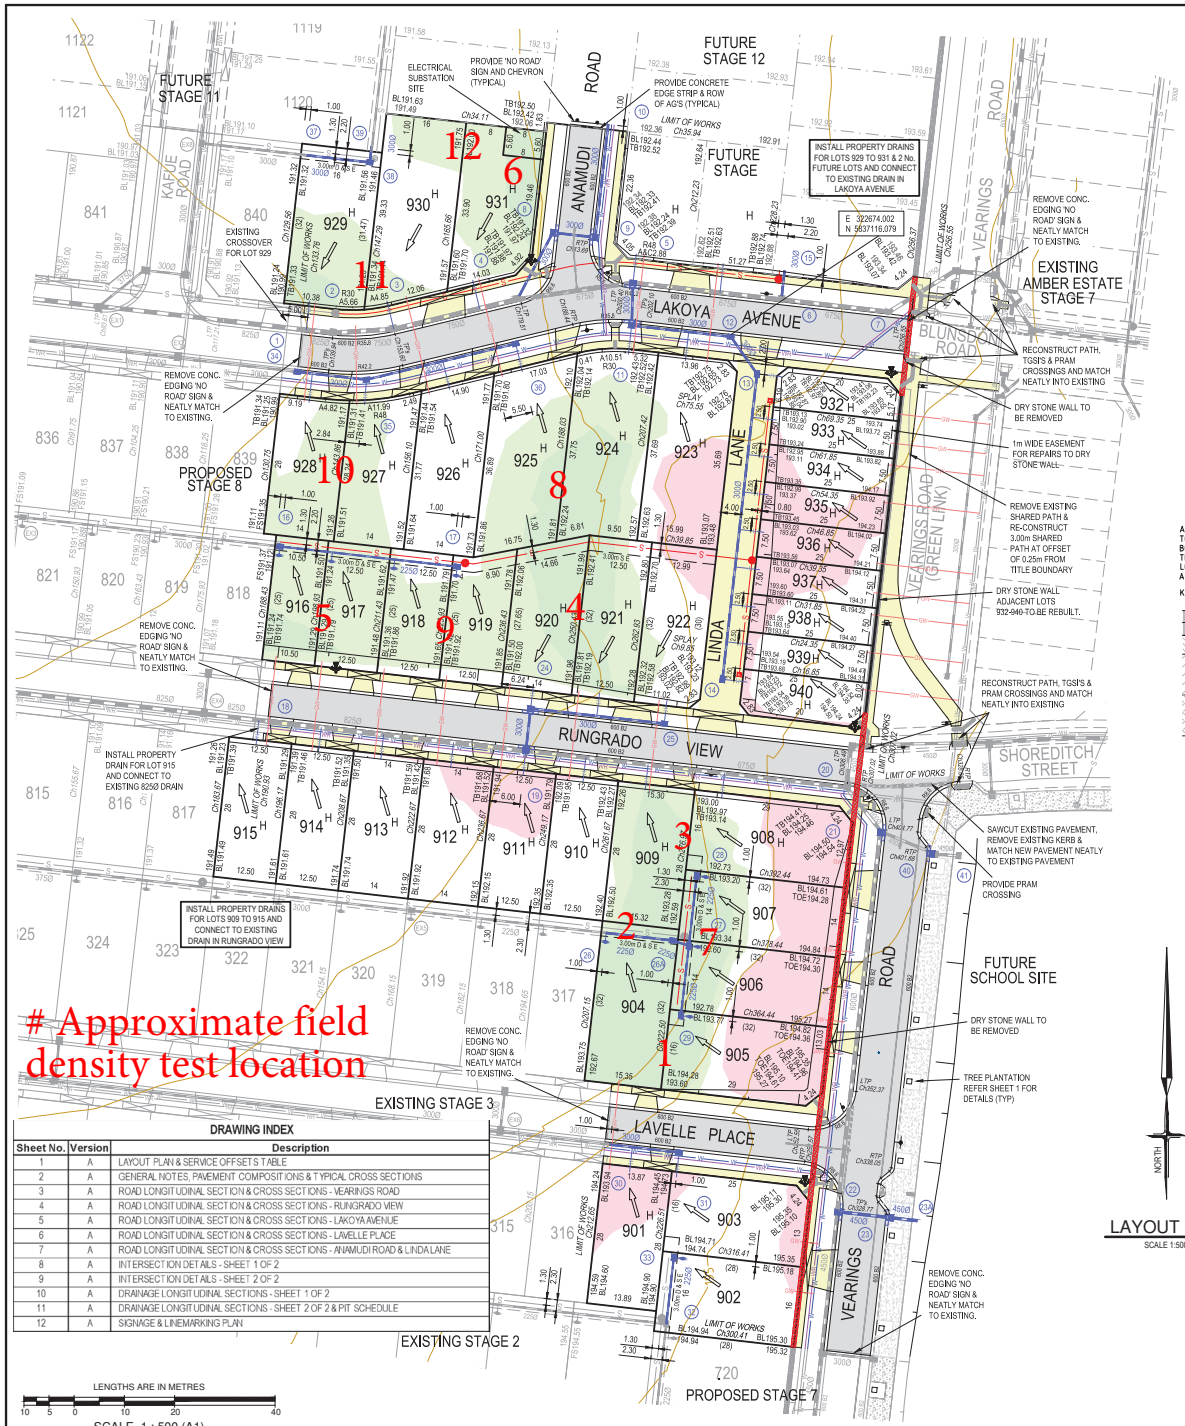
FIGURE 1

The site inspection and testing was performed by experienced geotechnicians from this office. Any areas that were deemed unsatisfactory were reworked and retested under their supervision. The testing was performed to the relevant Australian Standards and the accompanying test reports carry NATA endorsement. The attached compaction results, which were located randomly throughout the fill profile, are considered to be representative of the bulk fill materials that were placed across the reported allotments by Winslow Constructors during the aforementioned period. The approximate locations of the field density tests can be seen on the attached plan (Figure 1).

We are of the view that the bulk fill materials that have been placed across the reported allotments by Winslow Constructors during the aforementioned period can be considered as having been placed in a controlled manner to a minimum density ratio of 95% (standard compactive effort).
