Level One Inspection & Testing Report

MAIDEN'S GREEN, MOAMA - STAGE 2 & 3

Prepared for Northern Constructions Group PTY LTD

15/08/23

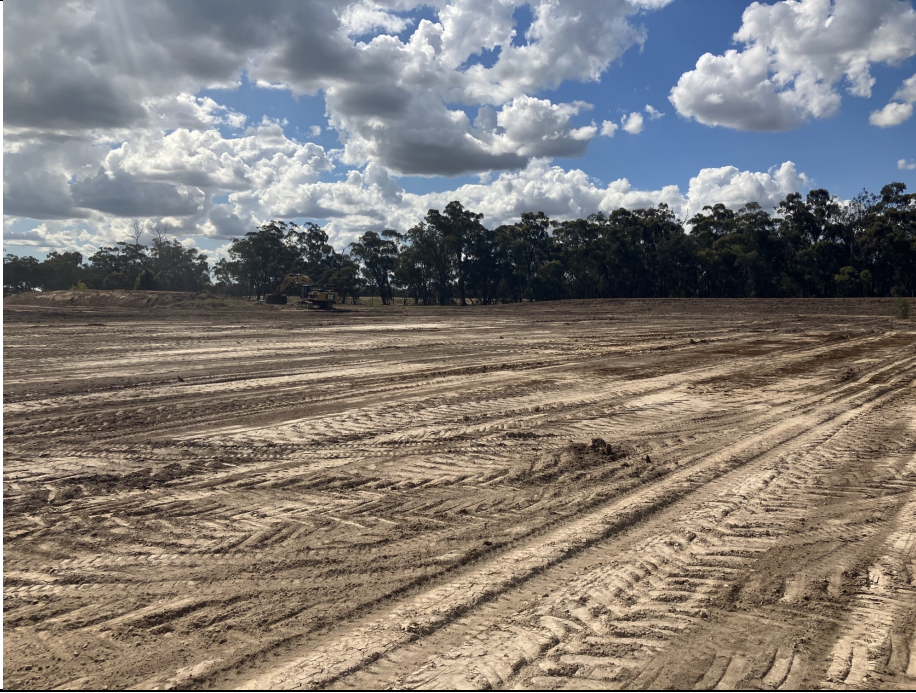
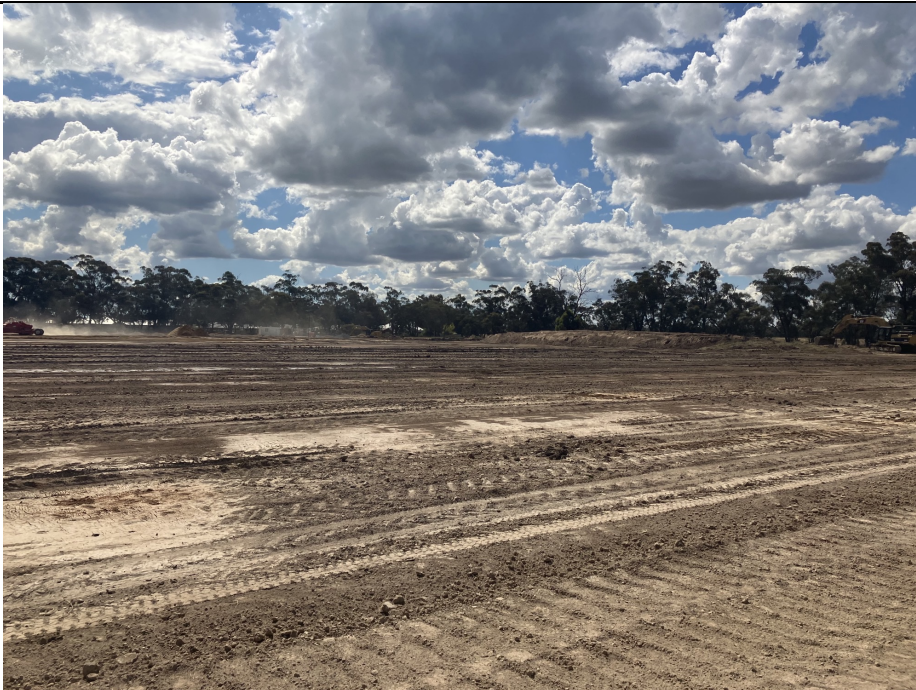
Remarks	Element:	Include observations on works, site conditions, meetings or conversations on site, and the like.
	Result:	No action required, advised to continue works as observed.
