LEVEL ONE

SURVEILLANCE

AND INSPECTION REPORT

Project Name: Wandana Estate Stage 6

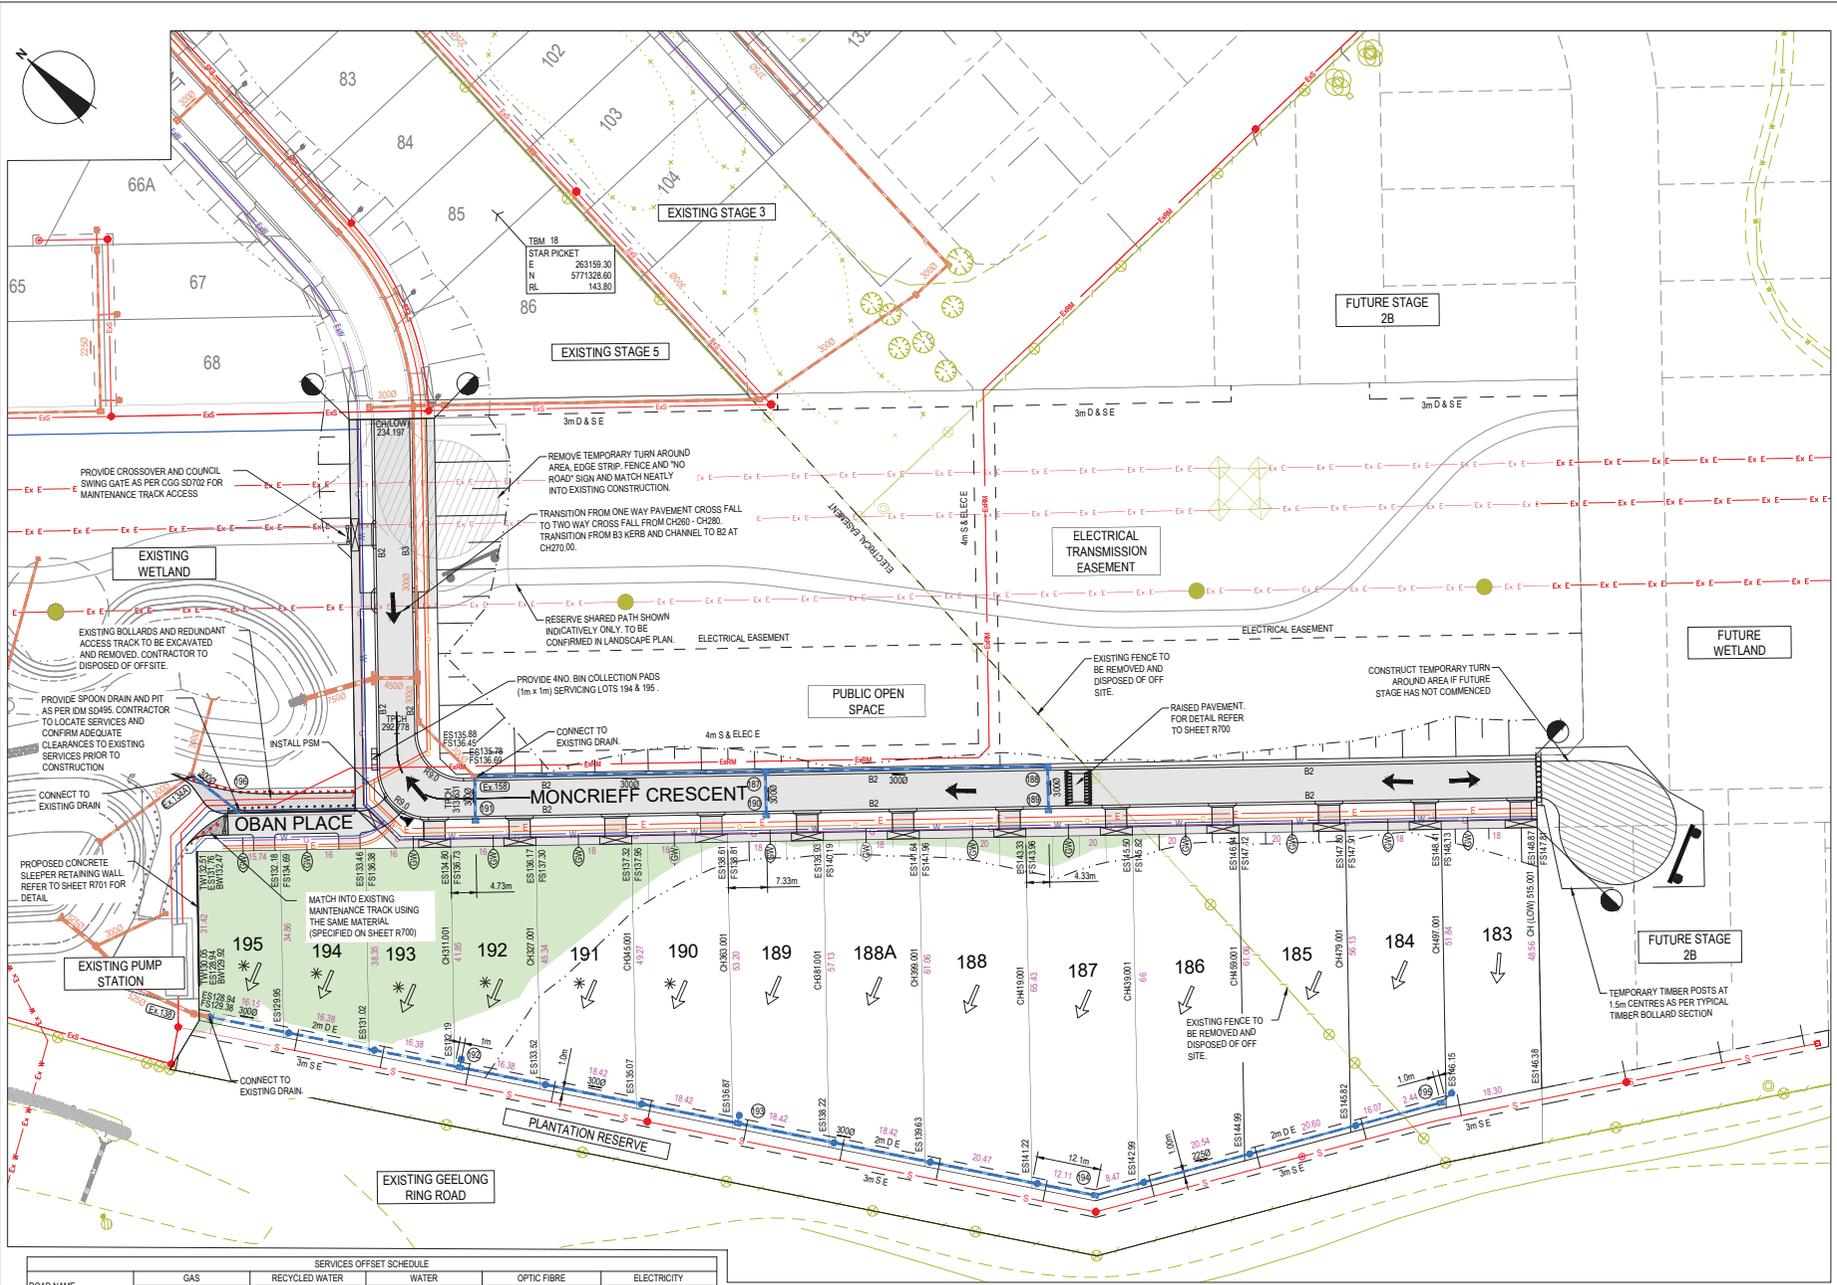
APPENDIX A

(1). Earthworks Detail Plan Project Reference No. R200 Rev 1.

The following documentation was submitted to Geotechnical Laboratories by Drapers Civil Contracting Pty Ltd and was used to determine compliance of earthworks in conjunction with the requirements of AS 3798 – 2007 (See Appendix A).

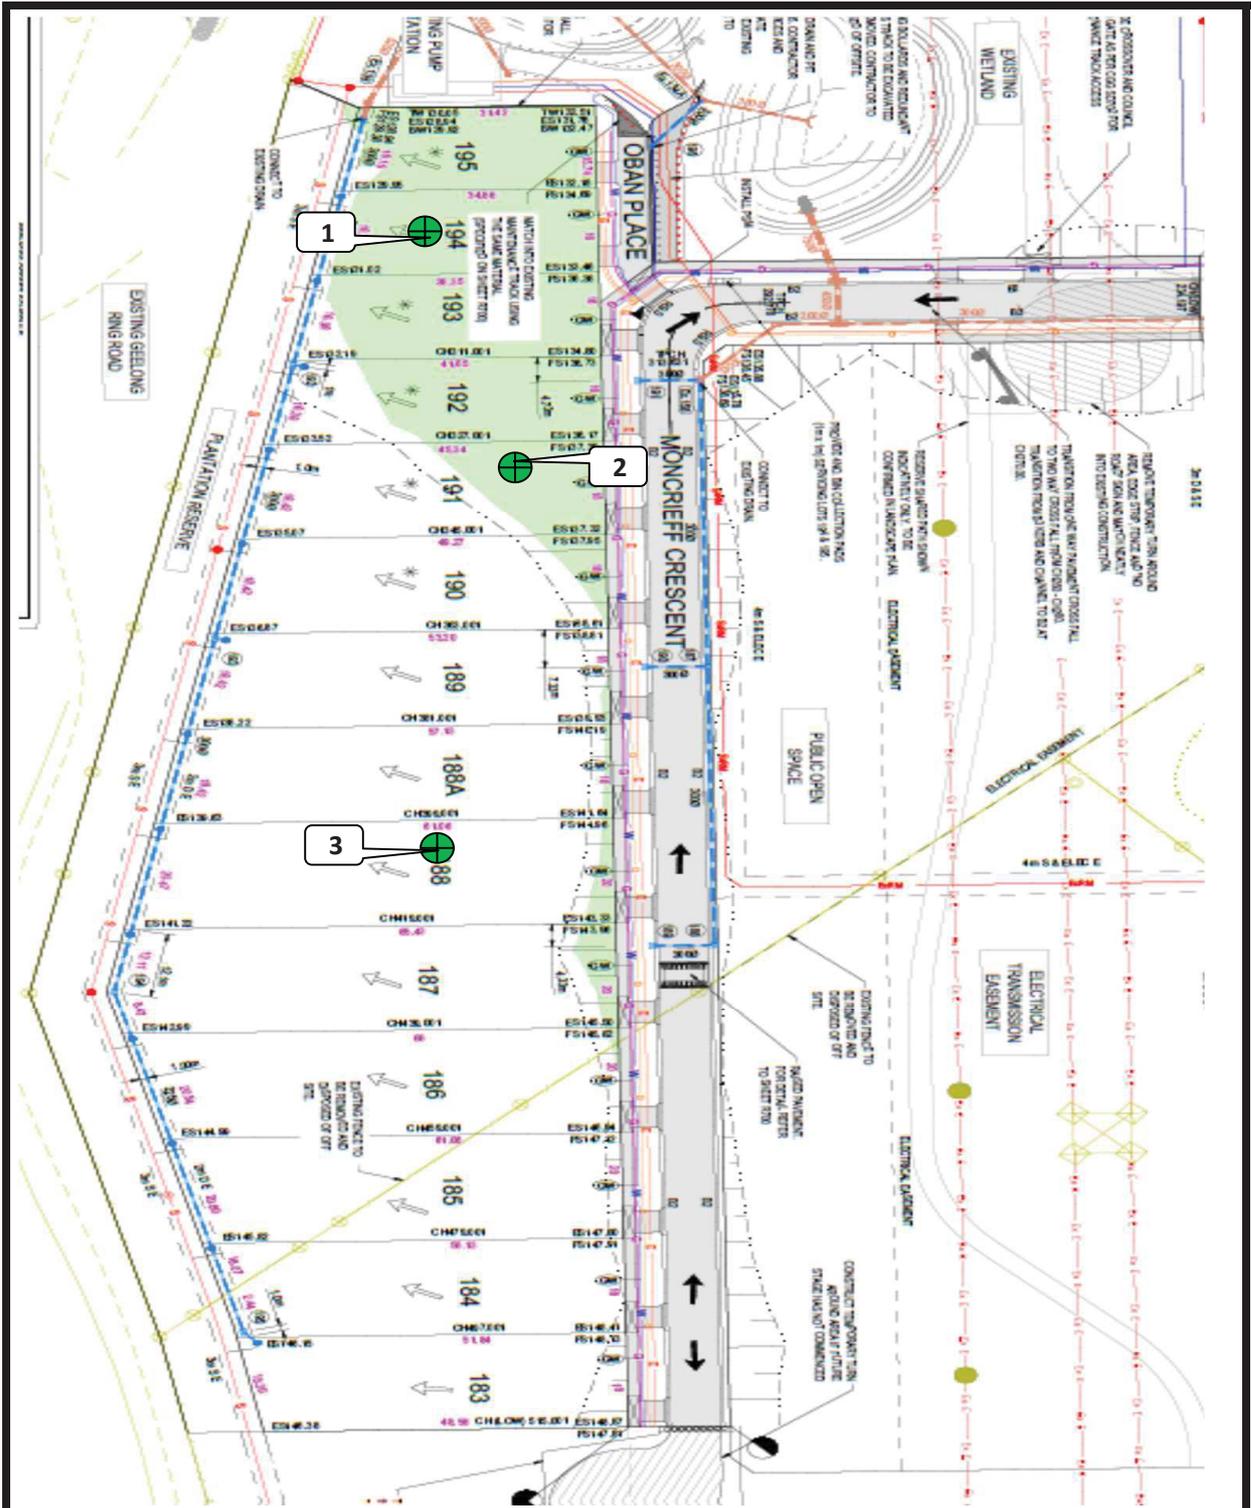
CLIENT: DRAPERS LOCATION: Wandana Estate Stage 6 Sketch indicating compaction test locations	DATE: 19/12/19	JOB No.: 1992/258
	OPERATOR: WS	CHECKED: EG
	SCALE: NTS	FIGURE No.: -

A total of twenty-one compaction tests were performed on the allotment filling construction. Results are presented in Appendix B of this report.
