Lot 3109 Terrapee Street Strathfieldsaye

Geotechnical Investigation for
Villawood Properties

Report 24C 0690
August 2024

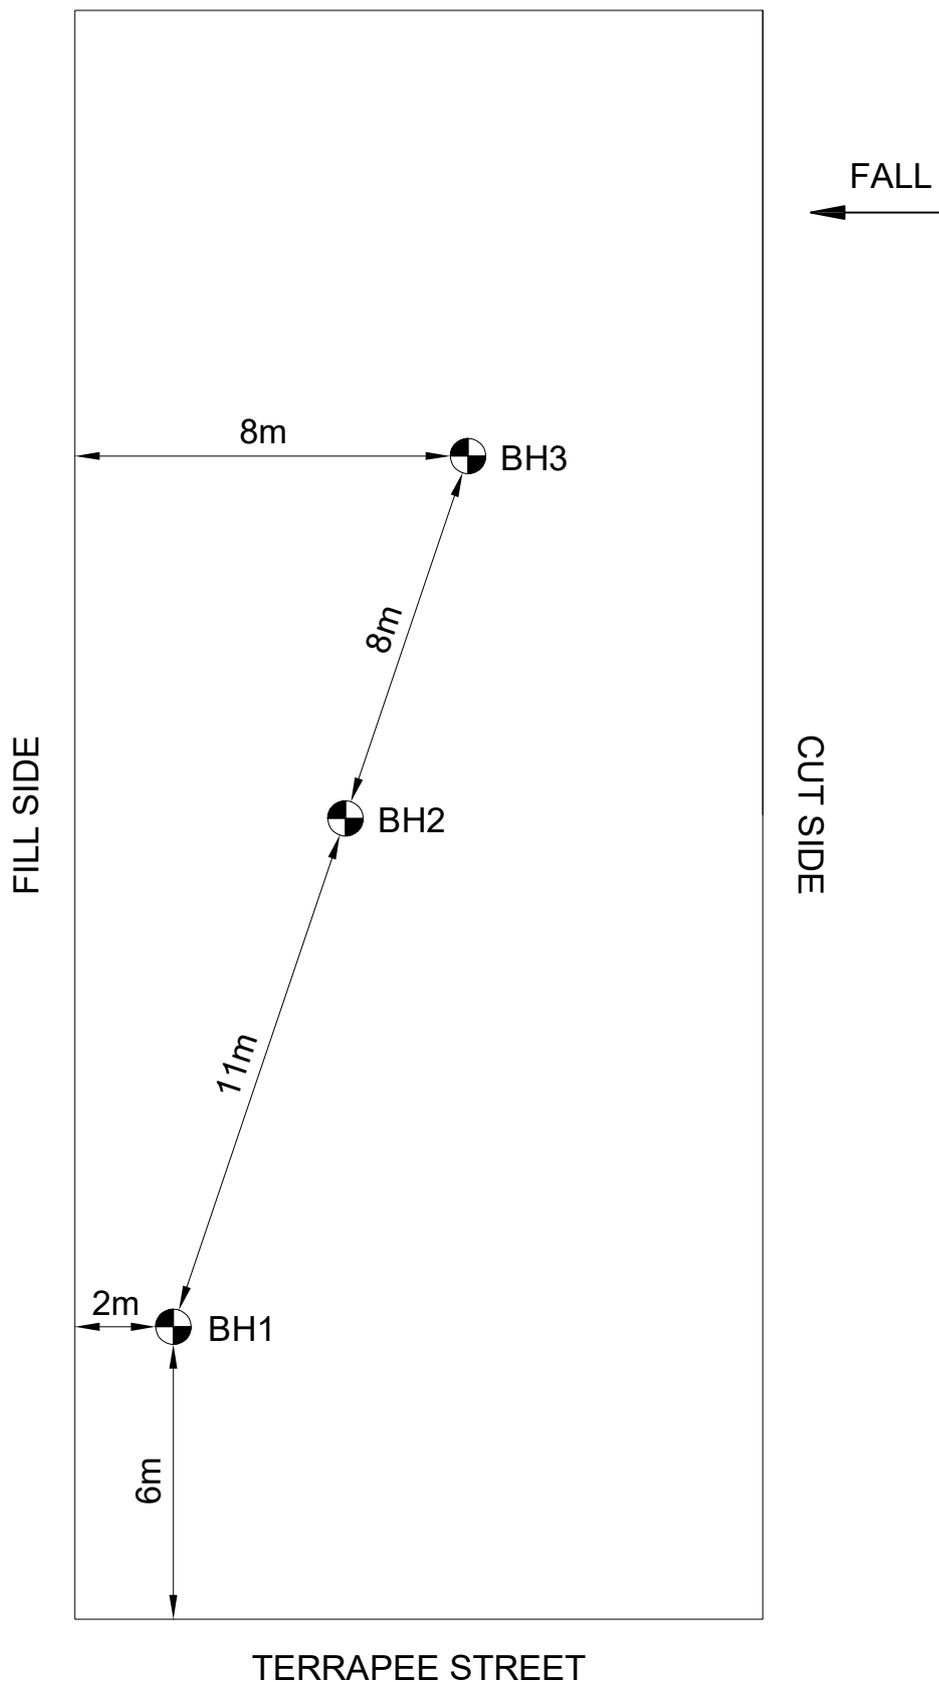
GEOTECHNICAL INVESTIGATION

APPROXIMATE LOCATIONS
NOT TO SCALE

CLIENT: VILLAWOOD PROPERTIES
PROJECT: LOT 3109 TERRAPEE STREET,
STRATHFIELDSAYE

The investigation was conducted on the 16th of August 2024 using a vehicle mounted drill rig to drill 3 boreholes to depths of 1.5 to 3.0 metres within the designated area. The soil profiles and borehole locations are presented at the end of this report.
