# Lot 3112 Terrapee Street Strathfieldsaye

Geotechnical Investigation for  
Villawood Properties

Report 24C 0691  
August 2024

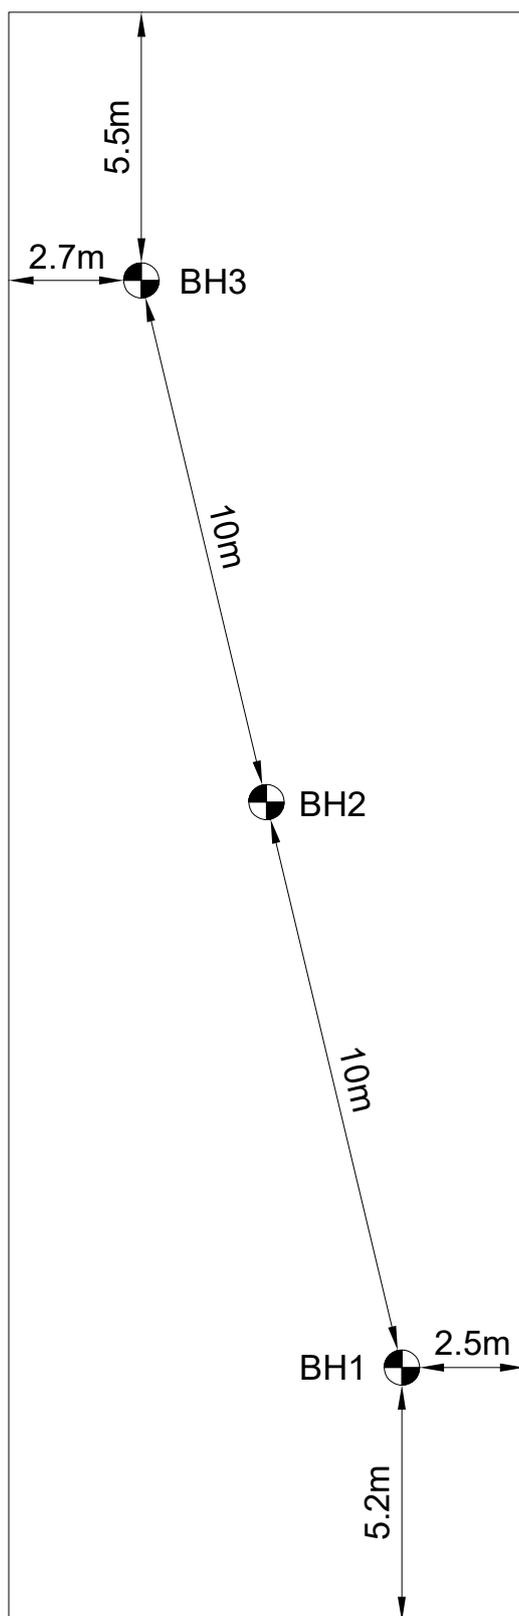
## GEOTECHNICAL INVESTIGATION

TERRAPEE STREET

APPROXIMATE LOCATIONS  
NOT TO SCALE

The investigation was conducted on the 13<sup>th</sup> of August 2024 using a vehicle mounted drill rig to drill 3 boreholes to depths of 3.0 metres within the designated area. The soil profiles and borehole locations are presented at the end of this report.
