LEVEL 1 INSPECTION & TESTING CORIDALE ESTATE STAGE 7B LARA

Prepared for Creo Consultants Pty Ltd

Report Reference: GSSW1303.1 AA

Date: 23 August 2021

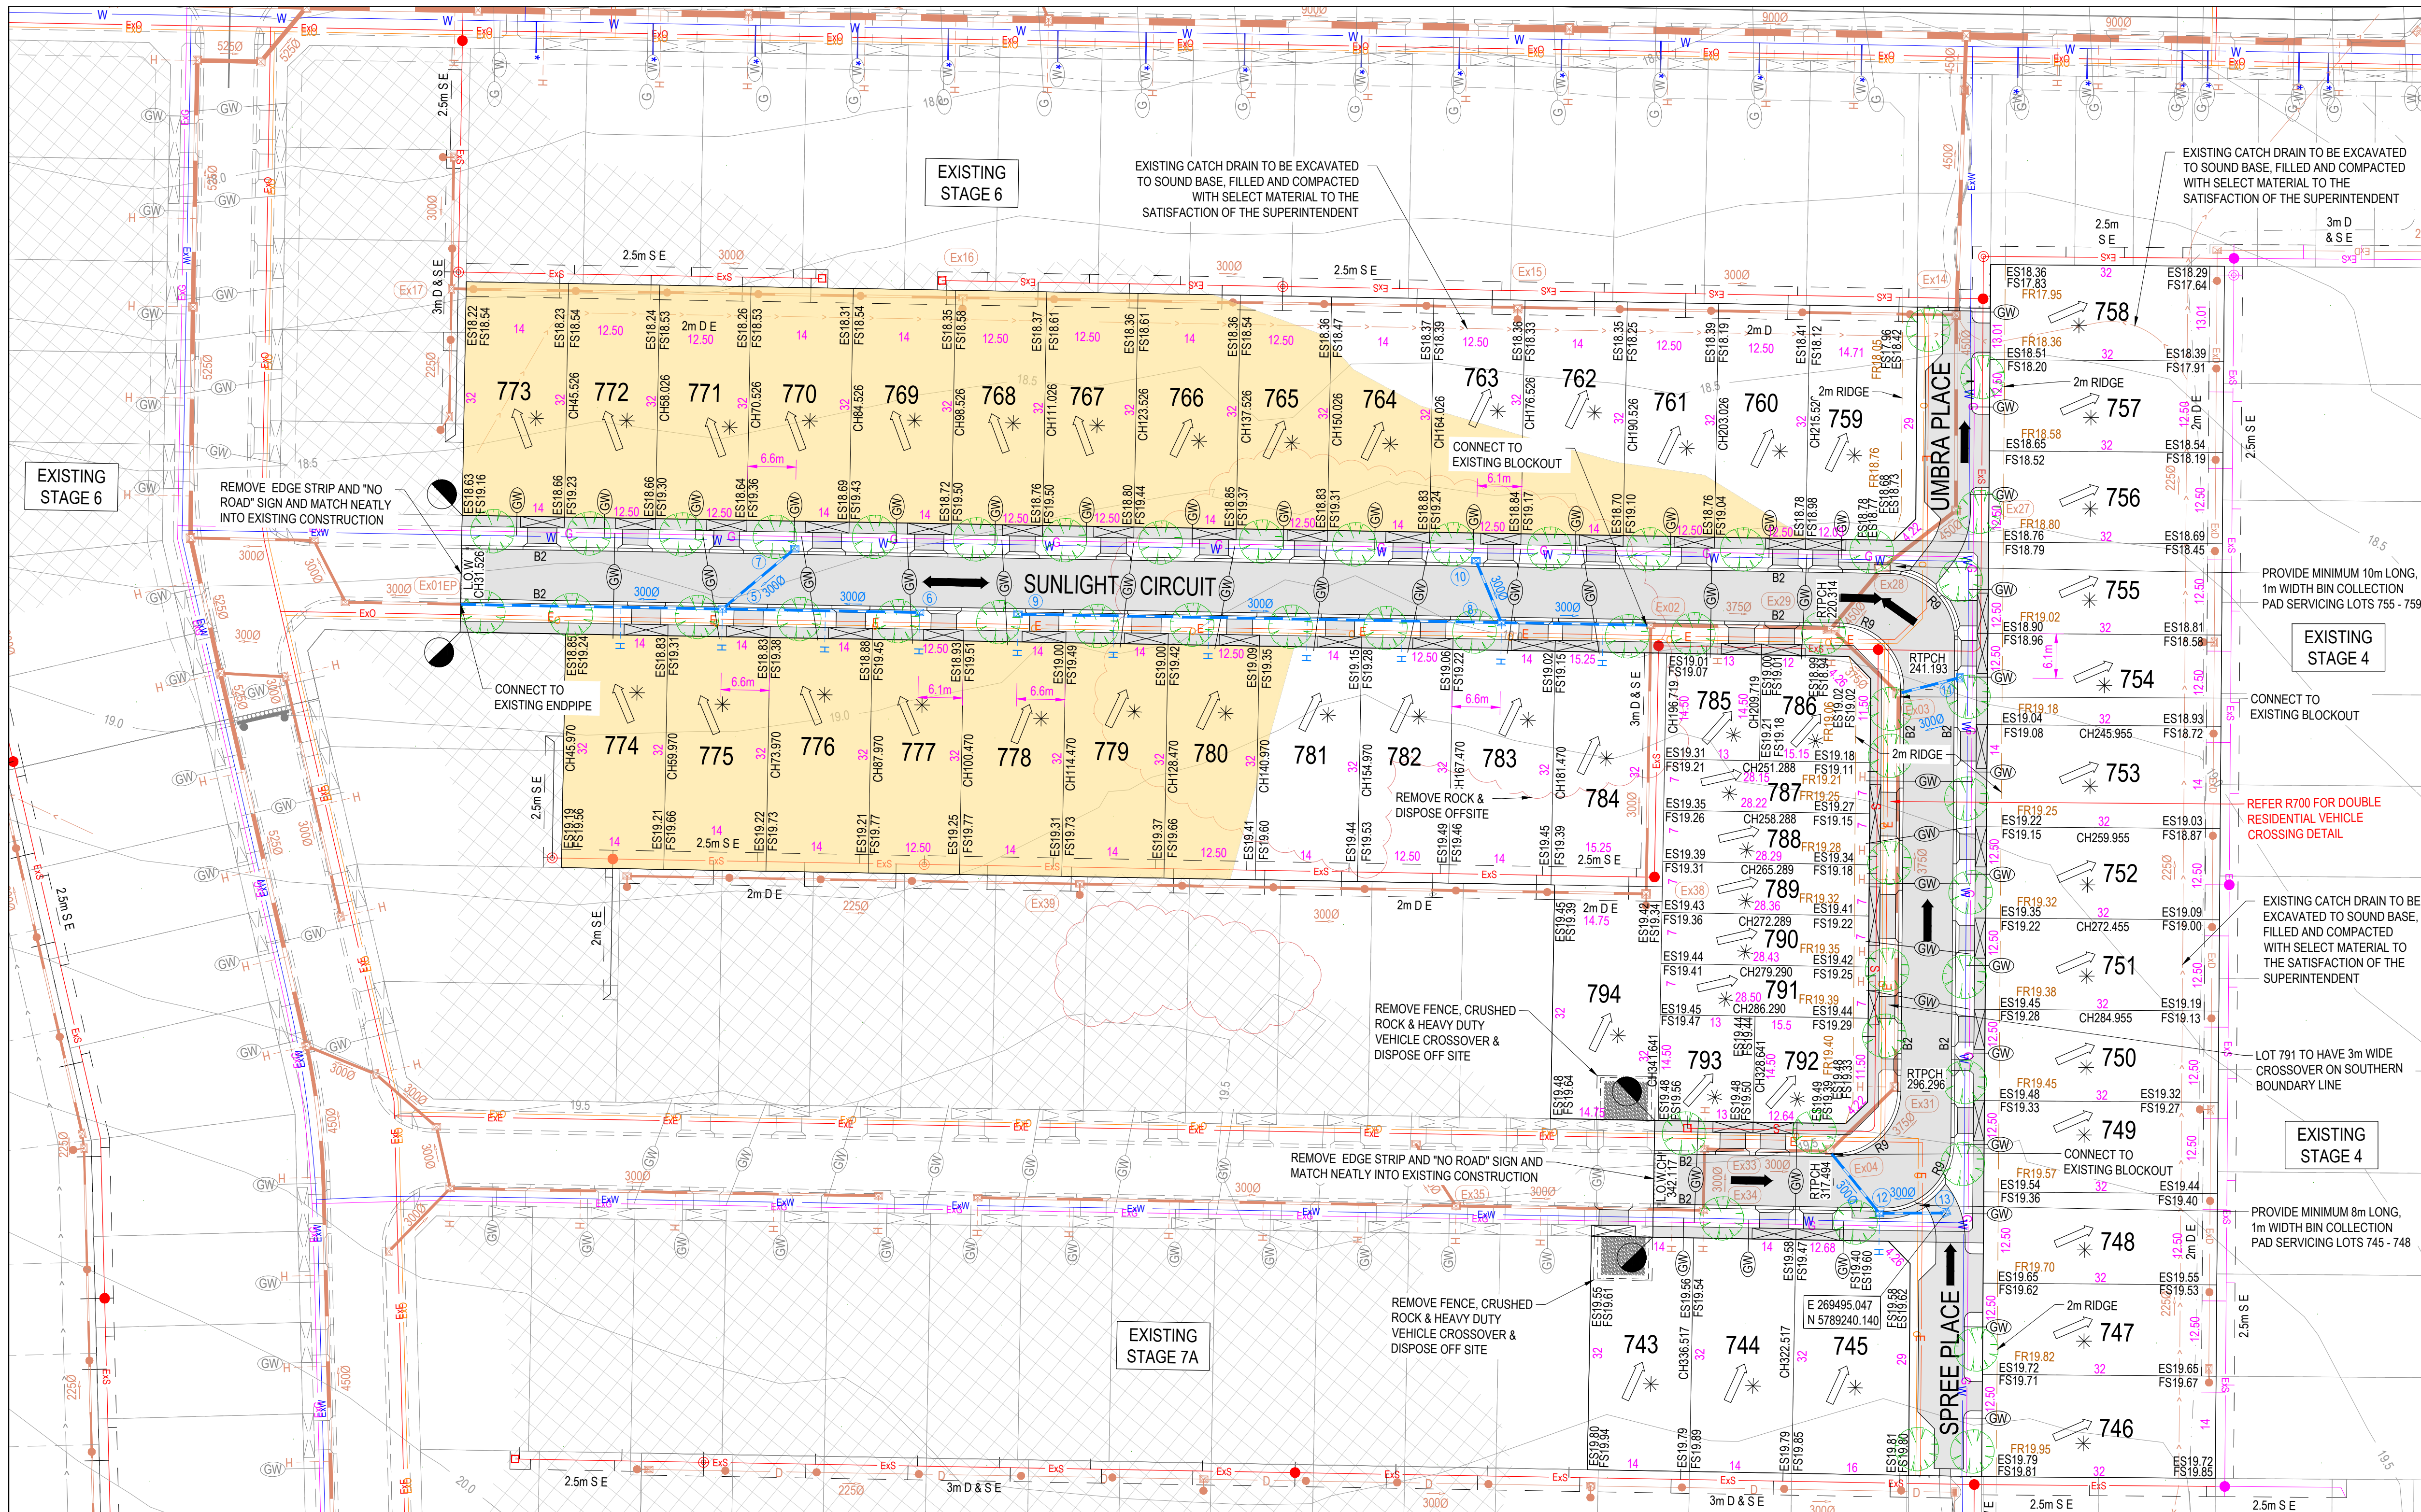
FIGURE 1

Ground Science provided Level 1 Inspection and Testing services for the construction of fill in areas requiring greater than 200mm of fill to achieve finished levels. The areas requiring Level 1 Inspection & Testing are shown on the supplied construction drawing, on Figure 1, prepared by Creo Consultants Pty Ltd (Coridale Estate - Stage 7B Layout Plan – 1 [No. 180014.7B R200 Rev A]).

Coridale Estate - Stage 7B Layout Plan – 1 [No. 180014.7B R200 Rev A]

Observations were made by a Ground Science staff member that filling had been complete up to the nominated finished levels designated on Figure 1 as per confirmation provided from the contractor's site foreman. We understand that the observed final levels are the constructed finished surface levels of the controlled fill. The overall fill depths are estimated using onsite visual tactile methods and may not be a true representation of fill depths given that conditions on site may change over time. True fill depths should be obtained from the contractor's survey data.

Ground Science Staff have undertaken Level 1 Inspection and Testing services of the construction of the controlled fill in the areas designated on Figure 1. Ground Science field staff have also observed that the prepared subgrade provided an adequate base for the subsequent placement of controlled fill.
