## **REDSTONE ESTATE STAGE 21A**

Level One Report

P242081

**RE: Redstone Estate Stage 21A**  
**Level 1 Compaction Control**

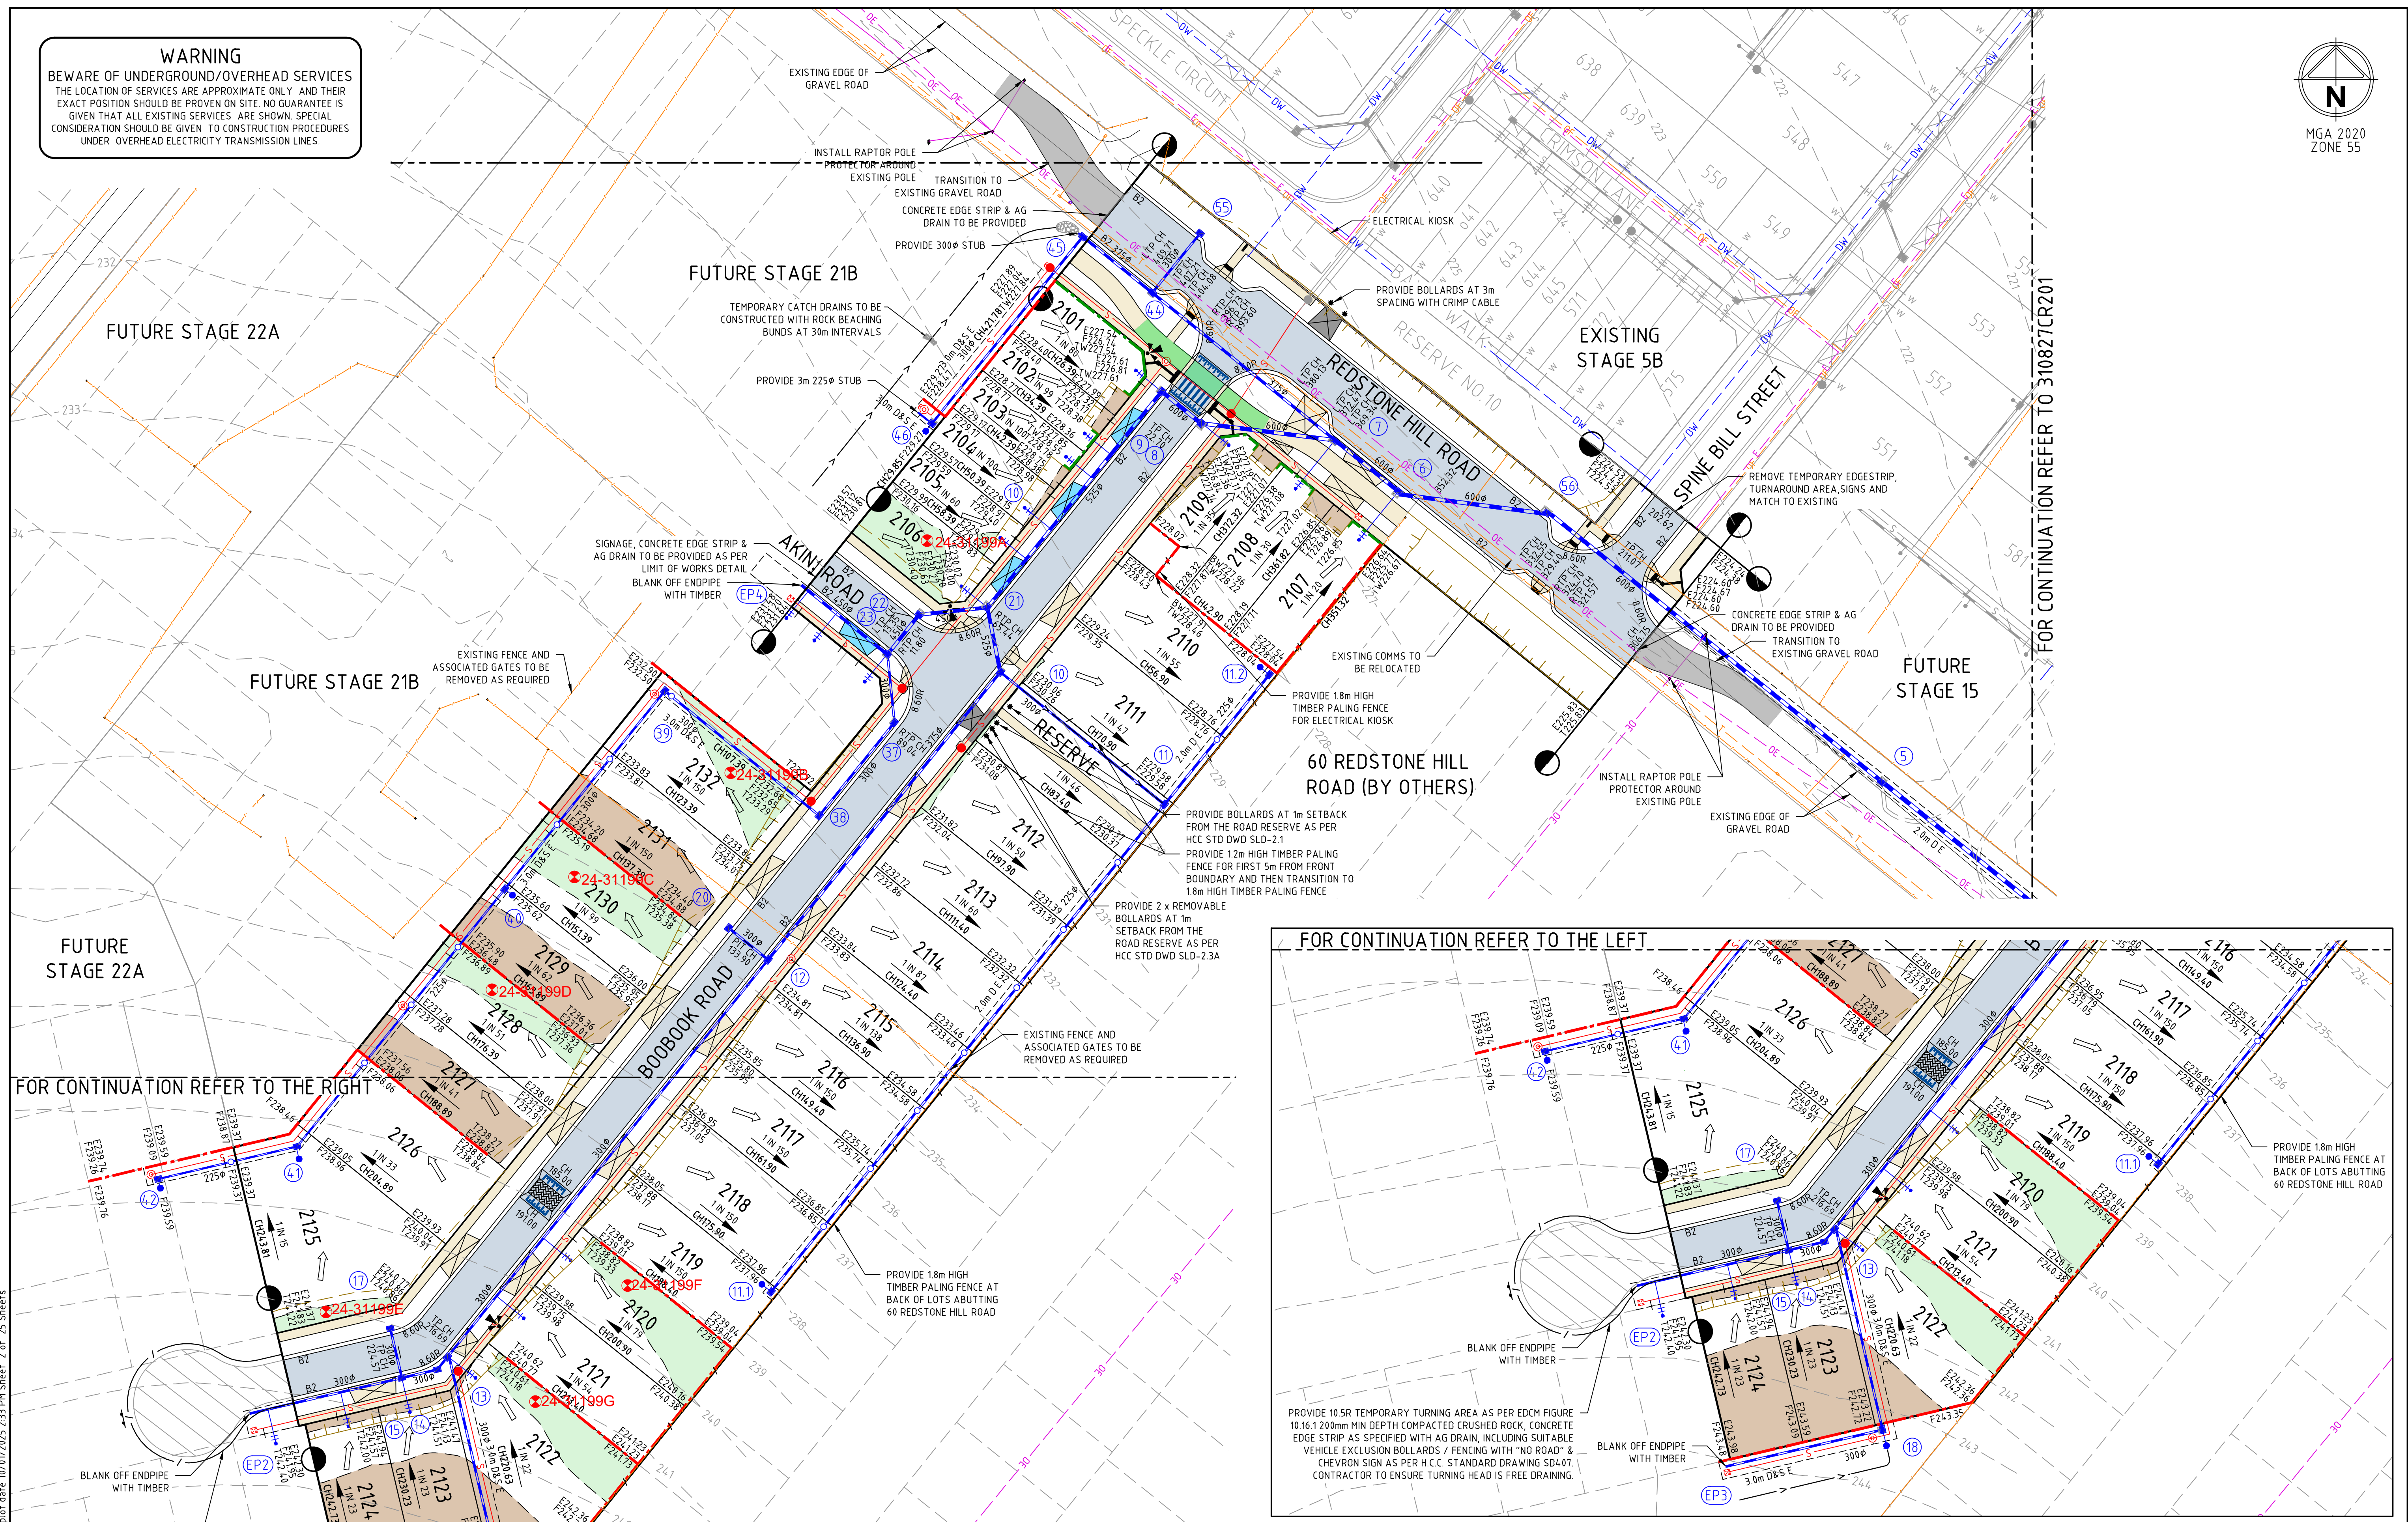
**REDSTONE ESTATE  
STAGE 21A  
ROAD AND DRAINAGE  
FACE PLAN - SHEET 1  
HUME CITY COUNCIL  
VILLAWOOD PROPERTIES**

Initial site inspection showed fill areas as per the attached site plan. These areas were consecutively stripped of all deleterious silty topsoil, organic matter and existing fill down to a Silty Clay. These areas were then compacted with a smooth drum roller and proof rolled with a loaded dump truck.
