Bushfire Attack Level Assessment Imagine Estate, Strathfieldsaye: Stage 17

Bushfire Attack Level Assessment

Imagine Estate - Stage 17

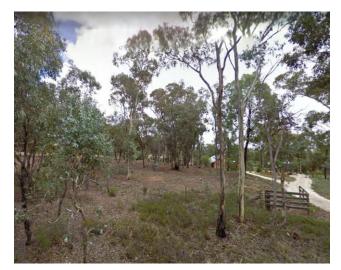
Figure 1. Looking West into the Woodland vegetation within the site

The subject site contains a mixture of Woodland (see Figure 1) and Grassland (see Figure 3) with existing development situated amongst this vegetation. Woodland vegetation is also present to the east of the site beyond Somerset Park Road (see Figure 2). The vegetation patches are detailed in Table 1, and shown on Map 2.

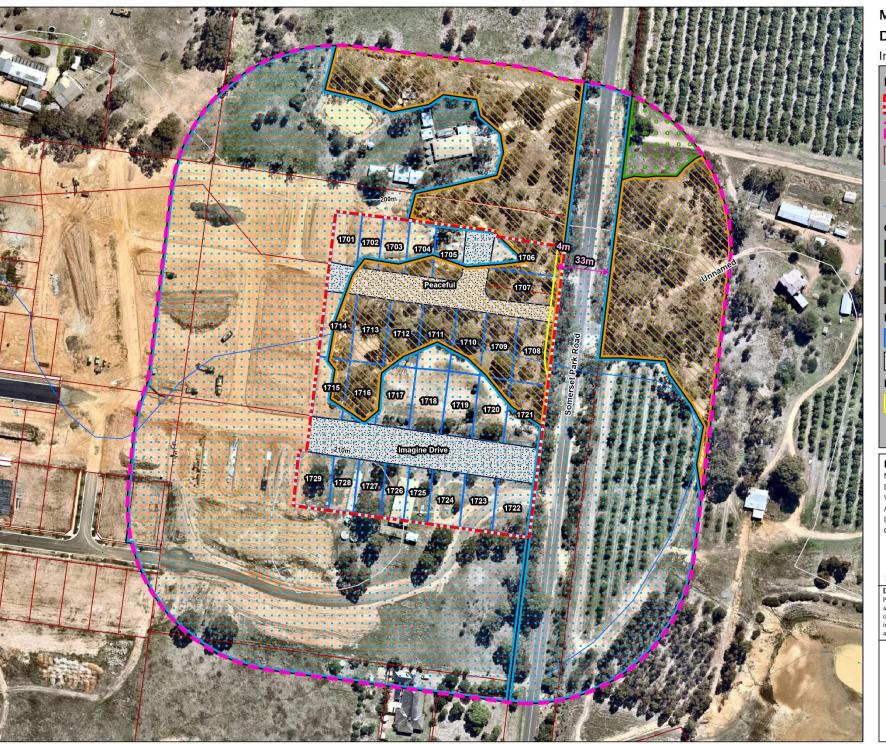
Map 3. BAL Assessment Development

Considering these exemptions, the only vegetation that will require a response to is the Woodland vegetation east of Somerset Park Road. Map 3 details the required setback of a building within lots 1706–1708 to achieve a BAL-12.5 Construction Standard. Remaining lots within the proposed subdivision will not require any setback to adhere to a BAL-12.5 Construction standard.

The majority of this vegetation is proposed to be cleared during the development of Imagine Estate (Table 1, and shown on Map 3), and is therefore exempt from the BAL Assessment. These areas include vegetation within a proposed residential subdivision to the north, south and west of the site. These areas are covered by the Development Plan Overlay – Schedule 26 which provides additional assurance that they'll be managed as residential.
